**Air Accidents Investigation Branch**

**Report on the accident to  
Pilatus Britten-Norman BN2B-26 Islander, G-BOMG  
West-north-west of Campbeltown Airport, Scotland  
on 15 March 2005**

Published 10 November 2006

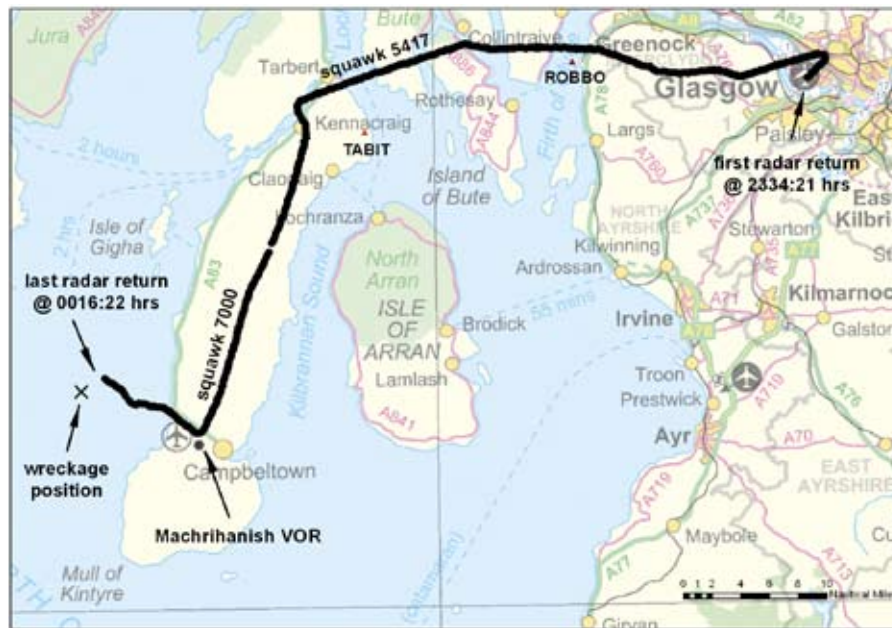
**Figure 5**

The track of G-BOMG, based on the SSR radar returns, is presented in Figure 5. The radar returns cover a period from 2334:21 hrs to 0016:22 hrs. With a transponder setting of 5417 and mode C selected, the first return of G-BOMG was from above the end of Runway 05 of Glasgow Airport, at about 740 ft aal, with a calculated ground speed of approximately 72 kt.

Radar track of G-BOMG

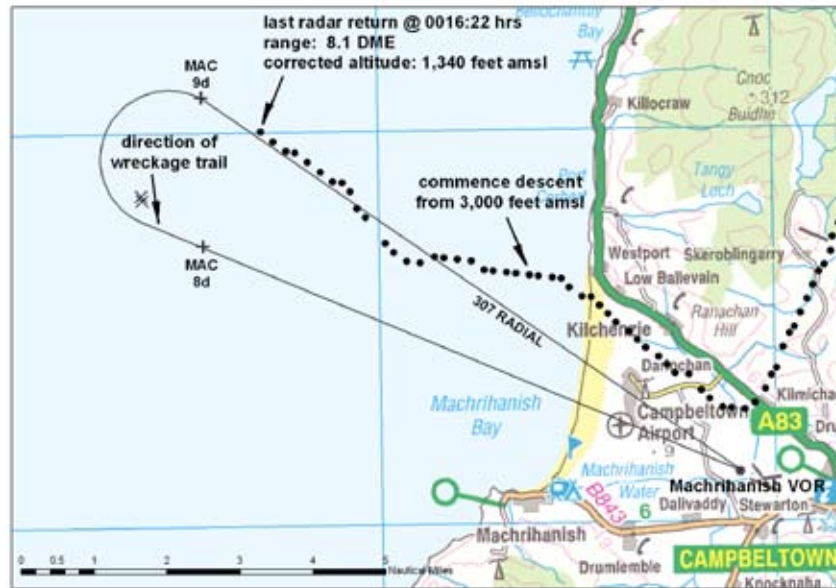
**Figure 6**

At 0013:45 hrs, G-BOMG turned to the left onto an intercept course with the 307° radial from the VOR/DME, and then began to descend. This latter portion of G-BOMG's track, in the vicinity of the Machrihanish VOR/DME, is presented in Figure 6.

The average groundspeed over the last 30 seconds of radar returns was 125 kt (approximately 131 KCAS taking into account the wind at 1,500 ft), having steadily increased from an average of about 120 kt earlier in the descent. The last radar return (0016:22 hrs) positioned G-BOMG at 8.1 DME on the 307° outbound radial, descending at 1,050 ft/min. The SSR mode C for the last return indicated FL017. Correcting for the Campbeltown QNH of 1,000 hPa, the aircraft's Mode C derived altitude at this point would have been 1,340 ft. Allowing for a maximum resolution error of plus or minus 50 ft in the Mode C returns, the aircraft's altitude would have been between 1,290 ft and 1,390 ft. The procedure minimum altitude at the position of the last radar return was 1,540 ft.

Radar track of G-BOMG in the vicinity of the Machrihanish VOR

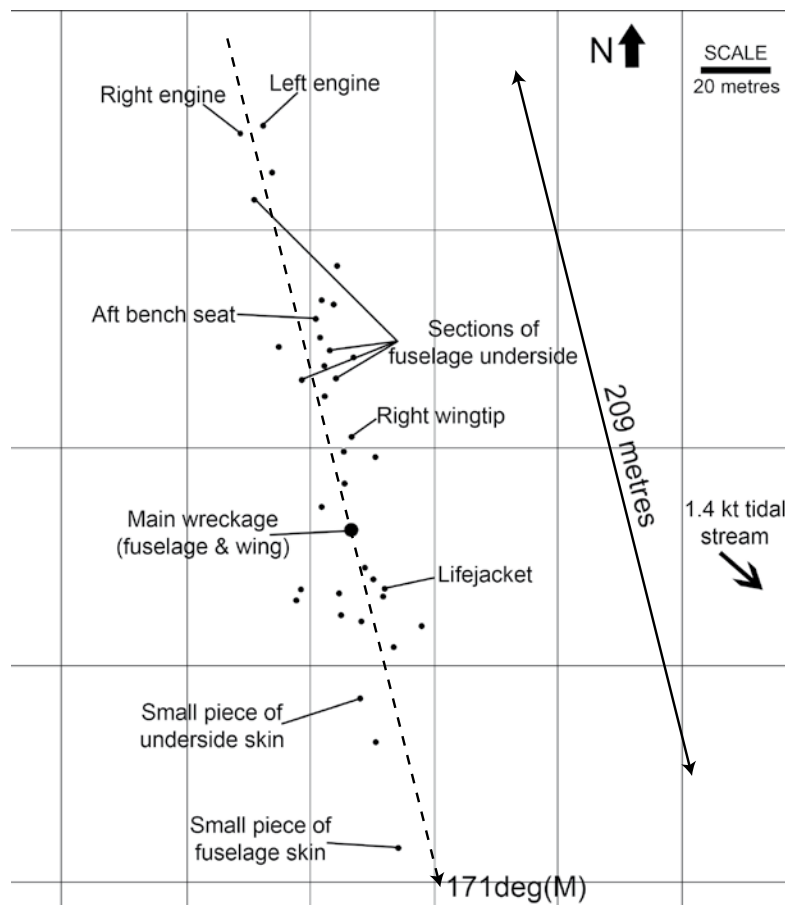
**Figure 7**

The accident site was located in the sea off the coast of Kintyre, 7.7 nm west-north-west of Campbeltown Airport. The wreckage was at a depth of 78 m and the wreckage trail was approximately 209 m long and 50 m wide. The two engines, located 7 m apart, at a position  $55^{\circ}29.21'N$   $005^{\circ}53.68'W$ , were the northern-most pieces of wreckage. The remaining wreckage was distributed south of the engines on an approximate track of  $171^{\circ}(M)$ . The main wreckage, consisting of the wings and fuselage, was located 117 m from the engines along this track. A plot showing some of the recorded wreckage debris is shown in Figure 7. The approximate tidal stream at the time of the accident was flowing in the direction of  $142^{\circ}(M)$  at 1.4 kt.

Plot of some of the wreckage debris at a depth of 78 m

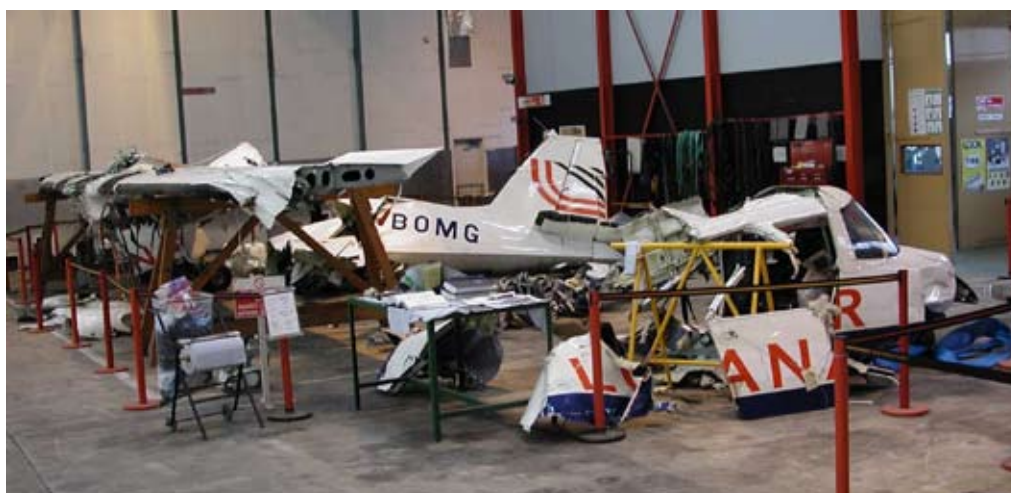
**Figure 9**

The aircraft had suffered severe structural break-up consistent with impact with the sea. The wreckage as laid out in the AAIB's hangar is shown in Figure 9. The aircraft's fuselage had broken into three sections: the front fuselage, the centre fuselage with the wings attached, and the rear fuselage. The three sections were held together on the seabed primarily by wiring and control cables. A large section of the centre fuselage floor had broken into multiple pieces. The forward and centre sections of the fuselage lower skin exhibited evidence of 'hydraulic'ing<sup>10</sup>, indicative of a moderate to high speed impact with the sea. Both engines, with propellers attached, had separated from the wing structural mounts. The right main-gear leg was still attached to the wing and was bent aft while the left main gear leg had separated. The left horizontal tailplane underside had an impact print consistent with the shape and size of the left main gear leg. Both the left and right wing tips, and outboard wing leading edges had suffered impact damage. The nose gear leg was bent aft and to the right. The cockpit area, including the windscreen and instrument console had suffered little damage, but the cockpit roof had collapsed due to the loss of structure on the sides. The flaps were in the UP position. An emergency checklist was found in its normal, stowed position on the right hand instrument panel.

Recovered aircraft wreckage

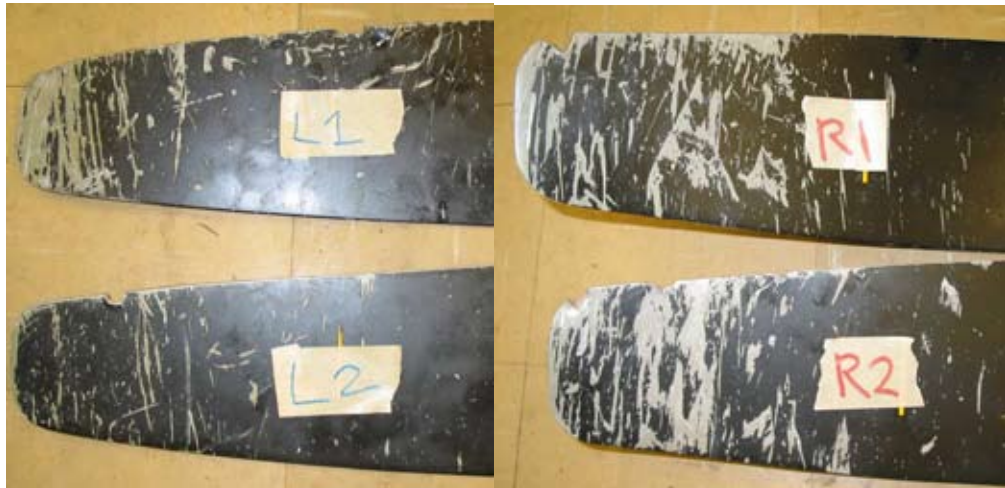
**Figure 10**

Both propeller blades from the left engine were bent aft and had chordwise scratches near the tips. Both blades also had one or more large leading edge indentations near the tips (see Figure 10). The propeller blades from the right engine had suffered similar damage to the left engine blades; the blades were both bent aft with chordwise scratches and they both had one or more large leading edge indentations (see Figure 10). Both sides of the aircraft fuselage, in line with the propeller's path, exhibited evidence of slash marks consistent with propeller blade strikes. On this type of aircraft the minimum clearance between the propeller and the side of fuselage is 10 inches. A strip examination of the propeller hubs was carried out. All four blades were latched in the fine pitch position (ie had not been feathered) and no evidence of a pre-impact failure within the variable-pitch mechanisms was found.

Left (L) and right (R) engine propeller blades – note leading edge indentations and chordwise scratches

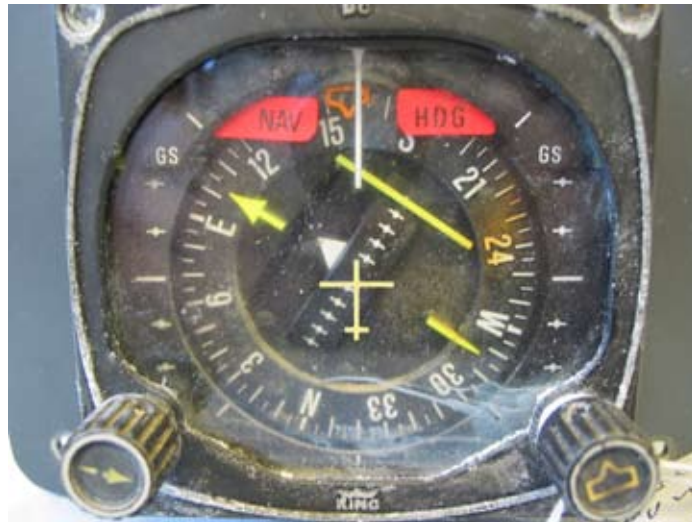
**Figure 11**

‘Course Select’ setting for the VOR approach into Campbeltown was 115°. These HSI settings could have changed during the impact sequence, although the ‘Course Select’ arrow is reasonably secure as it rotates in concert with a sizeable mass within the instrument. The Omni Bearing Indicator (OBI), which was also capable of displaying VOR deviation information, had a course setting of 309° which was within 2° of the 307° outbound radial for the Campbeltown VOR approach.

Horizontal Situation Indicator (HSI) from G-BOMG – note yellow course selector arrow set to 103° and orange heading bug set to 157°
