FINAL REPORT

AAIU Formal Report No: 2009-003

Manufacturer: Cessna Aircraft Company

Model: 208B

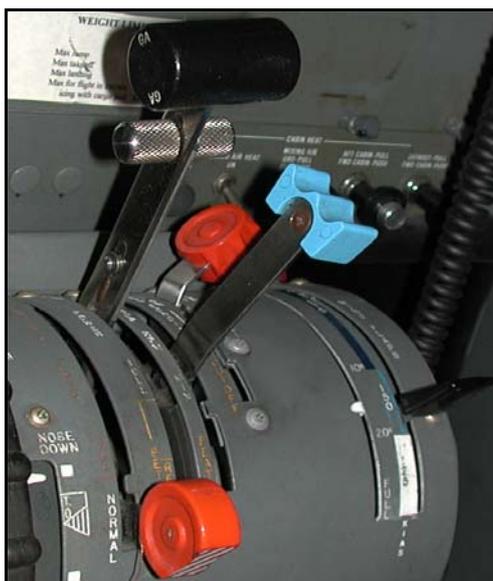
Photo No. 1: Powerplant and flap controls

Five control levers are mounted on the central pedestal of the Cessna 208B, between the pilots' seats as in **Photo No. 1**. The Flap Lever is mounted on the right hand side of the pedestal and the other four levers control the powerplant. Those levers are from left to right: Emergency Power Lever, Power Lever, Propeller Control and Fuel Condition.

The Power Lever was found at a high power setting, just short of maximum. The Propeller RPM Lever was found approximately 2.5 cm (1 inch) from maximum. The Fuel Condition Lever was noted in the "low idle" position. Since the controls to the fuel control unit had separated the pre-impact lever positions of these levers could not be determined with the exception of the Emergency Power Lever, which was wire locked in the "Normal" position. The Flap Lever position was approximately 10°.

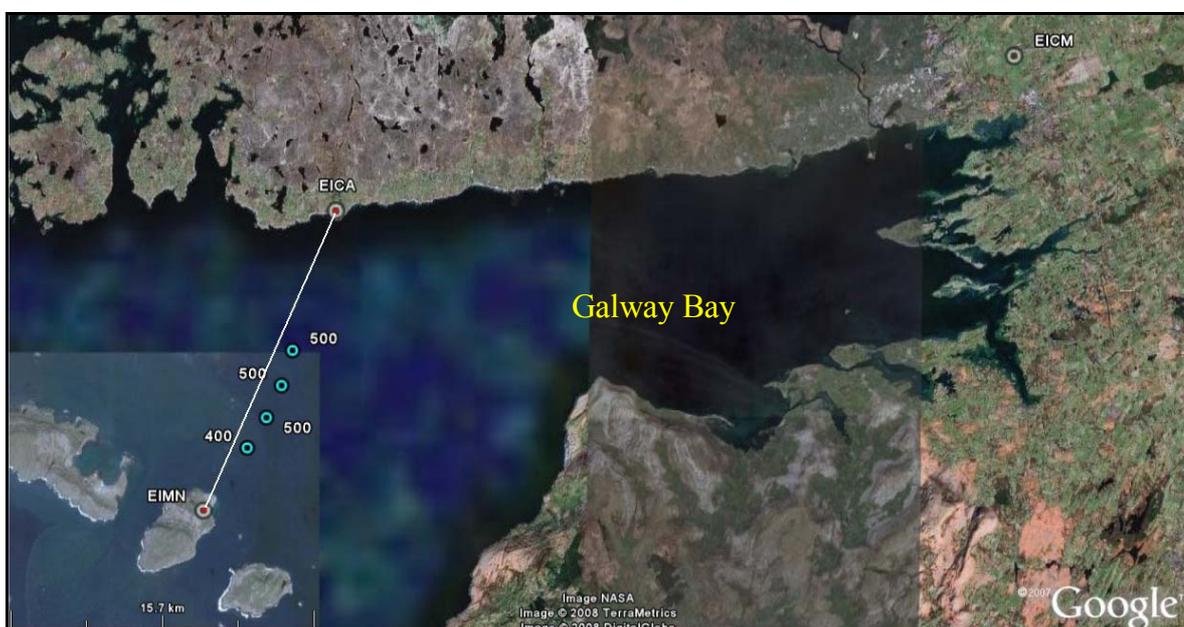
Graphic No. 1: Radar position and height plot of N208EC between 13.45:30 and 13:46:40 hrs.

Similarly, radar observed the aircraft for a limited part of the accident flight, appearing at 13.45:30 hrs but at a lower height of 500 ft. It disappeared off screen at 13.46:40 hrs. The complete ATC radar positions recorded for the accident flight are provided in **Appendix B**. **Graphic No. 1** was constructed from those readouts.

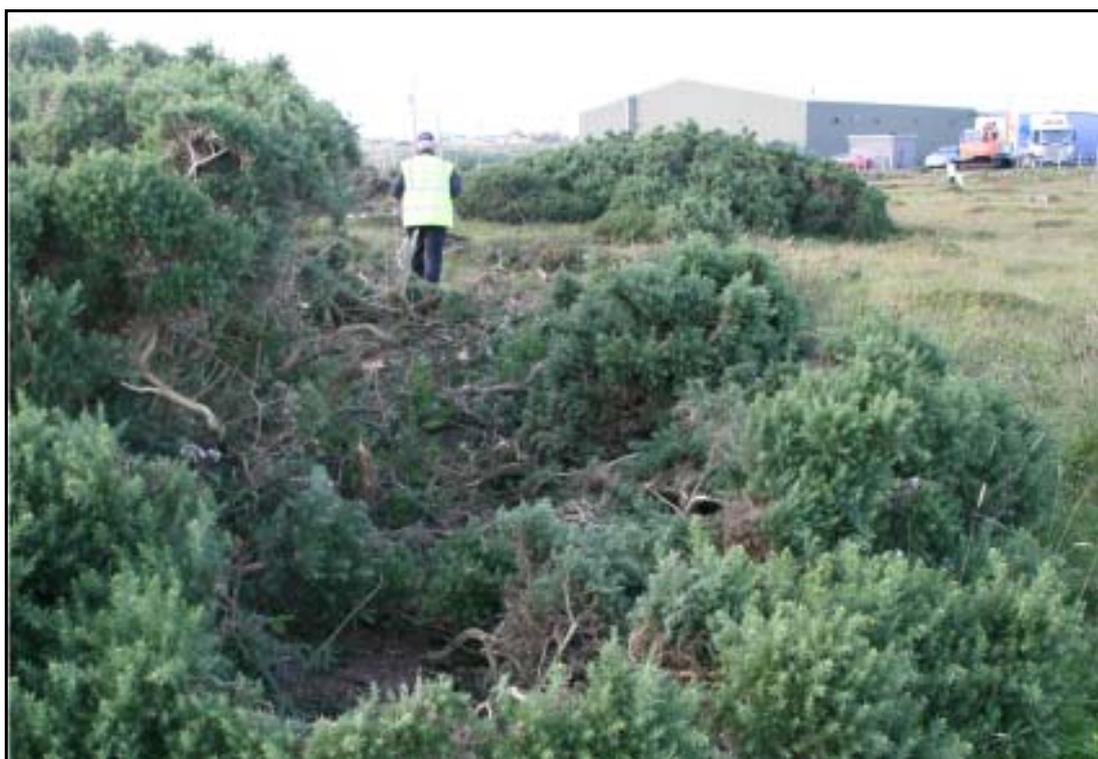
**Photo No. 2: Chopped path through the furze - heading 012°T
(Looking along the line of impact)**

The accident site is located in a field a short distance from the taxiway entrance to the ramp. The taxiway entrance is to the right of the vehicles in **Photo No. 2** below. The field itself is “commonage” or owned collectively by a number of local people. Though generally level, the ground is uneven with a thin cover of soft, peaty soil through which the underlying rock projects. The ground slowly rises in the direction of the debris trail. Initial contact was on the right hand side of a small mound, about three metres high, partially covered by furze (gorse).

A path some 19 metres in length and 012°T in direction, was chopped through these shrubs. The path widened as the ground rose in a northerly direction. On the left hand side of this path, where the furze ended, was a large boulder (**Photo No. 3**) on whose flat face were three vertical strike marks (see **Section 1.18**).

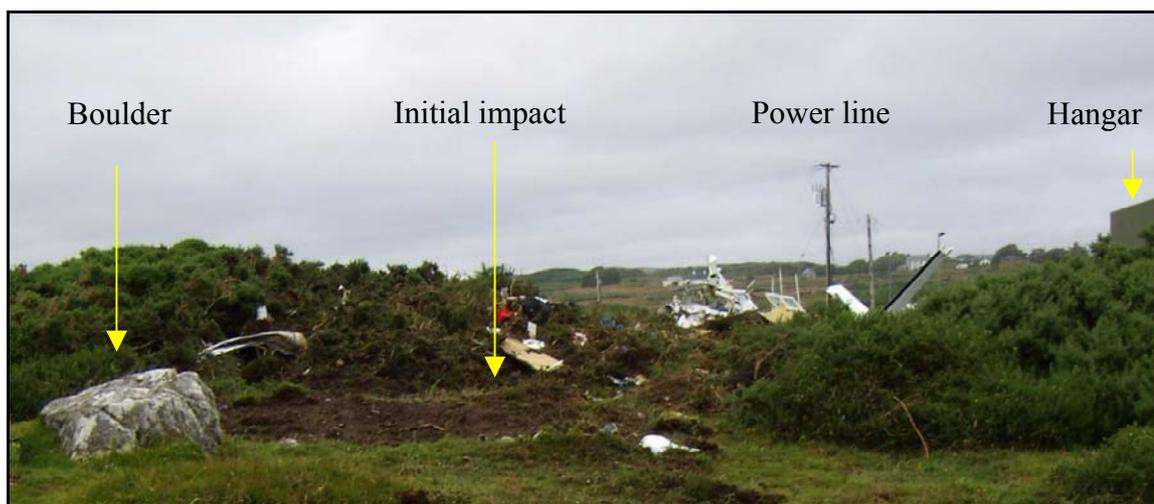
Photo No. 3: Showing boulder, initial impact position, wreckage and power line transformer.

The initial ground impact point was located 3 metres beyond this boulder and there the debris trail commenced. The ground at the initial impact point was soil-covered rock with bare rock to the left in the furze. The impact position was just under the right hand brow of the mound. The main wreckage was located 34 metres beyond this point with the fuselage pointing in the opposite direction to the debris trail. The final impact was in a shallow wet depression, partially filled with water.

The fuel tanks in both wings had ruptured and no fuel remained. However, there was physical evidence of a substantial fuel deposit at the impact site.

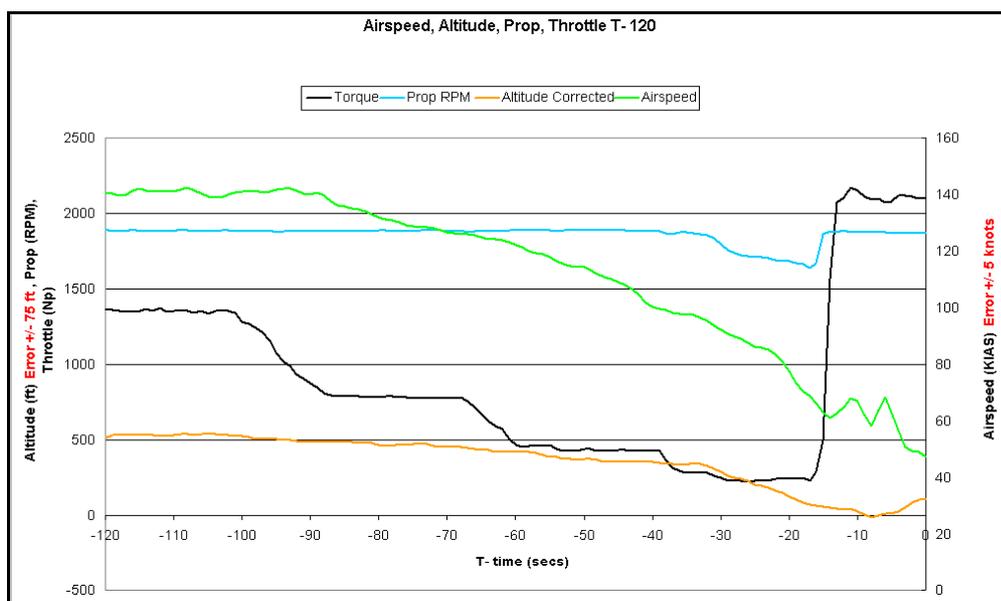
Graphic No. 3: Smoothed final 120 Seconds of ADAS recording

An Aircraft Data Acquisition Unit (ADAS) Model EMU-A-010-3, which monitors engine parameters, was fitted to the engine. This was recovered from the wreckage and, although substantially damaged, Altair the manufacturer successfully downloaded and read its data. It should be noted that the ADAS was designed to monitor engine parameters and not as a flight recorder. It therefore does not, nor is it required to, have the same level of accuracy or sampling rates as a flight recorder. **Graphic No. 3** below has been derived from the ADAS data for the last 120 seconds of the flight. The data in this graphic has been mathematically smoothed and corrected for pressure altitude deviation from standard at the accident time. The final 25 seconds of the amplified raw ADAS data, from T-25 to 0, is given in **Appendix E**.

This low speed is corroborated by a final ADAS recording of 46 kts (accuracy +/- 5 kts). The AMS on board the aircraft also commented that the aircraft was at an abnormally high nose up pitch attitude.

ADAS data confirmed that airspeed decay had by then become excessive and that the overshoot was commenced at an abnormally low airspeed. The consequent torque reaction to the application of maximum power and RPM, about the same time, probably resulted in the aircraft inadvertently turning left towards rising ground and the terminal buildings. Due to rising terrain, the heavy weight of the aircraft and increased apparent weight²¹ in the turn, the resulting drag and lack of altitude did not allow the aircraft to accelerate. This resulted in a semi-stalled condition with the stall warning sounding before impact, as the passengers reported. As the aircraft's speed was on the back of the drag curve and with no altitude available to descend and accelerate, ground impact became inevitable.

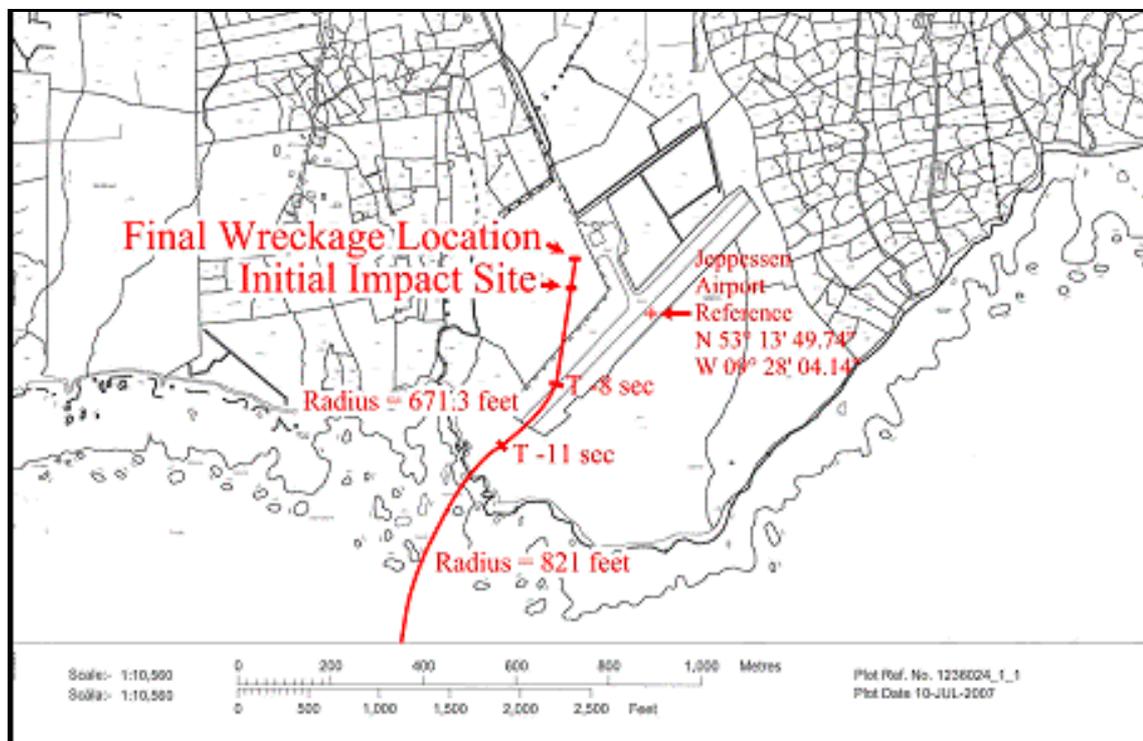
Graphic No. 4: Calculated plot of the final track of N28EC

The ADAS data was corrected for wind velocity and groundspeeds and drift angles were derived. Using ATC radar records during cruise, the observations of ground witnesses and the passengers, the probable final track of the aircraft was calculated yielding turn radii, bank angles, distances and G loading. This is shown in **Graphic No. 4**. The maximum bank angle was estimated at 35° with a g loading of 1.57g.

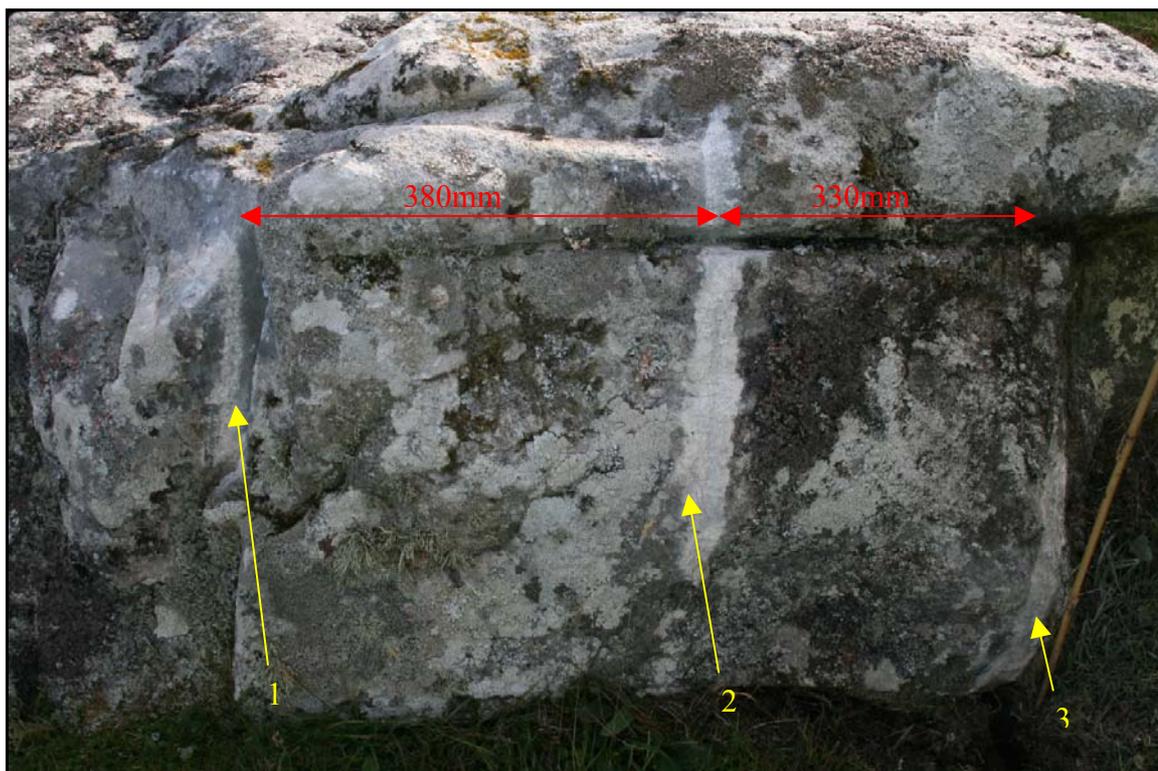
Photo No. 4: Rock with propeller strike marks

A large boulder or rock was situated on the outcrop slightly to the left of the flight path, approximately four metres before the initial impact. Three score marks were visible on the rock face as shown in **Photo No. 4**. The rock surface was an irregular plane whose alignment was not parallel to the direction of flight, but angled towards it. These score marks were regularly but not evenly spaced along the surface. The score marks shapes indicated that the propeller blades were not feathered. A small piece of propeller blade tip was found buried underneath the rock directly below the third score mark. The Investigation determined that the marks were caused by the rotating propeller striking the rock immediately before impact.

The Cessna Caravan has a three-bladed, constant speed, McCauley propeller. In one complete 360° revolution of the propeller would produce four strike marks (three spaces), as the first blade rotates to strike a second time on completion of the revolution. Therefore the three score marks (two spaces) indicate two thirds of a revolution of the propeller. Propeller RPM was 1,868 before impact, as recorded by the ADAS data (see **Section 1.18.2**). This RPM was then used in calculating the ground speed of the aircraft immediately prior to impact.

The Propeller strike marks on the boulder were analysed. If deceleration caused the variation in strike distance the force required would need to be of the order of $-5g$. There are, however, no witness marks at the location that would cause such a deceleration.
