## **FINAL REPORT**

**AIC 07-1002**

**P2-ALU**

**EMB-110P1 Bandeirante**

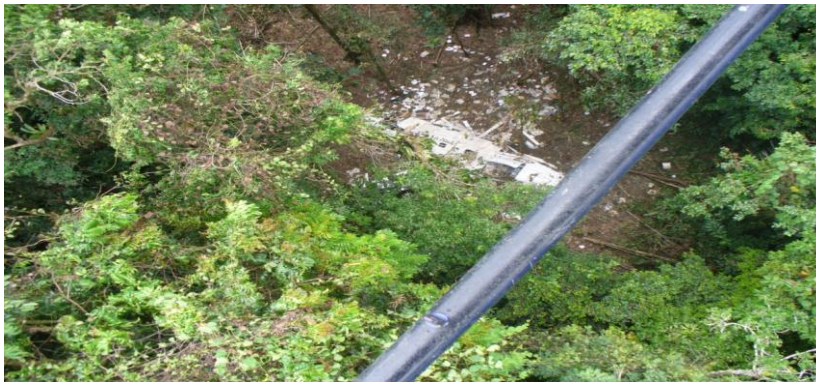
The aircraft was destroyed during the impact sequence after striking numerous trees and impacting the terrain.

**Figure 2: Aerial view of crash site**

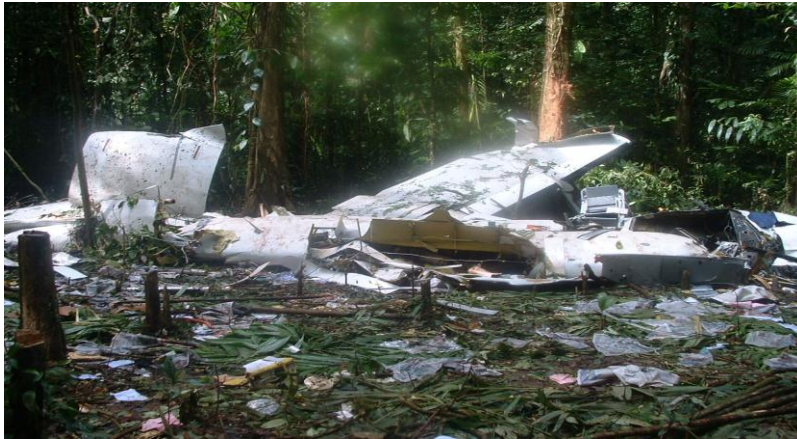
**Figure 3: Main wreckage site**

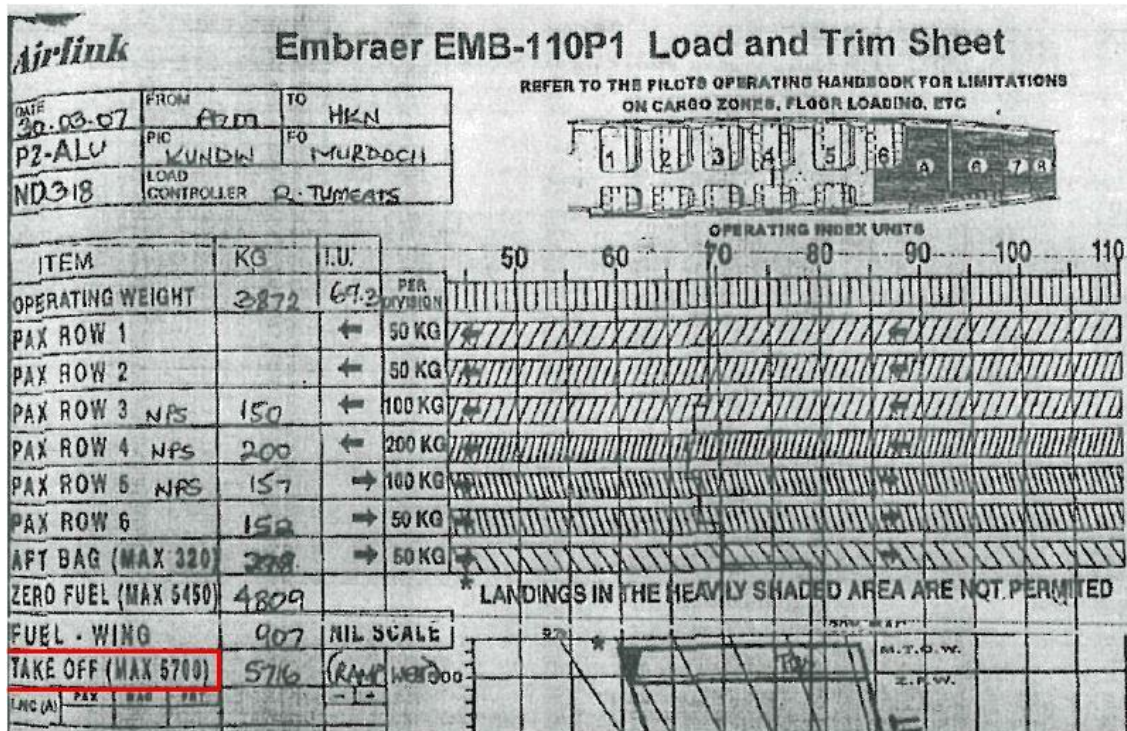
investigation determined that the Basic Operating Weight 3,872 kg as listed on the *Load and Trim Sheet*, was likely that of the passenger configuration and included the fitment of 18 seats (six single seats, and six double seats) in the cabin, weighing about 122 kg. Therefore, the Basic Operating Weight in the freight configuration was about 3,750 kg including two pilots.

**Figure 4: Section of P2-ALU Load and Trim Sheet for the accident flight**

weights, and allowing for a 16 kg pre-take-off fuel burn, the aircraft appears to have been 59.5 kg in excess of the maximum structural weight at takeoff. However, if the weight of the passenger seats was removed from the Operating Weight, the aircraft may have been 62.5kg below the MTOW. It was not possible for the investigation to conclusively determine the actual MTOW on departure from Port Moresby.

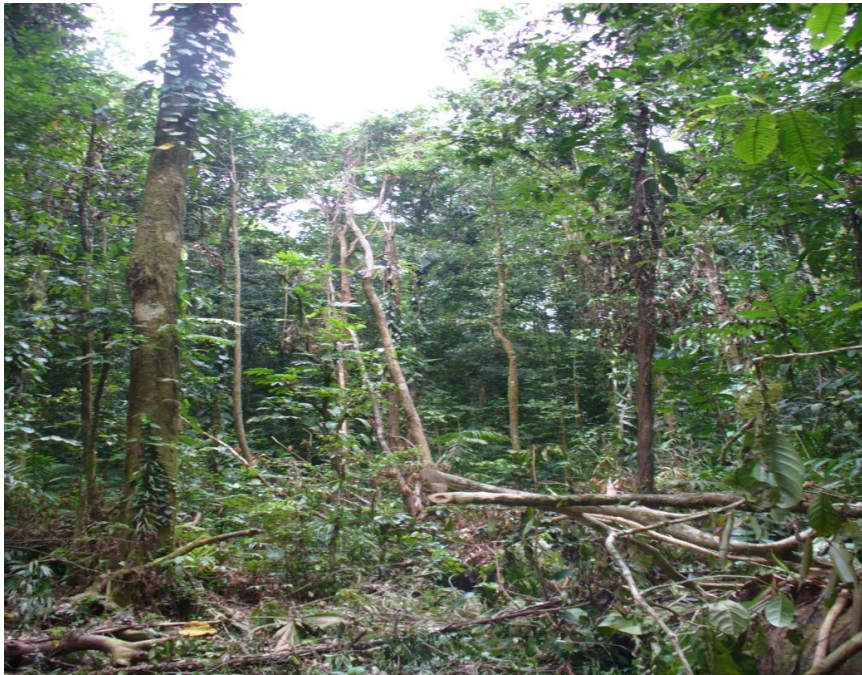
The wreckage was dispersed in a pattern that was consistent with the aircraft impacting terrain at high speed. The wreckage trail evidence indicated that the landing gear was extended, but the wing flaps were in the fully retracted position. The initial impact with trees was with the right main landing gear, which tore the landing gear out of the right wing and severed the wing from the fuselage. The narrow path through the trees provided evidence that, immediately after the initial impact, the aircraft rolled right, and was at a right bank angle of about 45° and a descent angle of approximately 70° until ground impact. Airframe empennage structure and components, the right engine, the right-main landing gear, and portions of the right wing separated during the initial impact. The left main landing gear was found partially extended, or may have collapsed during the impact sequence. The nose landing gear was determined to have been extended at impact.

**Figure 6: The flight path of the aircraft cutting through the trees**  
(photo from the Embraer Air Safety Report)

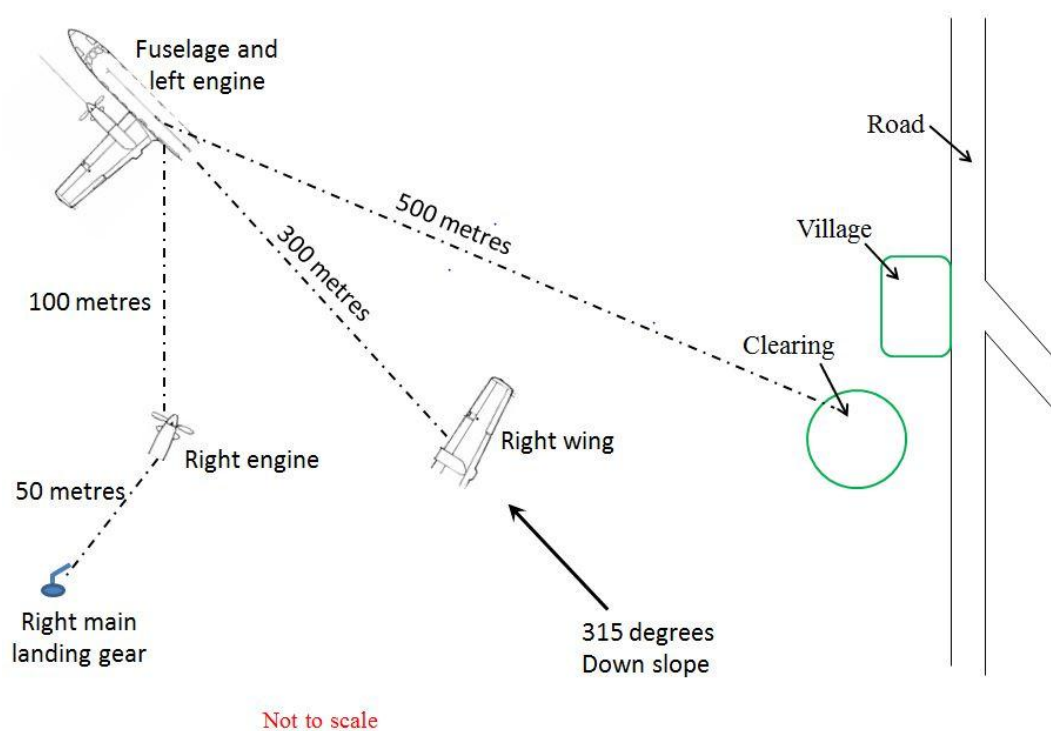
**Figure 7: Sketch of wreckage distribution**

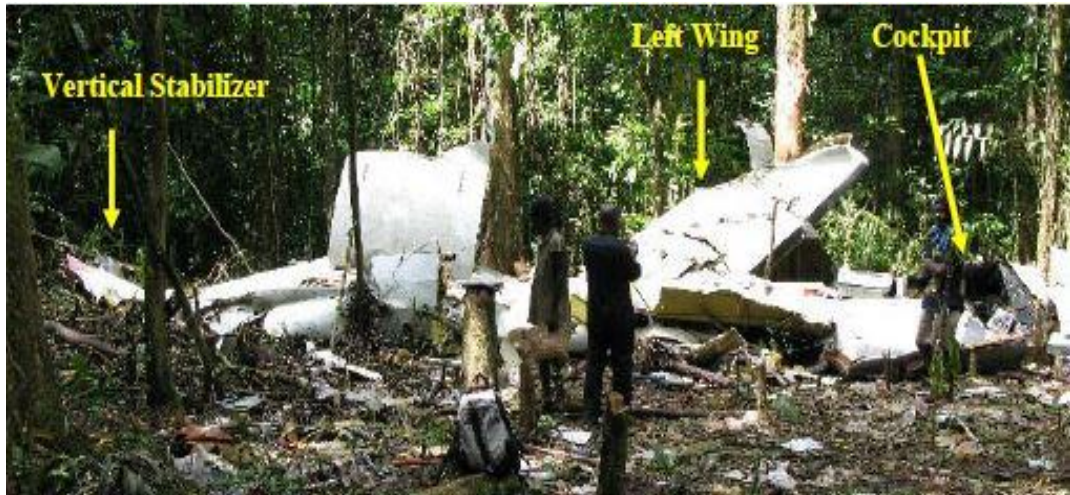
**Figure 8: Fuselage, left wing, left engine and lower portion of vertical stabilizer**  
(photo from the Embraer Air Safety Report)

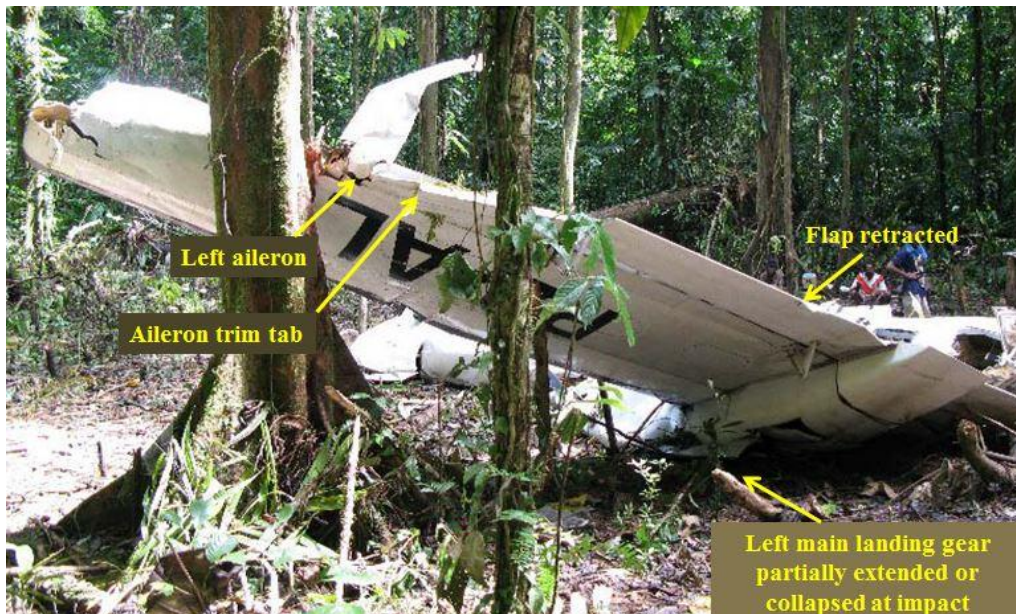
The left wing was still attached to the main fuselage wreckage, but had been displaced forward, allowing the left propeller to make contact with the fuselage. The out-board section of the left aileron was bent upwards, and the attached trim tab was trimmed /deflected downwards, indicating that it was trimmed to roll toward the left.

The outer left wing examination revealed a cord-wise overload failure of the upper wing-skin surface, which was consistent with the aircraft rolling violently toward the starboard side at a 45° angle at the moment of impact. The flaps were found in the retracted positioned.

**Figure 9: Left wing**  
(photo from Embraer Air Safety Report)

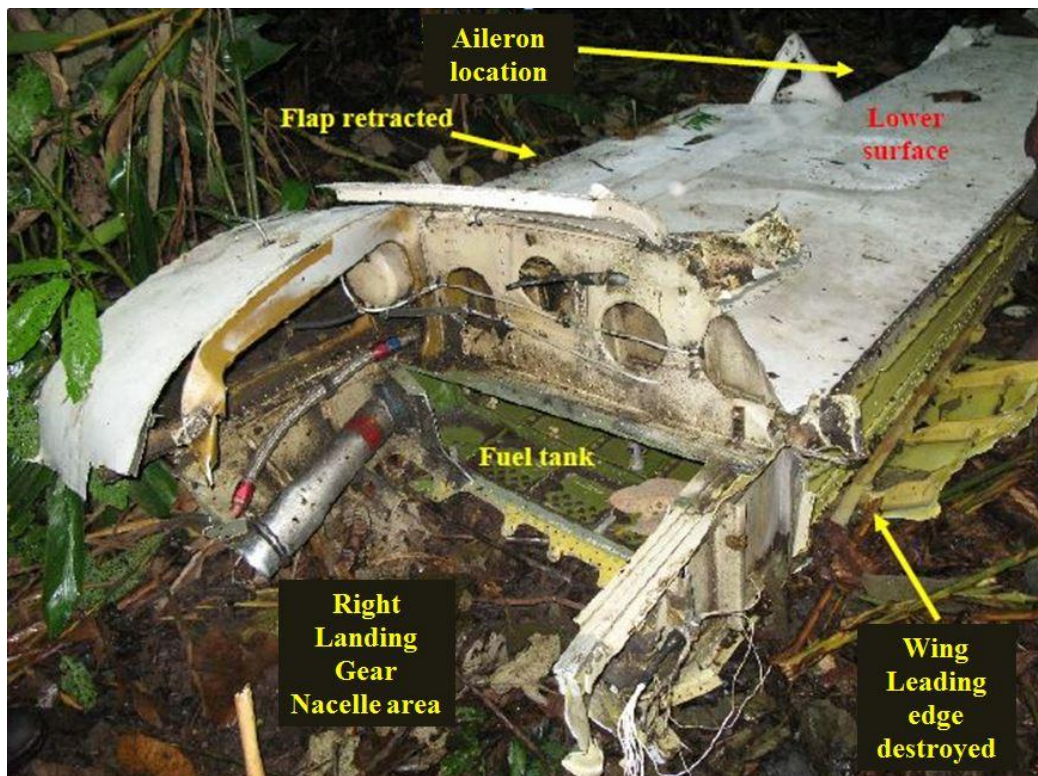
The right wing failed around the right main landing gear nacelle area. At the failed section, both upper spar structures had the appearance of being crushed by compressive forces. The lower front spar structure had deformations of traction and bending upwards, while the lower rear spar structure had deformations of traction, bending upwards and torsion. In this area, two and a half ribs were missing. The ribs were found with the right main landing gear. Ribs six and seven were pulled from the front spar, with rivet holes on spar web deformed aft. The outer failed rib (rib eight) was also the wall of the outer fuel tank section. Most remaining fuel exited the wing tank during the impact. The right wing upper surface, at the failed section, showed upward bending.

Most of the right wing leading edge had separated from the wing, with only a small section attached near the wing tip. At the separated section of the leading edge on the upper wing surface, there were parallel semi-circular scratches, indicating a strike followed by a rotating drag. The right aileron separated from the wing and the remainder of the right flap was retracted.

**Figure 10: Inverted right wing**

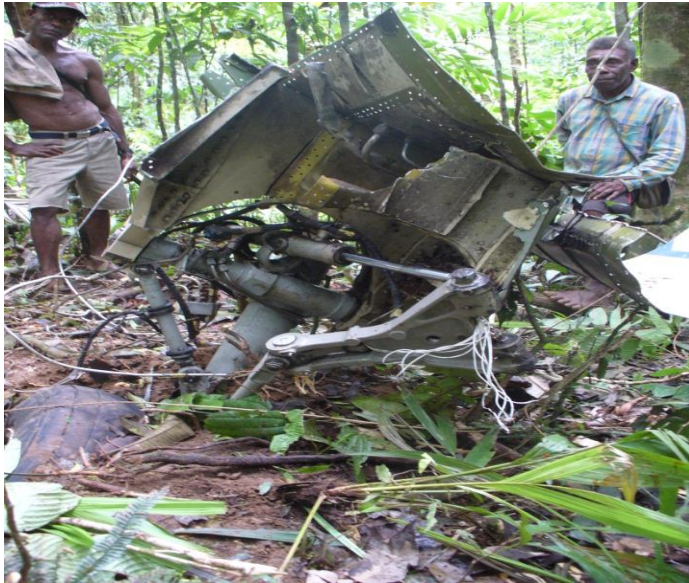
The left main landing gear was partially extended, or may have collapsed during the impact, with the left opening door open, and the right closed.

**Figure 11: Part of the left main landing gear attached to the wing structure**  
(photo from the Embraer Air Safety Report)

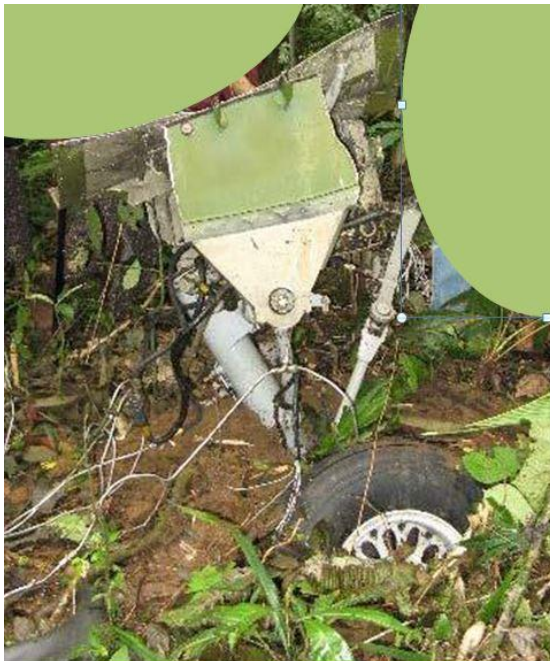
The right main landing gear was found in the fully extended position.

**Figure 12: Part of the right main landing gear attached to the wing structure**  
(photo from Embraer Air Safety Report)

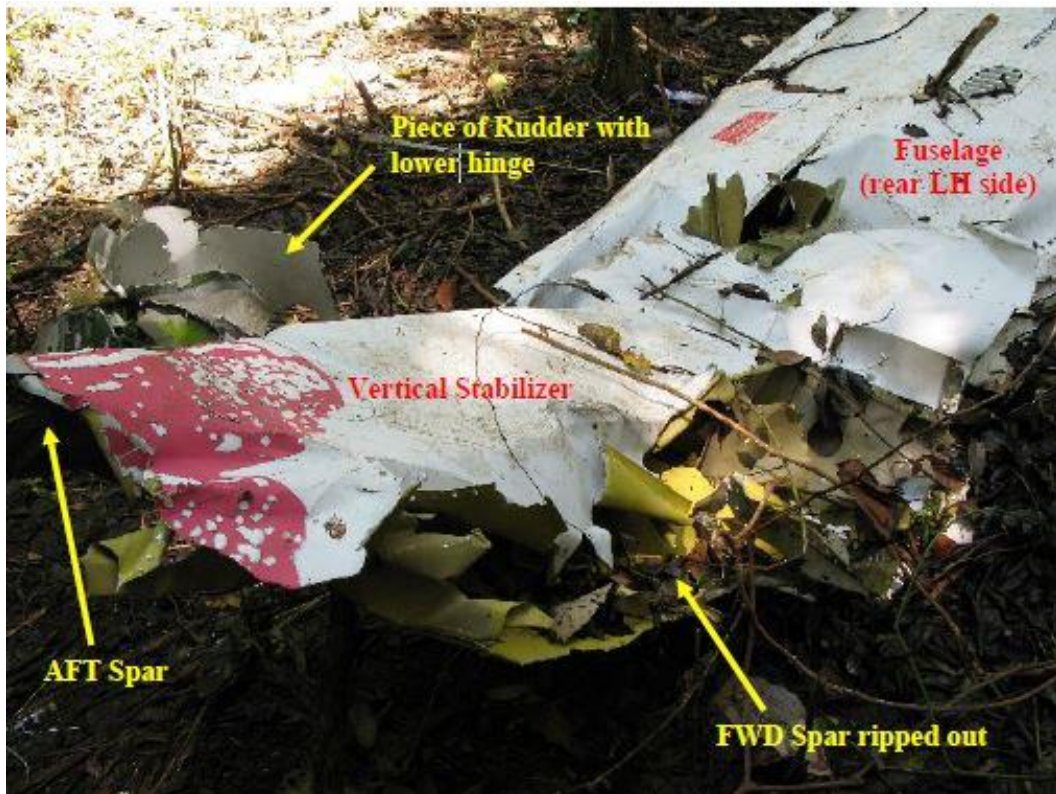
the lower rudder hinge and a lower section of the rudder. The forward vertical stabiliser spar was severely disrupted along with the attached skin panels. The forward main attach points were found broken in over-load failure. The fractured surfaces had a clean metallic appearance, indicating that failure was not caused by corrosion or fatigue. All of the fracture surfaces were consistent with over-load failure. Due to the destruction of the empennage and associated controls by impact forces, the investigation was unable to determine the deflection of the rudder trim tab.

**Figure 13: Section of vertical stabilizer and rear fuselage**  
(photo from the Embraer Air Safety Report)

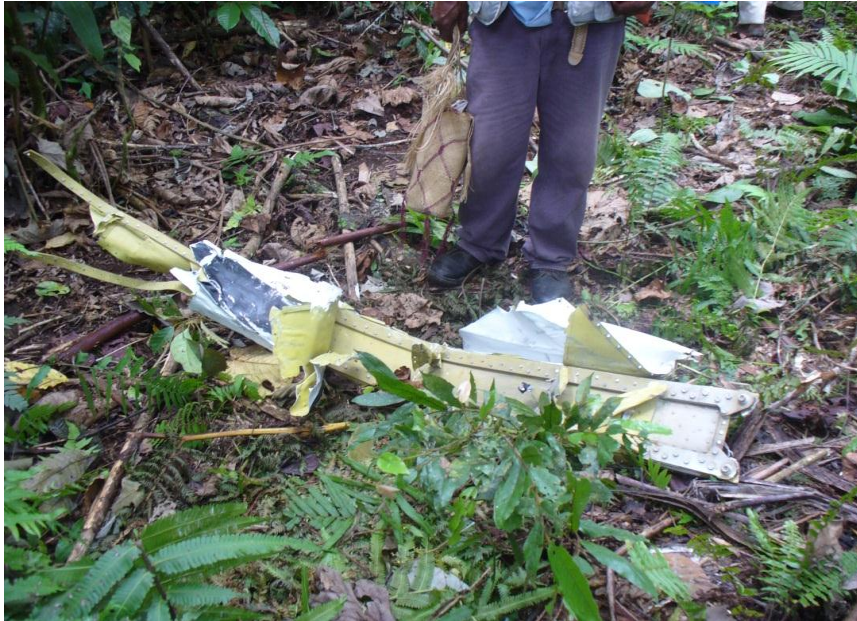
**Figure 14: Vertical stabilizer front spar**

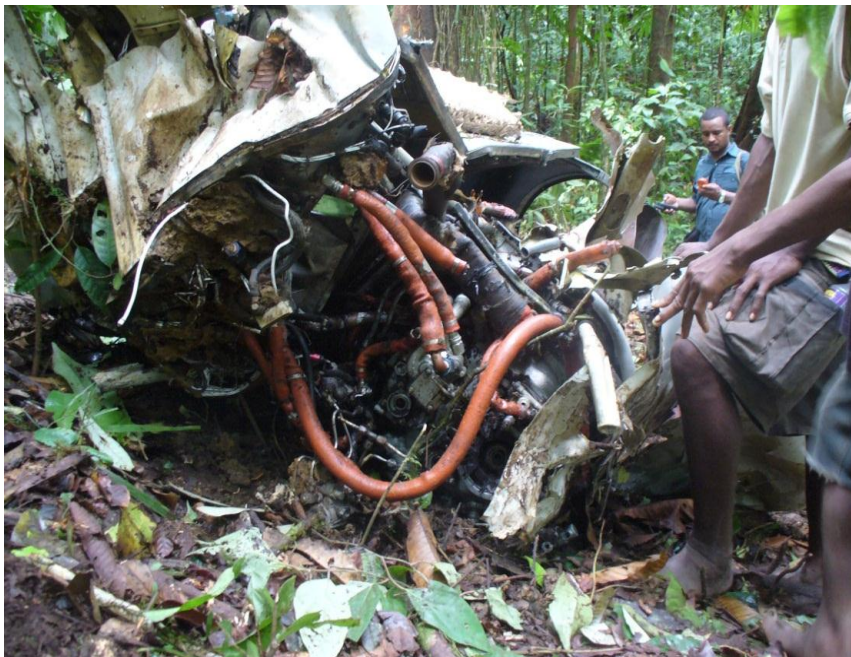
The left engine showed some evidence that it was developing power prior to impact. The propeller was found still attached to the engine, but only one blade was found at the site. An inspection of that blade revealed that it was bent forward, which was evidence that it was being driven under engine power.

**Figure 15: Left engine and propeller**

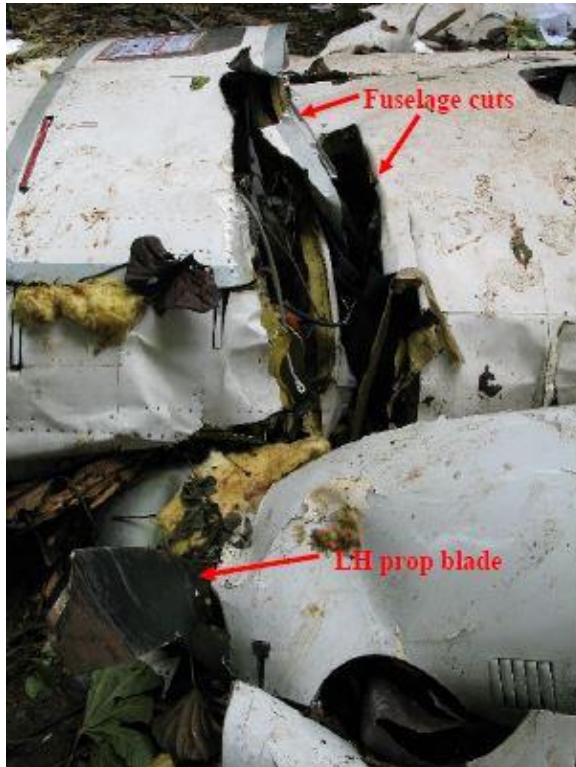
The propeller hub was fractured. The investigation determined that the fracture was likely to have been the result of ground impact, and/or striking the fuselage when the left wing was deflected forward on ground impact. Of the three blades, only one was visible; it was bent forward. The evidence of the propeller blade pitch angle and the forward bend were consistent with the engine developing power and driving the propeller at impact.

**Figure 16: Left propeller blade and fuselage cuts**

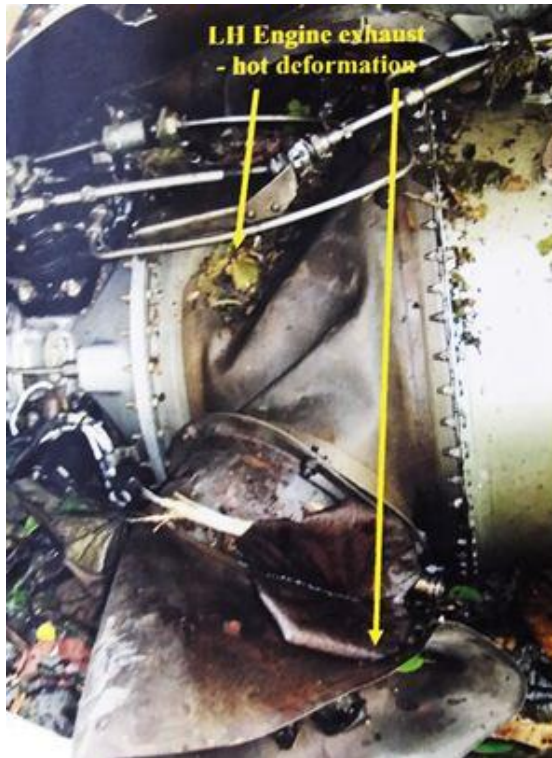
The engine exhaust outlet exhibited clear evidence that it had been deformed while operating at high temperature; further indicating high power at the time of impact.

**Figure 17: Left engine exhaust pipes showing hot deformation**  
(photo from the Embraer Air Safety Report)

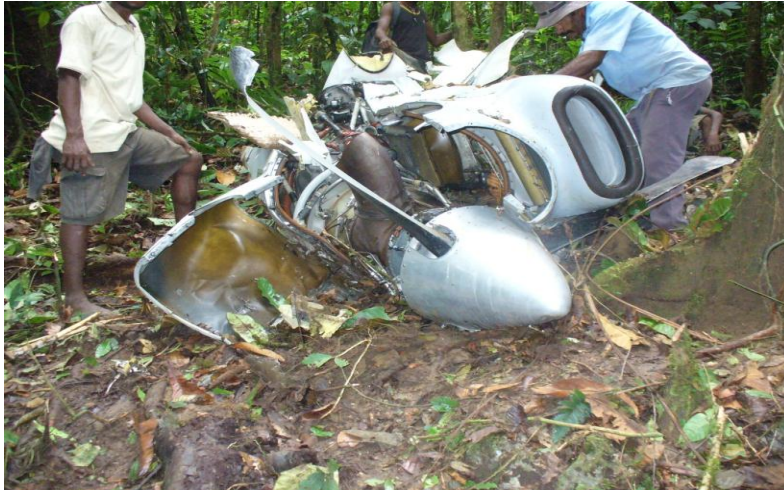
The right engine was found approximately 180m behind the main wreckage. The right propeller, engine nacelle, firewall, and engine supports were still attached to the engine. The right propeller blades were feathered<sup>12</sup>, with damage only in the blade tips; the tips were bent in the direction of rotation. Some material was missing at the blade tips, probably due to impact. One of the blades was buried and showed more bending deformation.

The engine exhaust showed some deformation, but appeared to be cold deformation. The engine power turbine was jammed/locked. There was no evidence that it had failed due to excessive rotational speed. There was also no evidence of in-flight fire.

**Figure 18: Right engine and propeller**  
(photo from the Embraer Air Safety Report)

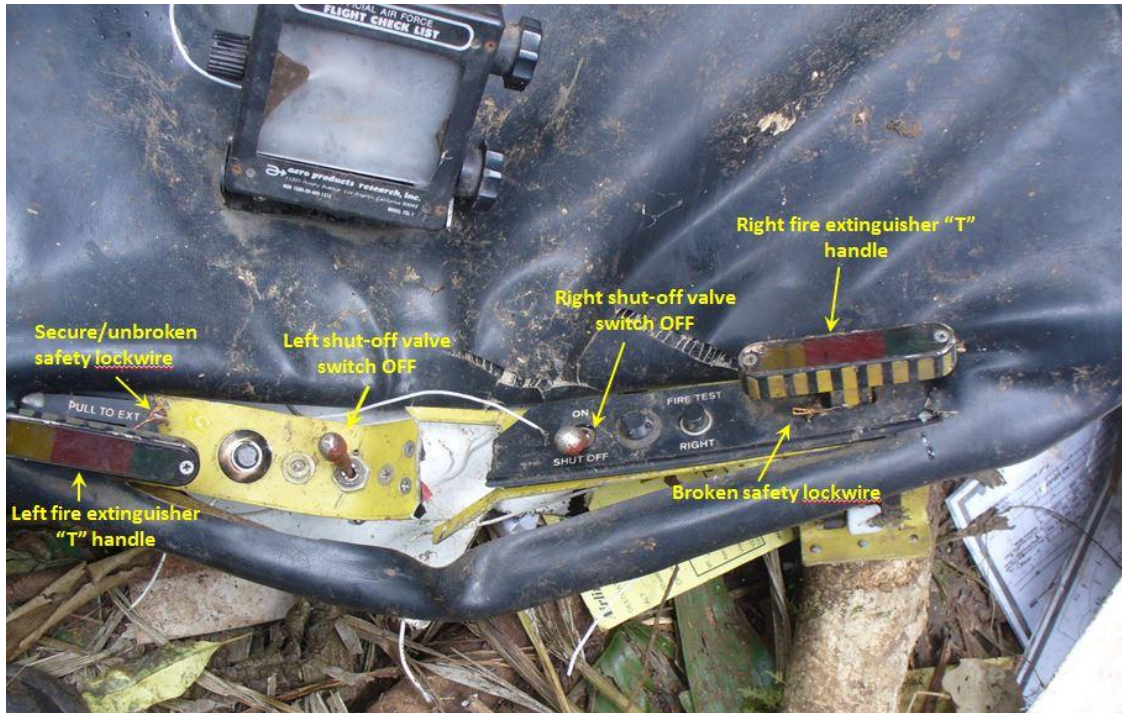
The Fire Extinguisher “T” Handle for the right engine had been activated. The safety “witness” lockwire was broken, confirming activation. The left “T” handle “witness” lockwire was unbroken/secure.

**Figure 20: Activated right engine fire extinguisher “T” handle**

Although the cockpit fire extinguisher "T" handle had been activated, there was no evidence of fire in flight or after the aircraft impacted terrain.

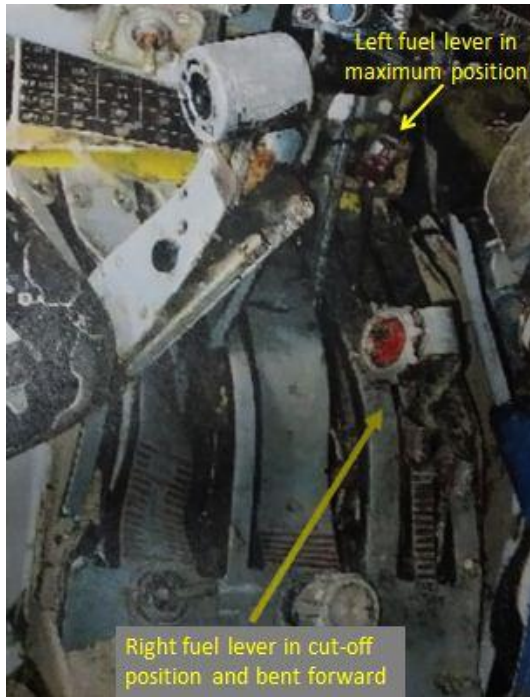
The fuel levers have a locking device at the cut-off position to prevent movement from that position. The right engine fuel lever was found in the cut-off position.

**Figure 21: Fuel cut-off levers**  
(photo from the Embraer Air Safety Report)

The engine controls were damaged and may have been moved by impact forces or loose objects during the impact sequence, or from the rescue team workers' actions. However, the fuel levers have a locking device at the cut-off position to prevent movement from that position. The left engine's fuel lever was in the maximum position. The right engine's fuel lever was found in the cut-off position, with the lever significantly bent forward.

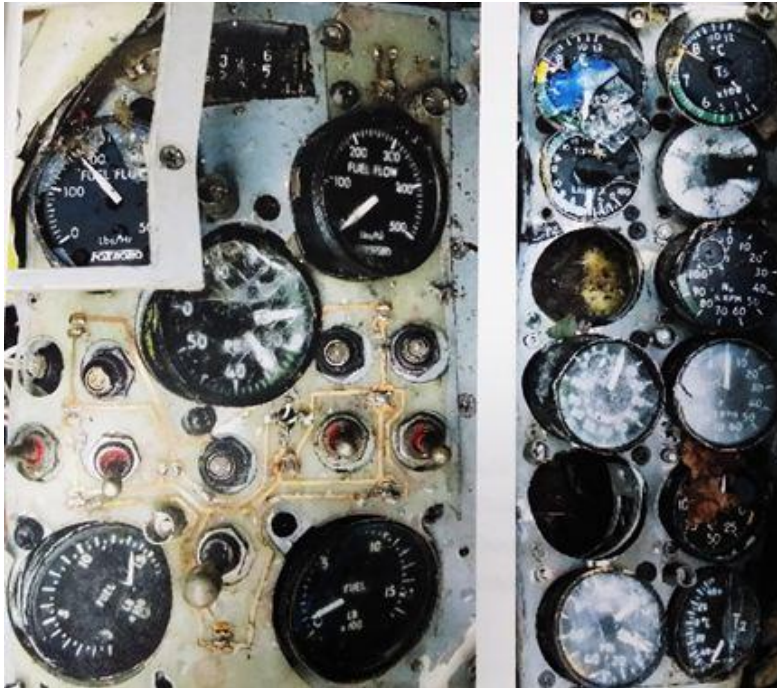
The right engine and fuel instruments, “frozen” / jammed at impact, had significantly lower readings than the left engine instruments. Specifically: torque, oil pressure, and T5 readings. The left fuel gauge was damaged and the needle was bent and showing about 1,300 lbs in the needle tip bent position or 1,500 lbs taken in a straight line from the needle pin before the bend. The right gauge was jammed at 100 lb.

**Figure 22: LEFT: ALU fuel gauges. RIGHT: ALU engine gauges**  
(photo from the Embraer Air Safety Report)

The left fuel gauge was damaged and the needle was bent and showing about 1,300 lbs in the needle tip bent position, or 1,500 lbs taken in a straight line from the needle pin before the tip bend. The right gauge needle did not appear to be damaged and was jammed at 100 lb. The investigation determined that because of the observed damage to the left fuel gauge, the left fuel gauge reading could not be considered reliable. Furthermore, the known fuel on board pre-taxi from Port Moresby, and the calculated fuel burn to the accident site confirmed the investigation's finding.
