ATSB TRANSPORT SAFETY INVESTIGATION REPORT  
Aviation Occurrence Report 200501977  
Final

Collision with Terrain  
11 km NW Lockhart River Aerodrome  
7 May 2005  
VH-TFU  
SA227-DC (Metro 23)

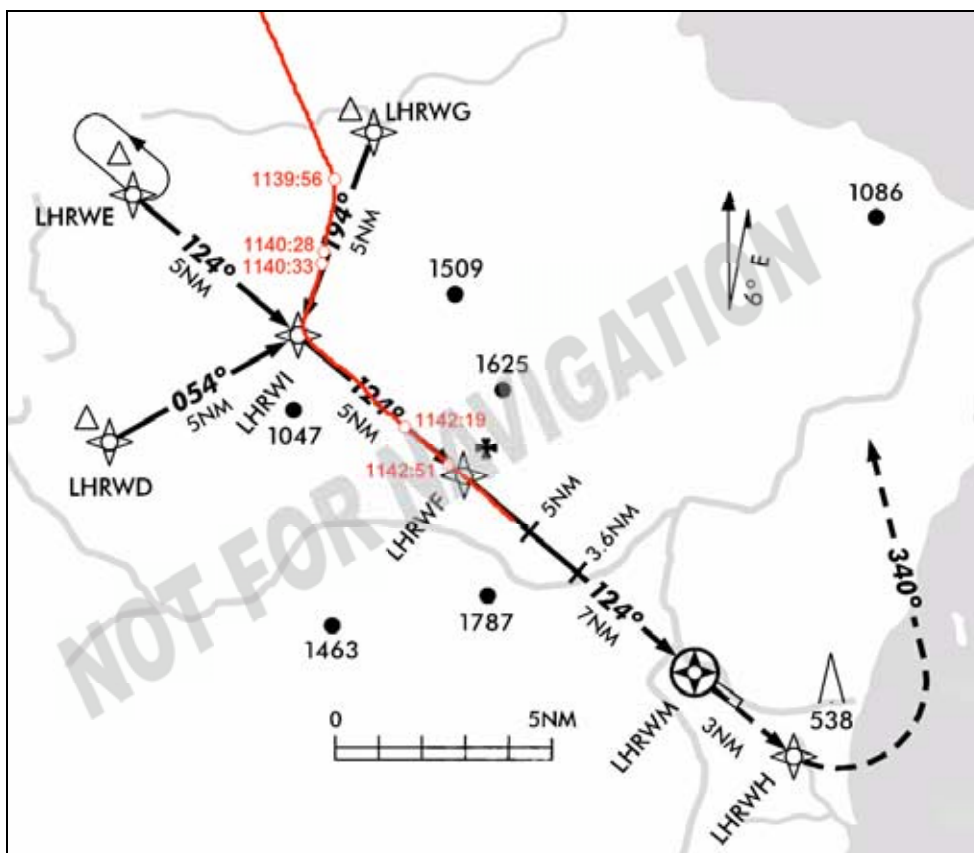
Figure 4: Approach track (in red) derived from FDR data overlayed on an extract of the Airservices Australia Runway 12 RNAV (GNSS) approach chart<sup>17</sup>

The accident site was located on the published Lockhart River Runway 12 RNAV (GNSS) final approach track (Figure 4). The initial impact point with trees was at an elevation of 1,210 ft AMSL. At that point on the approach, the segment minimum safe altitude was 2,060 ft AMSL (Figure 5).

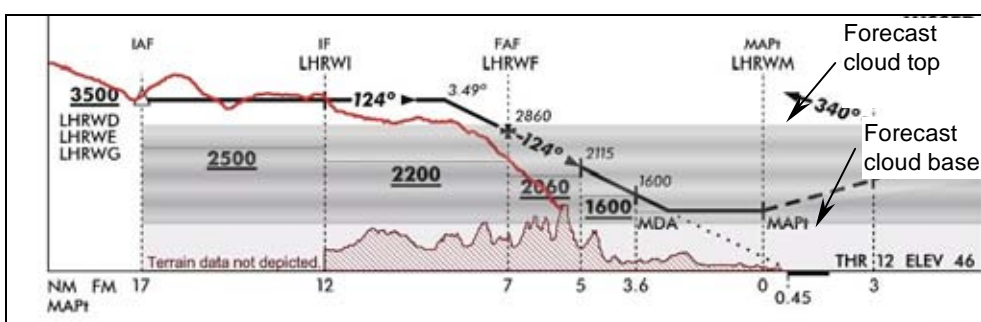
Figure 5: Approach profile (in red) derived from FDR data and terrain profile (in brown) overlayed on an extract of the Airservices Australia Runway 12 RNAV (GNSS) approach chart<sup>17</sup>

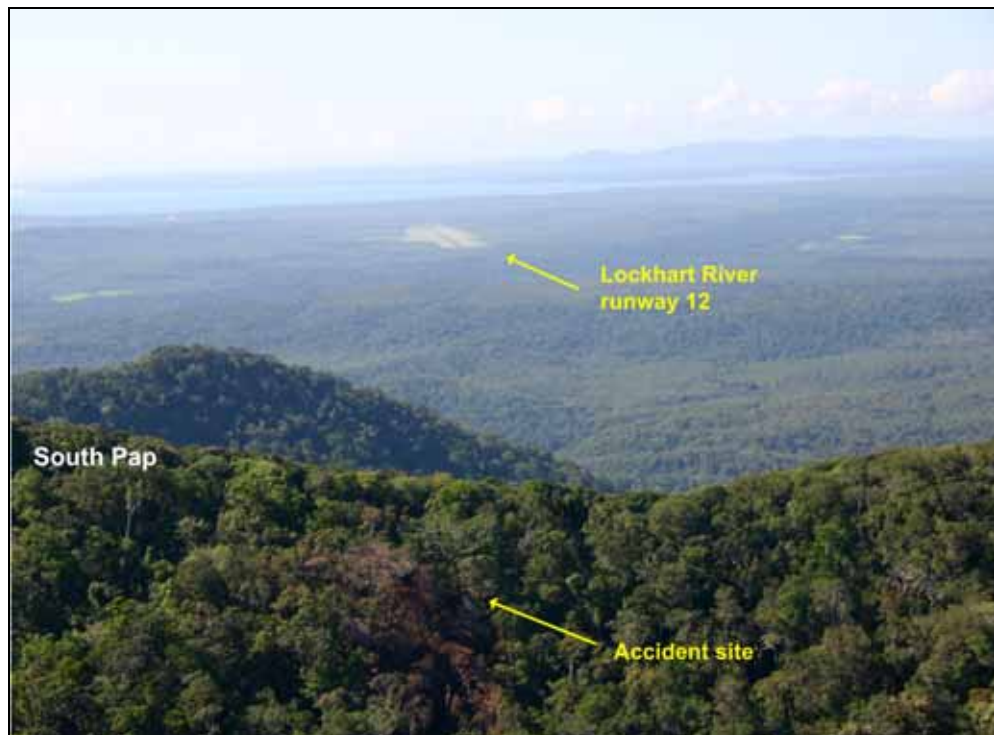
**Figure 19: General view of the accident site looking toward the south-east**

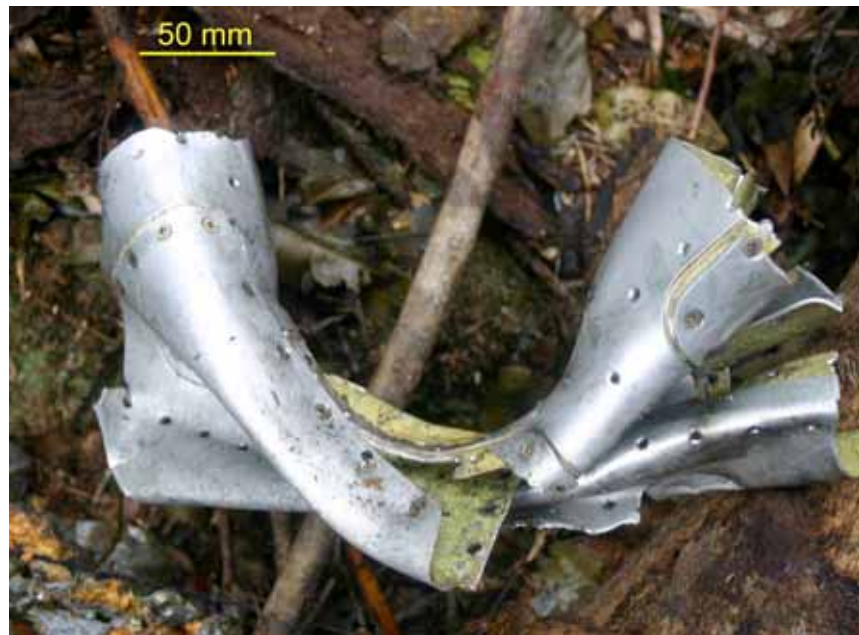
**Figure 20: Wing section showing impact damage with a tree trunk or branch**

As the aircraft flew through the crowns of the trees, the outboard sections of both wings and the blades of both propellers separated from the aircraft. The aircraft continued along a descending flight path, contacting tree trunks and branches. This resulted in further sections of both wings, the engines and sections of the horizontal stabiliser and elevators being torn off. The nose of the aircraft then impacted boulders and broke up. The remaining left wing structure then impacted a rock outcrop causing the fuselage to roll to the right approximately 50 degrees (Figure 21).

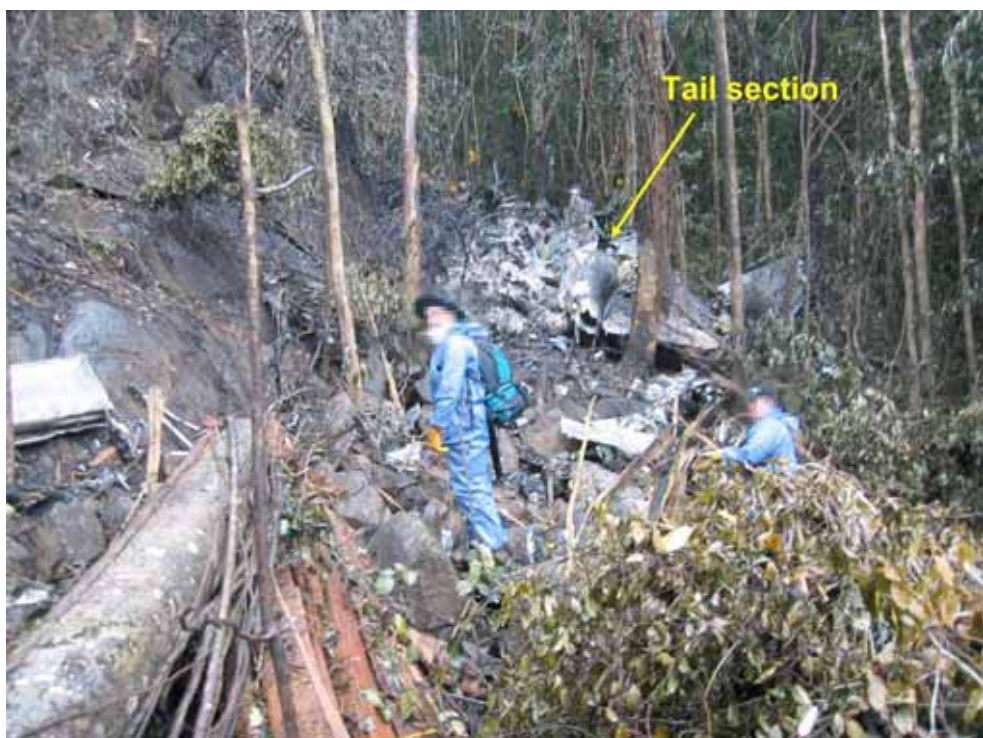
**Figure 21: View along the direction of travel showing the rock outcrop and main wreckage in the background**

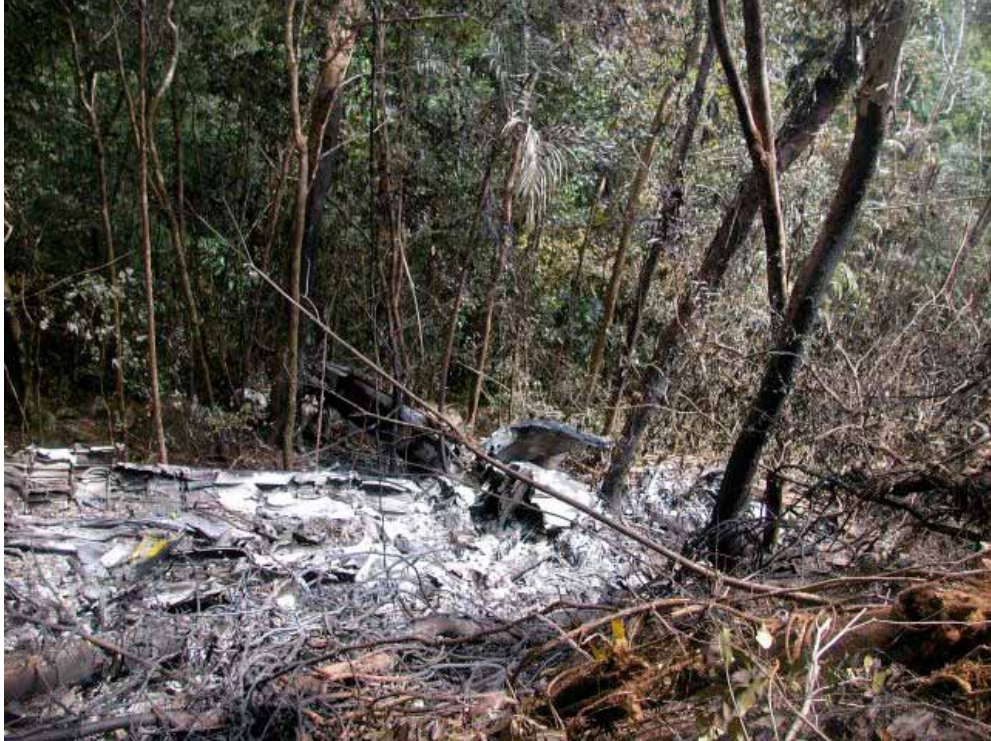
The remaining wreckage then continued about 20 m up the steeply sloping ground before stopping. It was then consumed by an intense, fuel-fed, post-impact fire (Figure 22).

**Figure 22: The rear fuselage section**

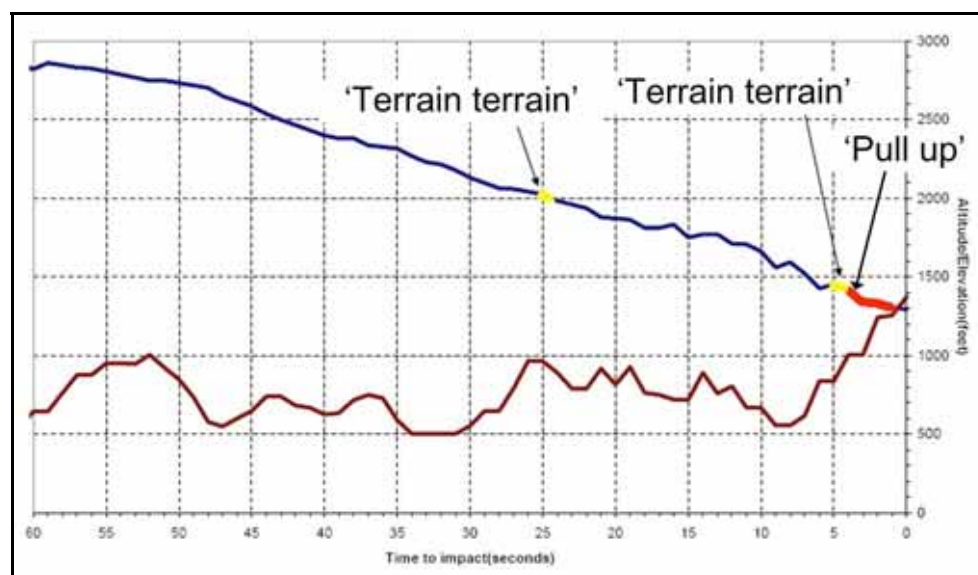
**Figure 26: Accident flight simulation showing GPWS alerts and warnings<sup>88</sup>**

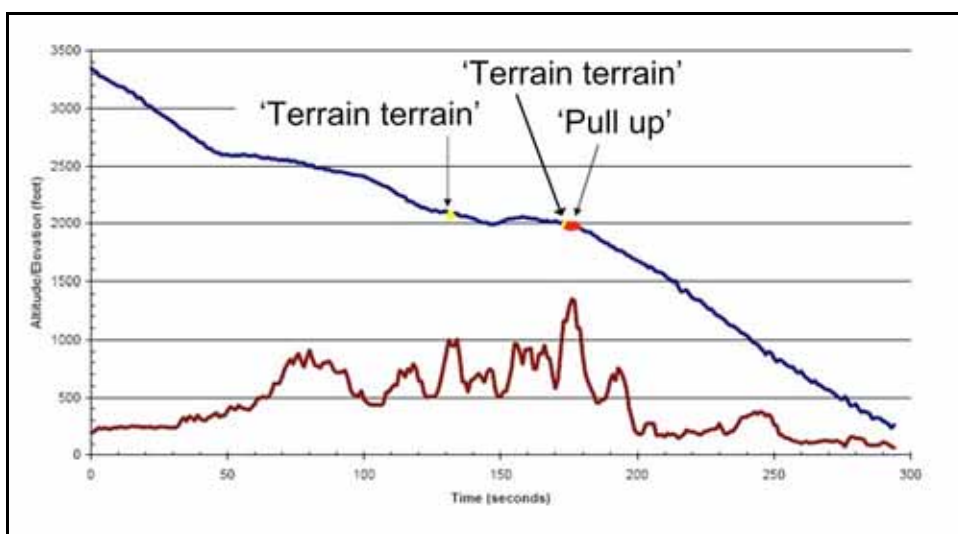
**Figure 27: Simulation for Bamaga to Lockhart River on 27 April 2005 showing GPWS alerts and warnings<sup>88</sup>**

The copilot of this flight initially reported that he had not received any GPWS alerts or warnings when flying the Lockhart River Runway 12 RNAV (GNSS) approach in cloud, but ‘had it go off when visual’ (that is, flying the approach in visual conditions). Later in the investigation when asked about the flight on 27 April 2005, the copilot could not recall this particular flight.
