**ATSB TRANSPORT SAFETY REPORT**

Aviation Occurrence Investigation AO-2007-037

**Controlled flight into terrain - 24 km S Tully, Qld**

**Pacific Aerospace Corporation Cresco 08-600**

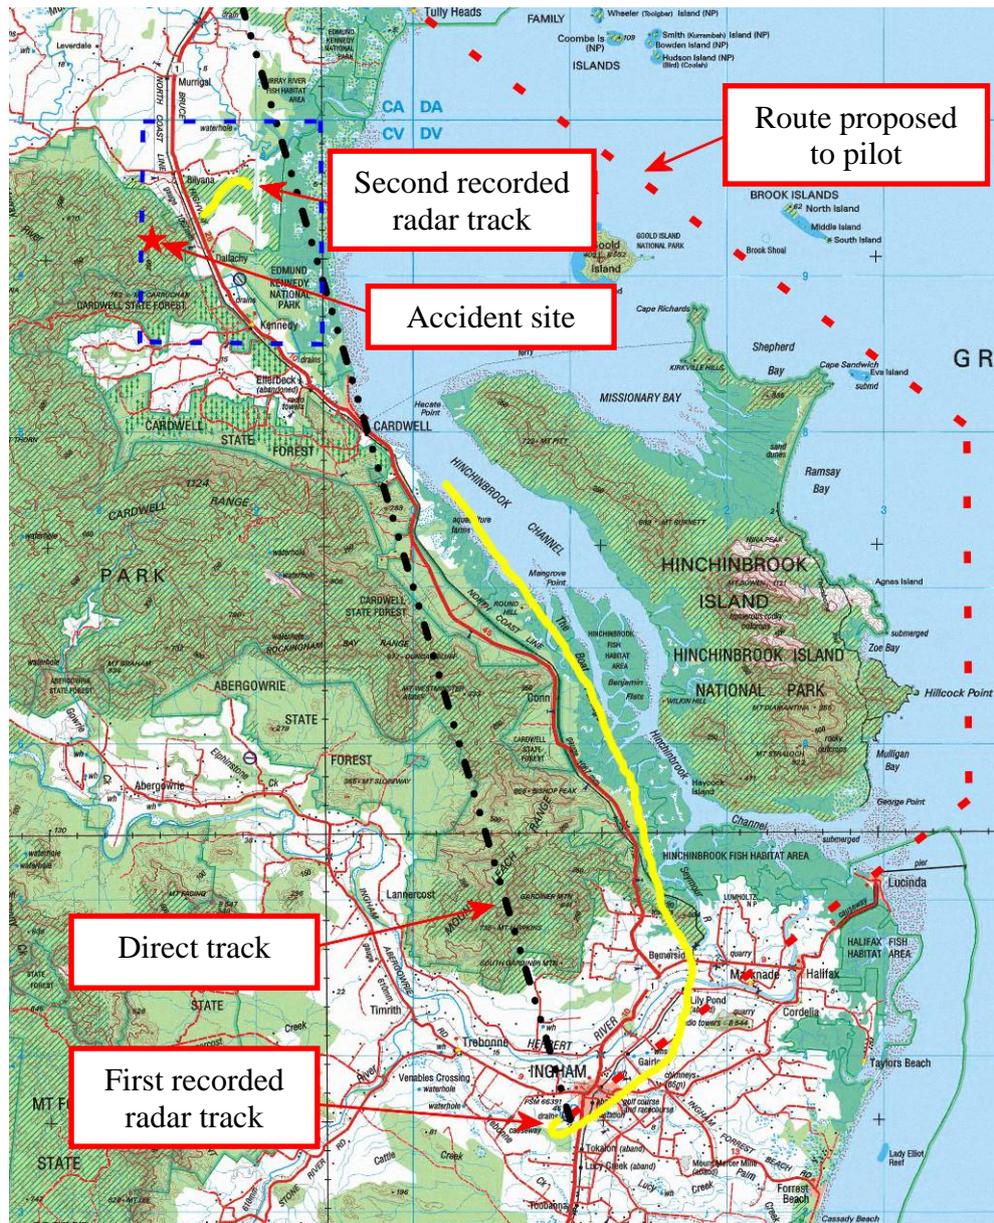
**Figure 4: Direct track, proposed route and recorded radar tracks**

The next radar return had been recorded at 1511:21, 21.7 km (11.7 NM) south of Tully. The aircraft appeared to have been in a climbing left turn before descending and taking up a south-westerly heading. The aircraft once again disappeared from radar and the last observed radar return at 1512:26 was later calculated to be 3.3 km (1.8 NM) from the accident site (Figure 1), with a groundspeed of between 100 and 120 kts.

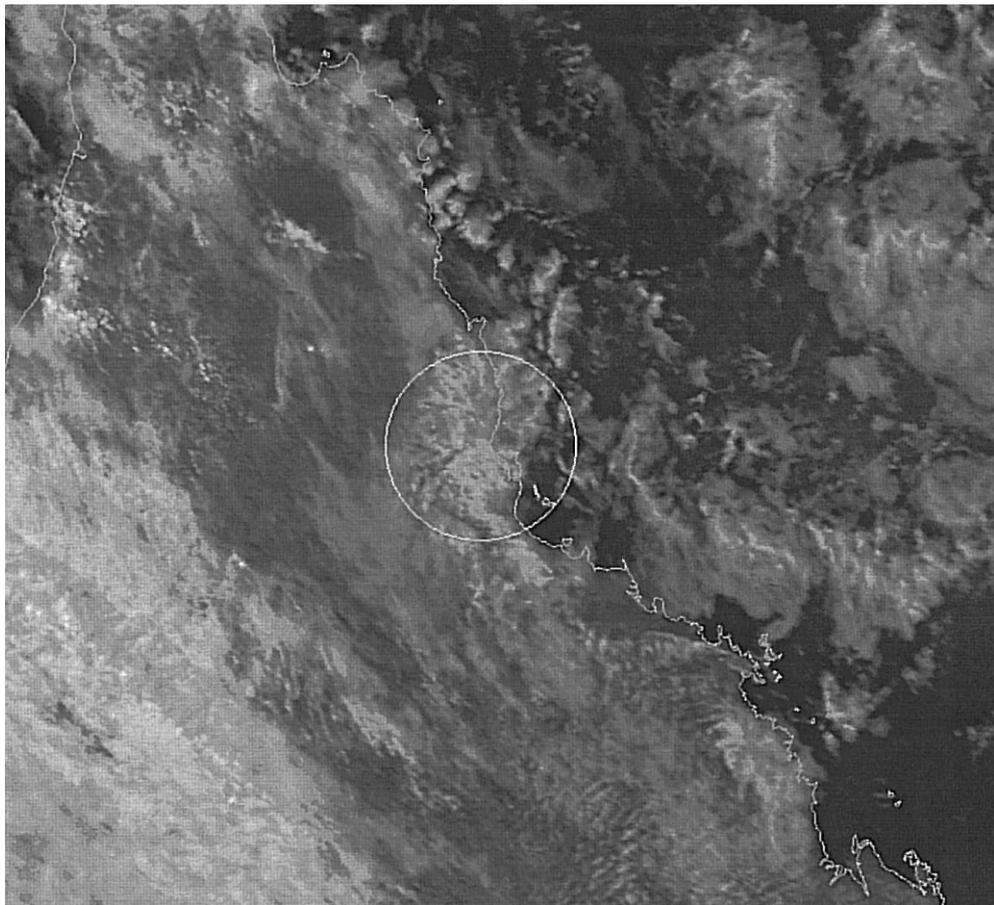
**Figure 5: BoM visible satellite image at 1501 showing considerable cloud in the local area (circled)**

A large high pressure system was located offshore from New South Wales with fresh to strong south-east winds and generally cloudy conditions with some showers along the Queensland coast. A trough was situated over inland Queensland, well to the west of the area in which the accident occurred. The weather conditions were noted by the Bureau of Meteorology (BoM) to present a 'low cloud issue' for aviation during the morning (Figure 5)

Post accident, the BoM analysed all available weather information and provided advice that it considered that the weather conditions in the area at about 1500 were most likely to have been:

...generally cloudy along the coast with isolated, predominantly coastal, showers and intermittent drizzle. Broken to overcast low cloud (5 to 8 oktas) with a base between 700 ft (coastal) and 1,000 ft (near ranges) above mean sea level depending on whether a shower was passing through at the time or not. South-east winds averaging about 10 kts.

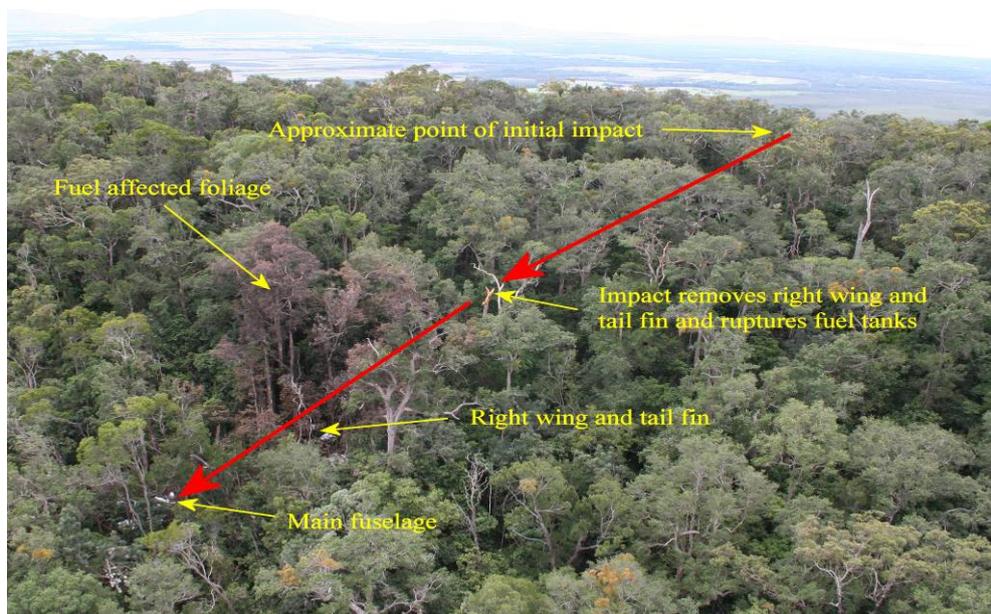
**Figure 6: Wreckage trail**

The aircraft initially impacted large trees near the top of a ridge line, at an elevation of 1,279 ft AMSL (Figure 6). The outer section of the left wing separated and the aircraft continued forward on a bearing of approximately 260 degrees magnetic. After colliding with a number of smaller trees that caused additional damage, the aircraft impacted another large tree, which resulted in the outer and middle sections of the right wing, together with the tail fin separating from the fuselage. The impact forces also ruptured the fuel tanks and distributed fuel forward over a large section of the forest.

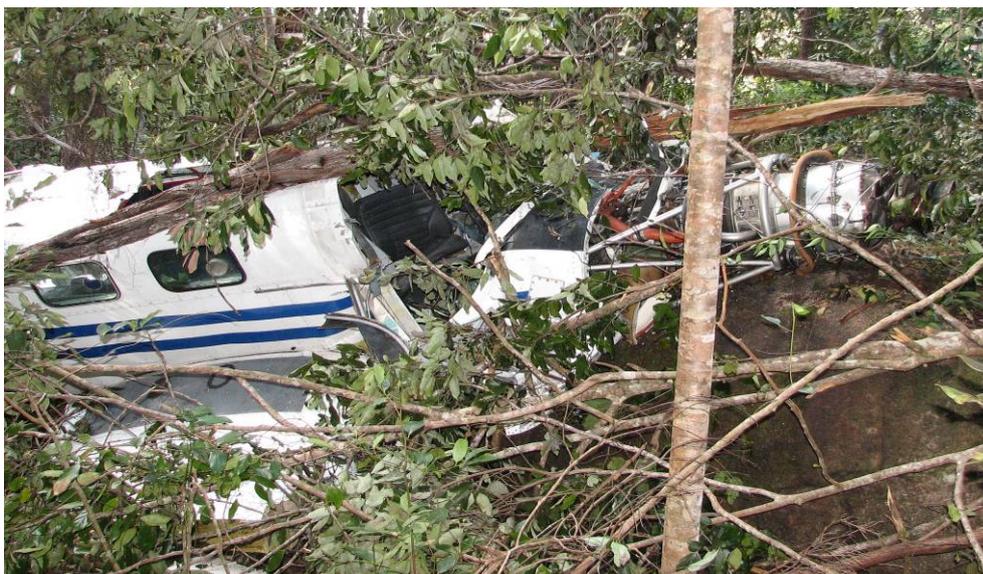
**Figure 7: Forward fuselage and engine resting on a large rock**

The impact trajectory prior to the aircraft coming to rest was calculated to be approximately 45 degrees. The fuselage, together with the engine, inner section of both wings, horizontal stabiliser and rudder came to rest on a large rock (Figure 7).

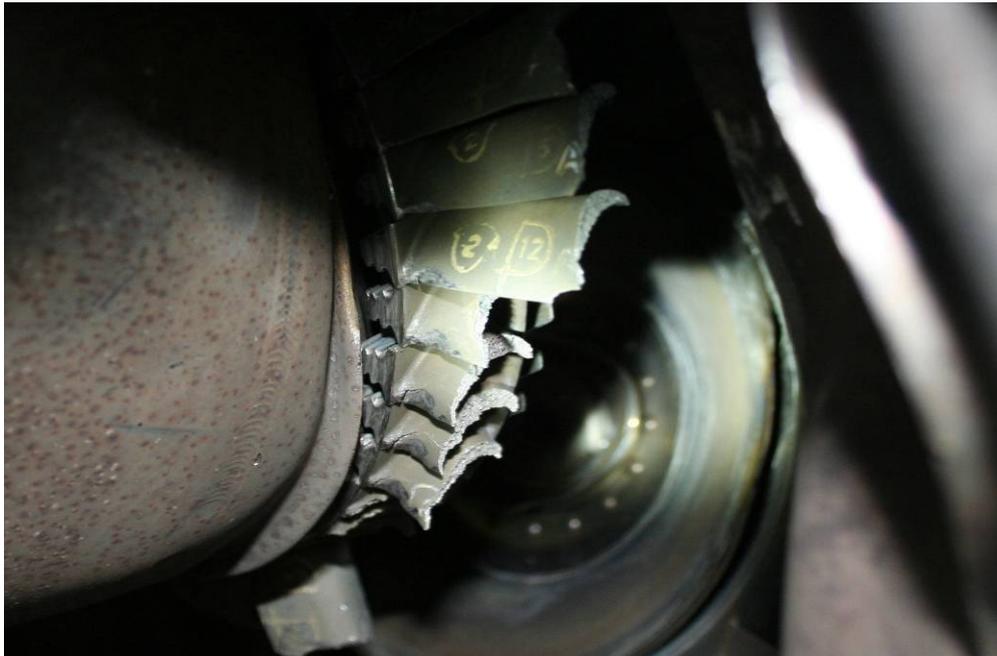
**Figure 8: Damage to power turbine blades**

The engine was inspected on site and there was no evidence of any pre-impact defects. Continuity of the engine controls was established. Examination of the power turbine blades indicated that they had fractured in overload due to the blade tips coming in contact with the power turbine shroud (Figure 8). Approximately two-thirds of the blades were missing and the remainder were broken at the tips. There was also evidence of rotational damage to the power turbine shroud. The damage to the power turbine and shroud were indicative of the engine producing significant power at impact.

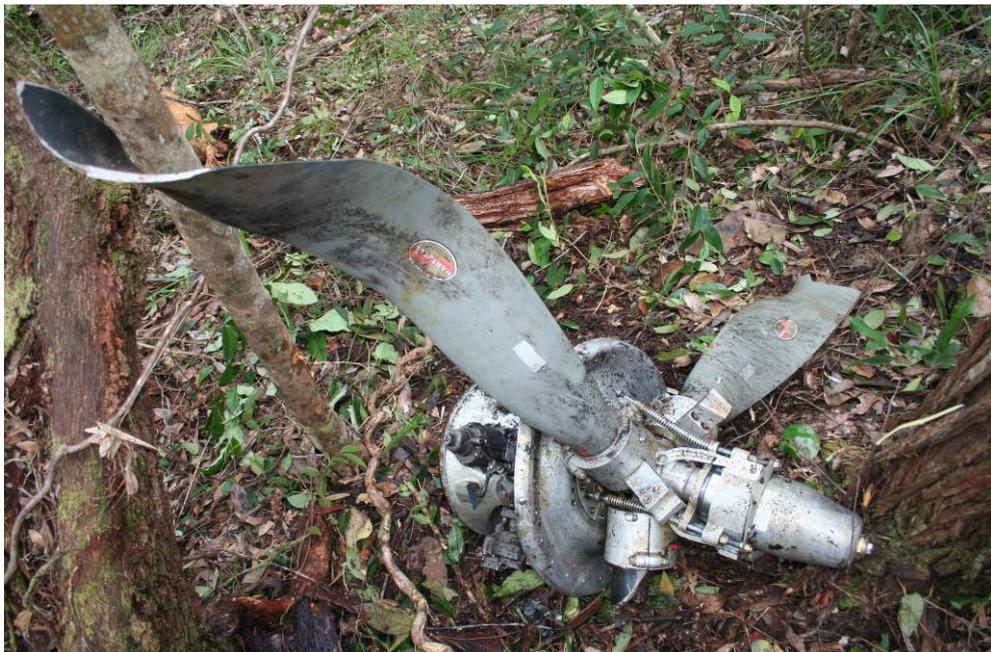
**Figure 9: Propeller showing blade bending and missing tip section**

The propeller and forward section of the engine reduction gearbox were located approximately 15 m from the main fuselage (Figure 9). One blade had fractured in overload at the propeller hub and it was located approximately 30 m back along the wreckage trail. All of the blades exhibited significant bending due to rotation impact damage and had approximately 25 cm sections missing from their tips. These fracture surfaces showed evidence of overload due to rotational impact forces. There was no evidence of any pre-existing propeller defects. The rotational damage to the propeller indicated that the engine was producing significant power at the time of impact.

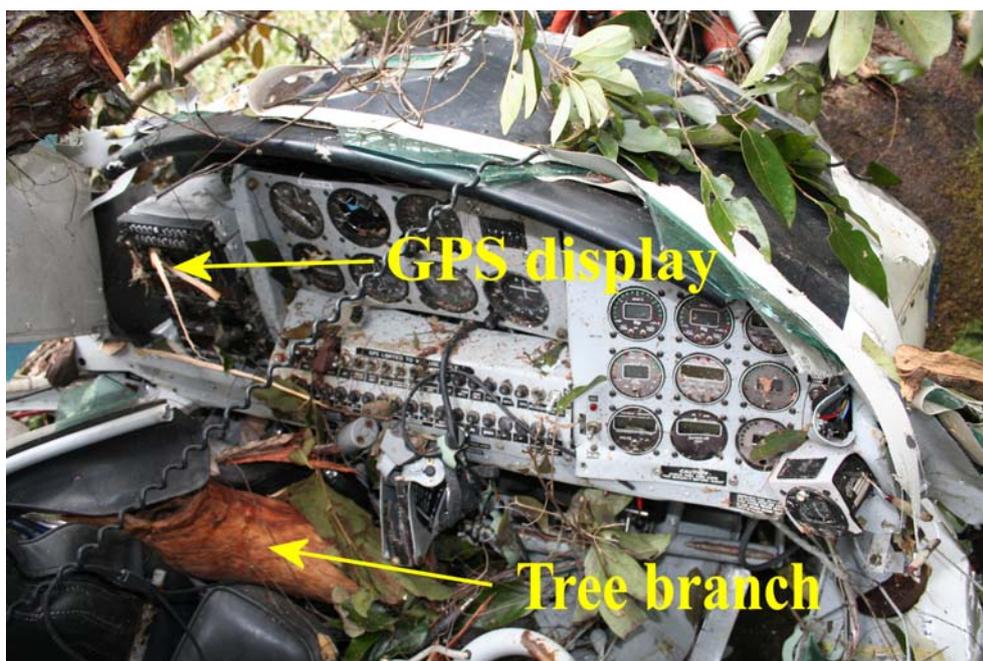
**Figure 10: Damage to cockpit area**

The first rescuers on the scene documented that the pilot was seated in the right seat, that the four point harness had been secured and was intact, and that the pilot had been restrained by that harness during the accident sequence. The on-site investigation team noted that there had been clear evidence that the cockpit had been breached by tree branches during the accident sequence (Figure 10).
