**ATSB TRANSPORT SAFETY REPORT**  
Occurrence Investigation Report AO-2007-029  
Final

**In-flight breakup – Clonbinane, Vic.**

**31 July 2007**

**VH-YJB**

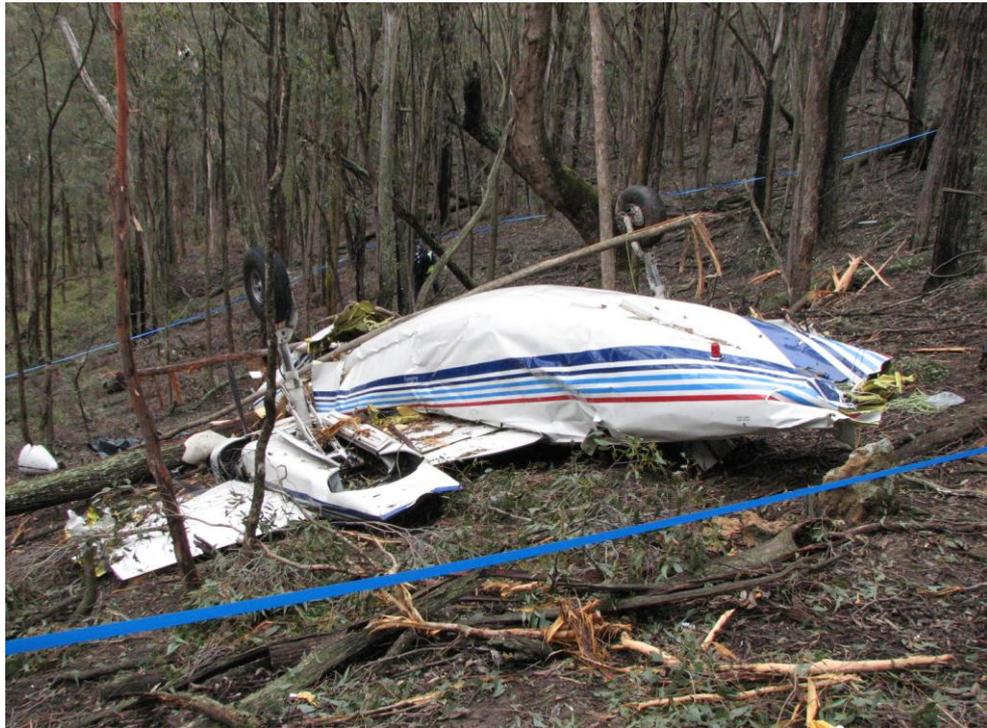
**Figure 2: Main wreckage**

The aircraft was seriously damaged<sup>3</sup> by excessive in-flight aerodynamic forces and impact with the terrain (Figure 2). The vegetation in the immediate vicinity of the main aircraft wreckage was slightly damaged as the aircraft descended, nearly vertically, through the trees.

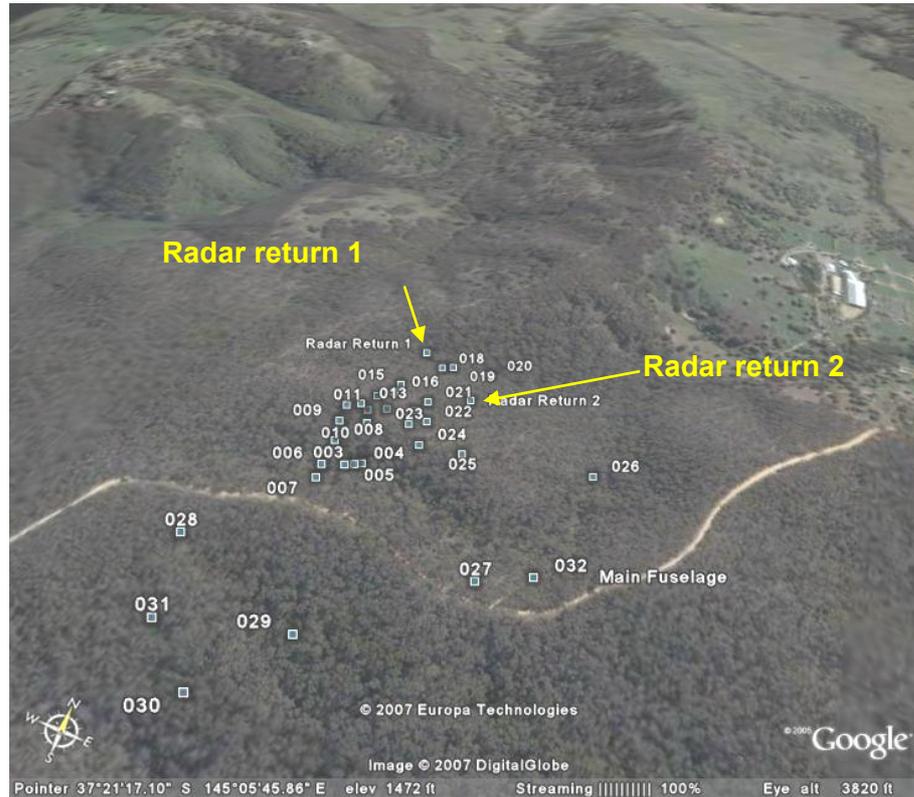
**Figure 5: Accident site, showing the distribution of the wreckage and the position of the last two radar returns.**

The wreckage was distributed in timbered, hilly terrain at an elevation of approximately 1,400 ft. The area surrounding the site was covered with eucalypt trees that were 15 to 20 m high. The main section of wreckage was located at position 37° 21 39’S, 145° 05 92’E (Figure 5) on the northern face of a ridge, the slope of which was between 17 and 20 degrees. It had descended almost vertically through the tree canopy and impacted the sloping ground in a flat, inverted attitude (Figure 2). The main section of wreckage consisted of the fuselage and the inboard section of the main wing, which included the engine nacelles, engines and propellers. There was no evidence of a fire.

The outboard section of both wings from approximately the aileron/flap junction, the rear fuselage, the tail cone/empennage, and the aft cargo door had separated from the aircraft and were located up to 700 m north and west of the main wreckage. The empennage and the associated control surfaces had separated, and broken into nine major components. All control surfaces and trim tabs were recovered. Continuity of the control cables within the main section of wreckage, and in the separated wing and tail sections, was established. Damage to the severed cable ends was consistent with overload forces during the breakup. The elevator trim position was consistent with a normal cruise flight setting.

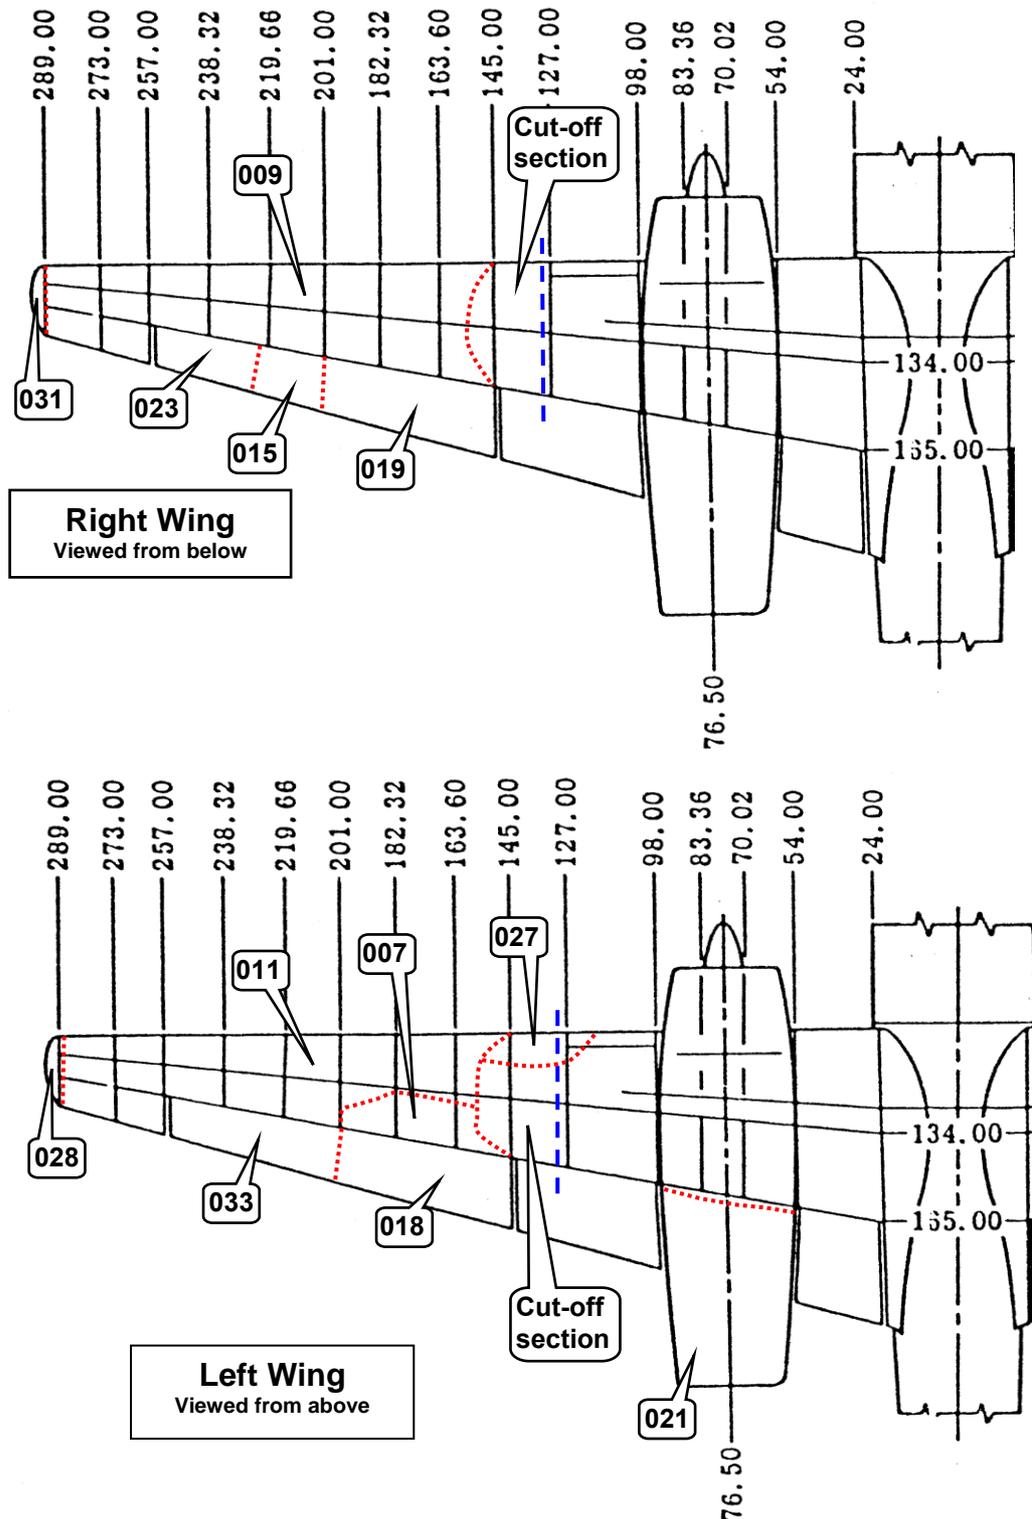
**Figure 2: Right wing section (upper) and left wing section (lower). Paths of separation indicated as red dotted lines**

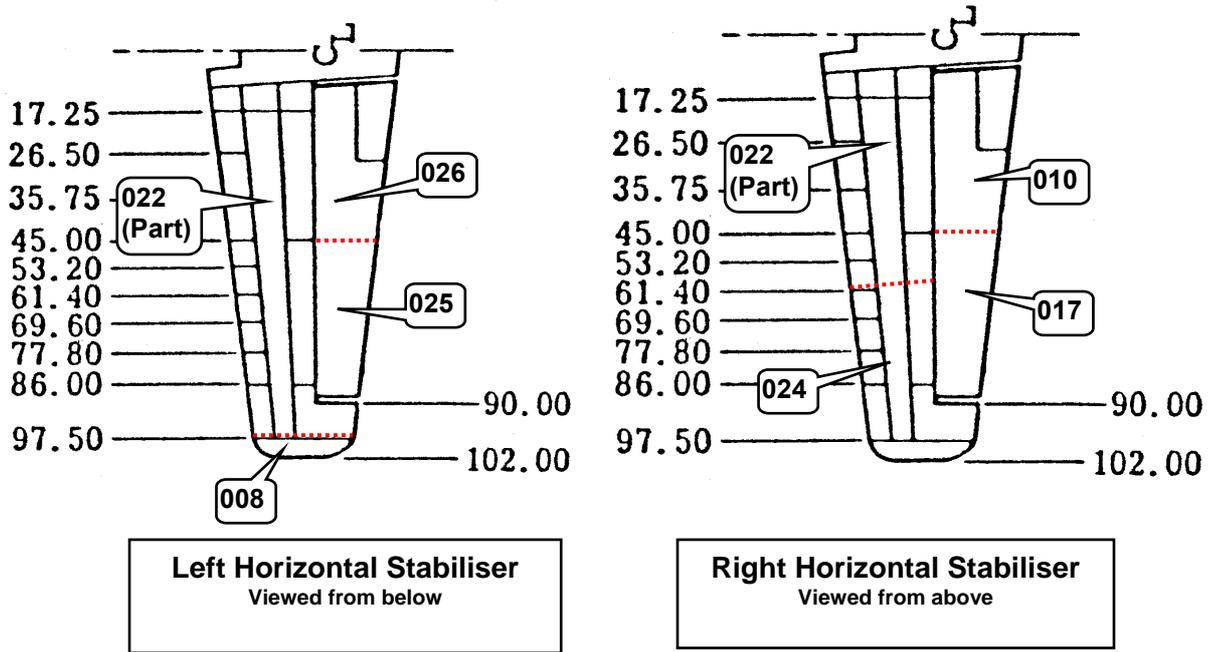
**Figure 3: Horizontal stabiliser sections (left and right as oriented). Paths of separation indicated as red dotted lines**

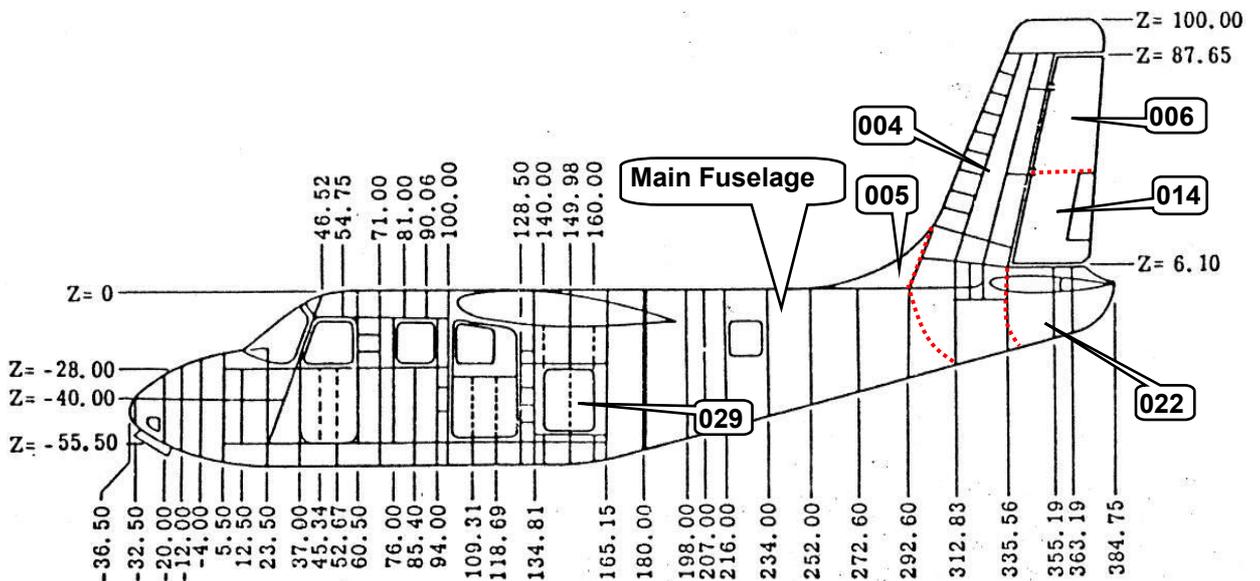
**Figure 4: Fuselage, empennage and vertical stabiliser sections. Paths of separation indicated as red dotted lines**

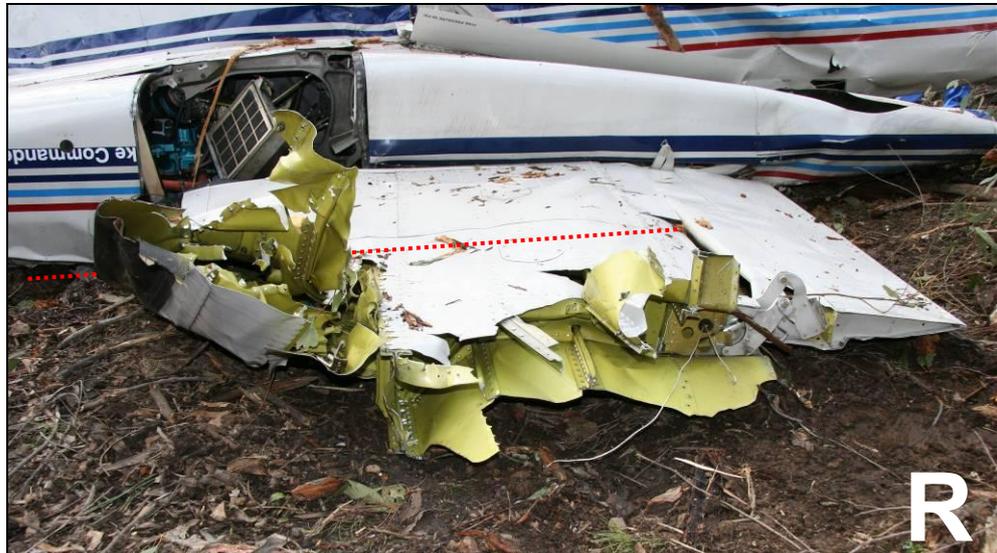
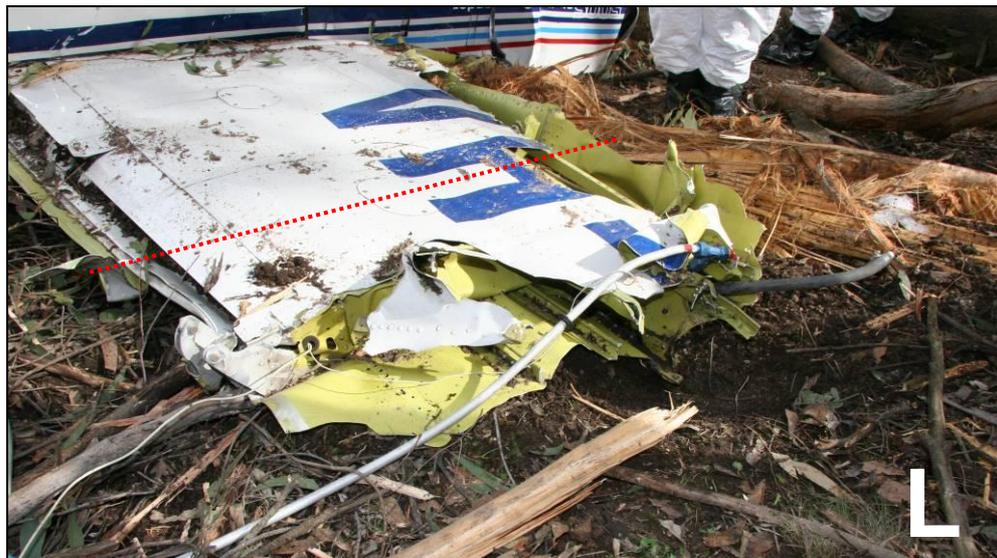
Both aircraft mainplanes had fractured in a chord-wise, semi-symmetric manner, at a position coincident with the outboard flap / aileron transition (wing station 145) (Figures 5 and 6). Comparable levels of mechanical deformation were present in the upper and lower main spars of both wings, with the permanent structural distortion being consistent with the failure and separation of both outer wing sections under downward bending loads. Similar downward bending characteristics were also exhibited by the wing rear spar elements.

**Figures 5 and 6:** Wing failure presentation. Inboard fracture sections removed along broken lines shown

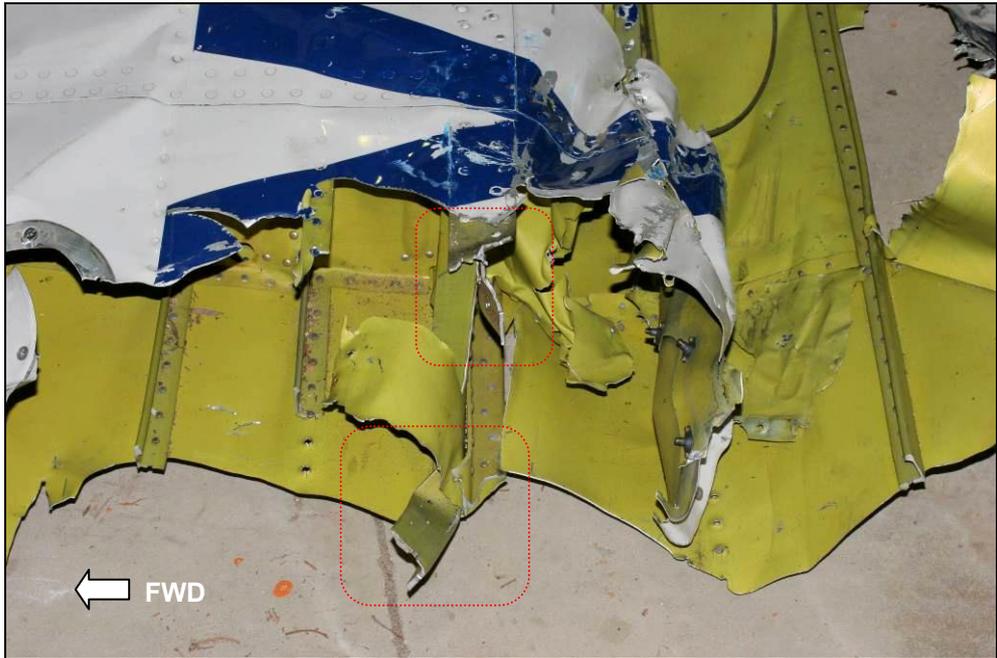
**Figure 9: Left wing main spar cap fractures (viewed from wing underside)**

All of the wing spar fracture surfaces presented characteristics typical of ductile tensile and/or shear failure under combined tensile/bending loads. There was no evidence of pre-existing cracking, corrosion, material discontinuities or other anomalous features that could have affected the structural integrity of the spar elements or the wing structure generally.

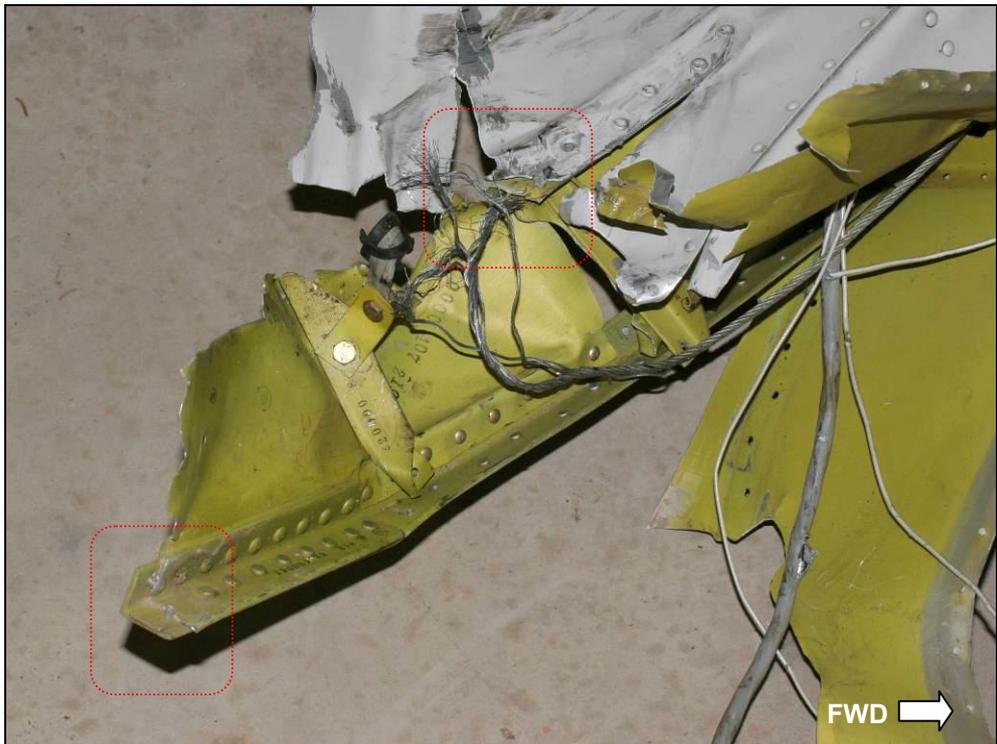
**Figure 10: Left wing rear spar cap fractures (viewed from wing underside)**

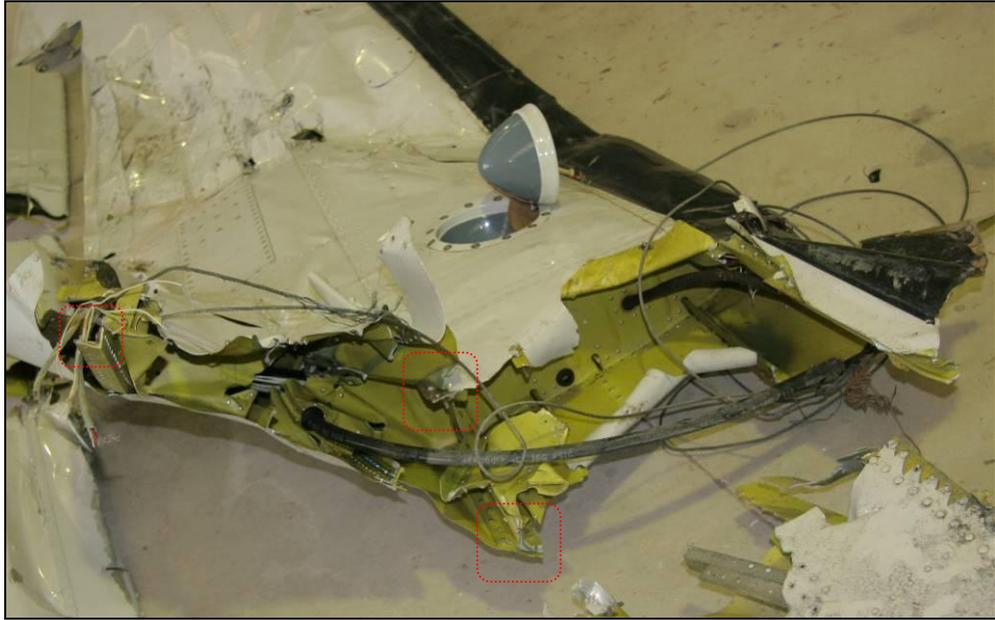
**Figure 11: Right wing spar cap fractures (viewed from wing underside)**

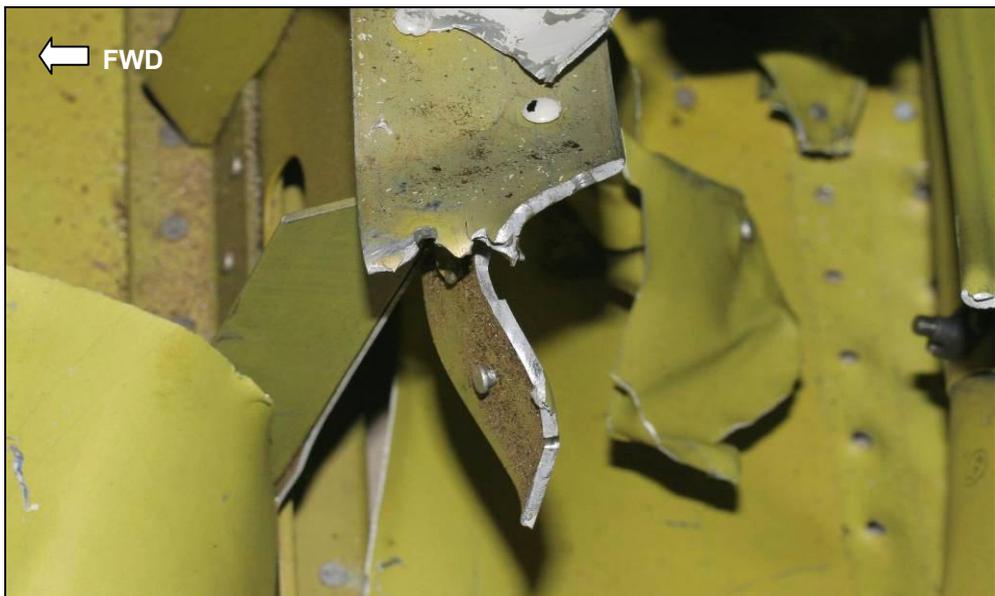
**Figure 12: Left wing lower main spar cap fracture**

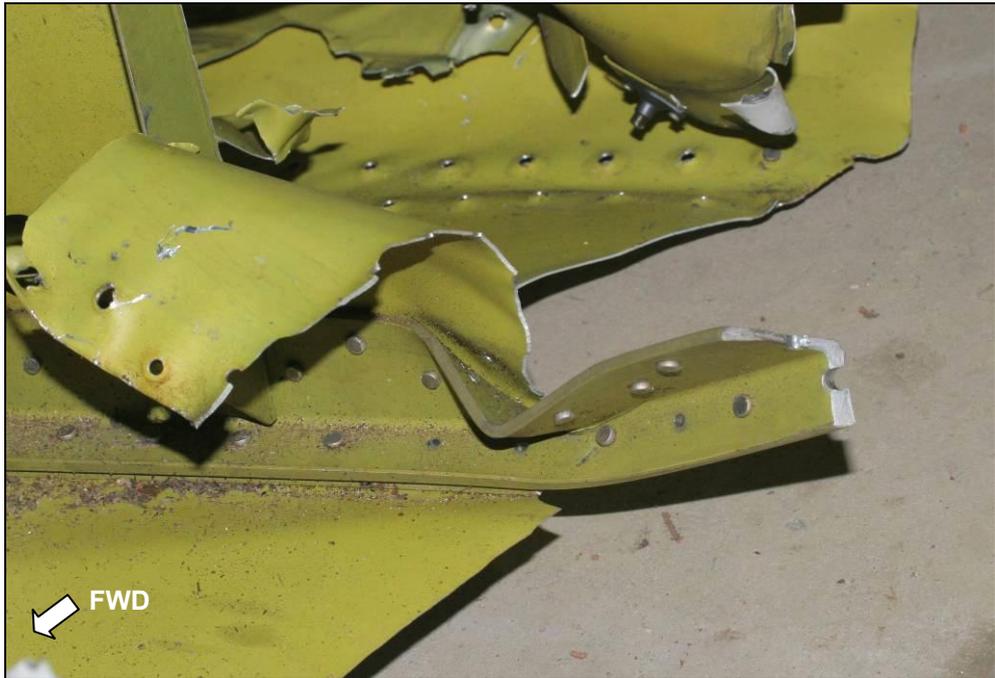
**Fig. 13: Left wing upper main spar cap distortion and fracture**

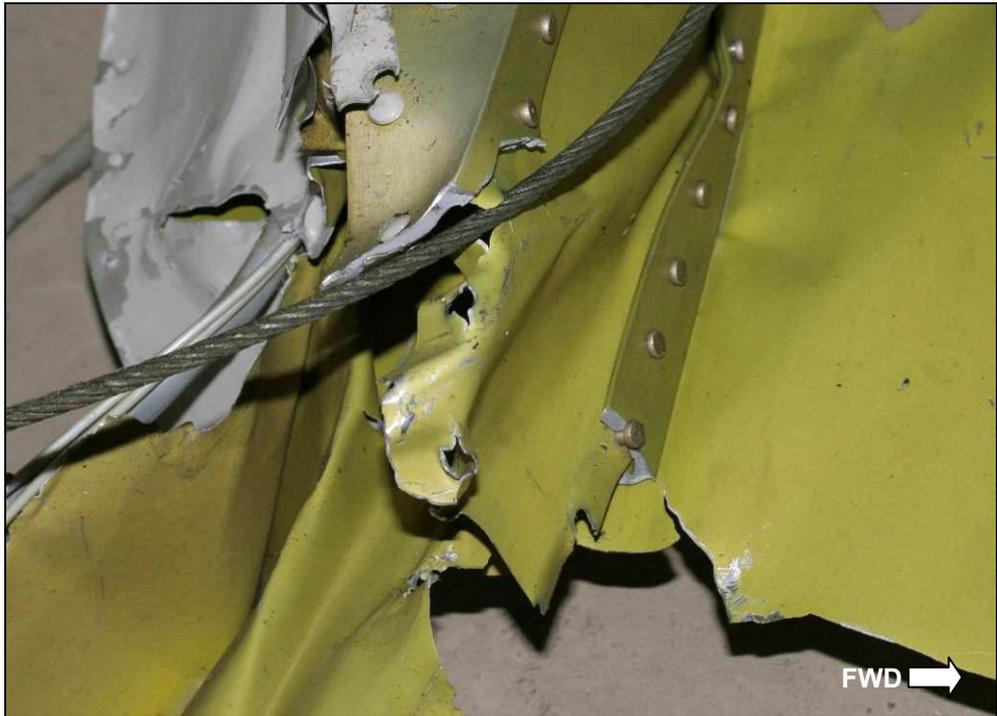
**Figure 15: Upper and lower rear spar cap fractures – left wing**

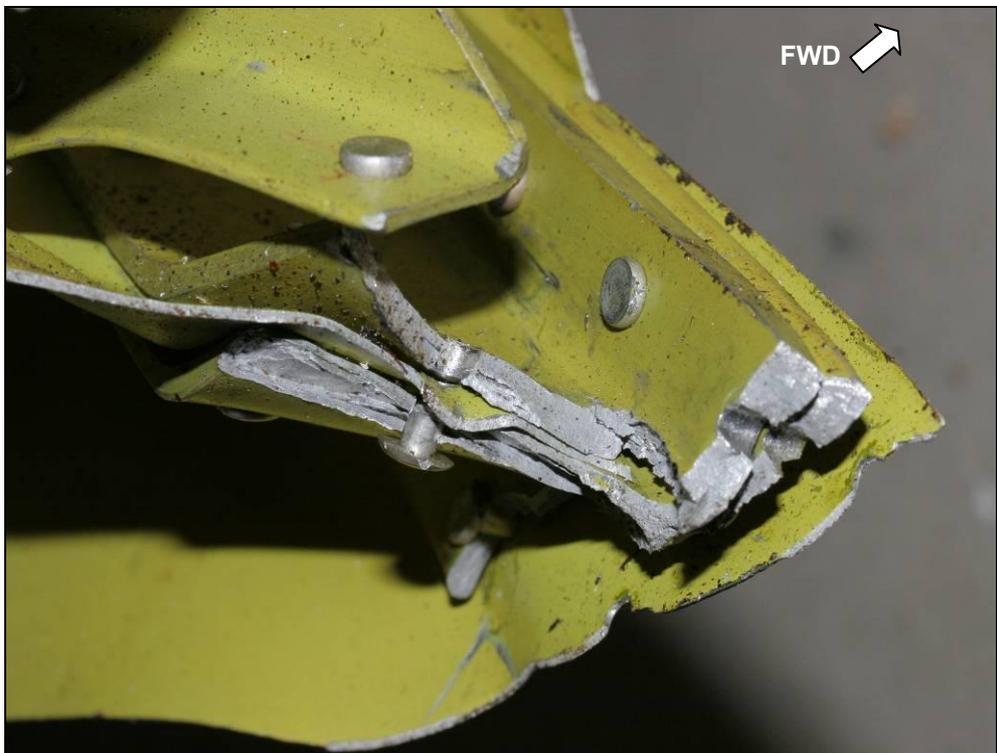
Both wing main spar failures had occurred immediately outboard of the design connection between inboard wing and outer wing spans (wing station 145). In the right wing instance, failure of the upper main spar element had occurred through the reinforced section adjacent to the outboard spar termination.

**Figure 16: Right wing main spar upper cap fracture – through reinforced section adjacent to splice joint**

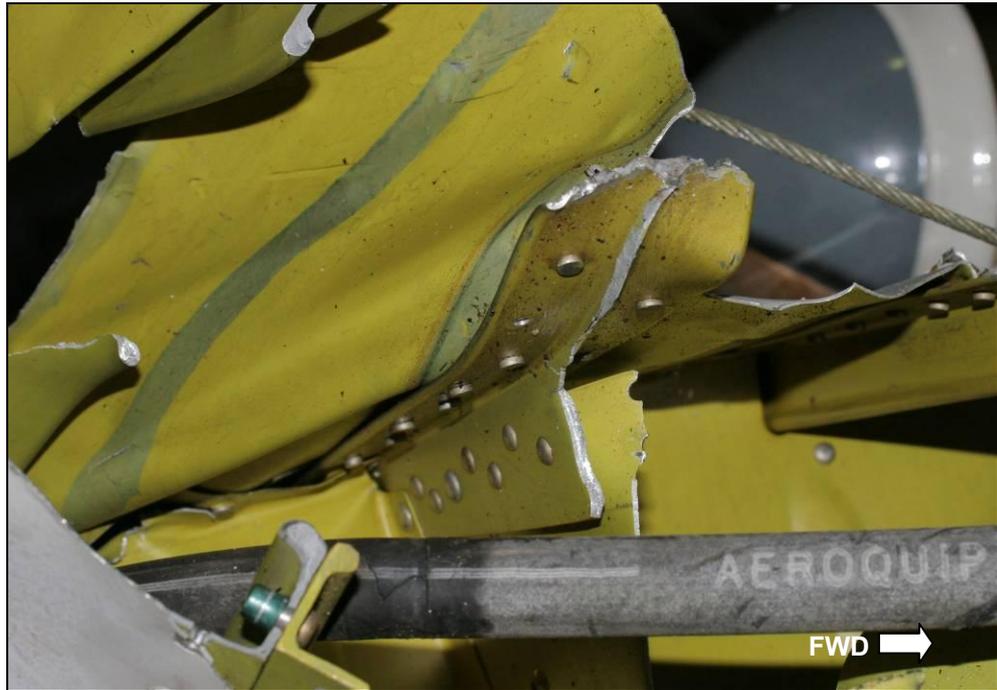
**Figure 17: Right wing main spar lower cap fracture**

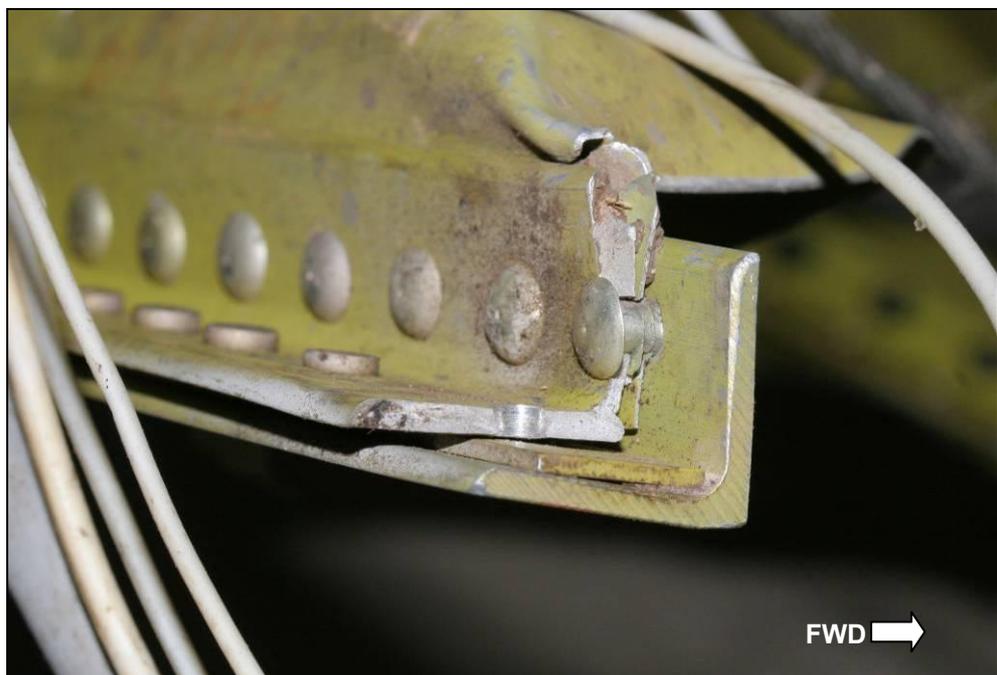
**Figure 18: Right wing rear spar upper cap fracture**

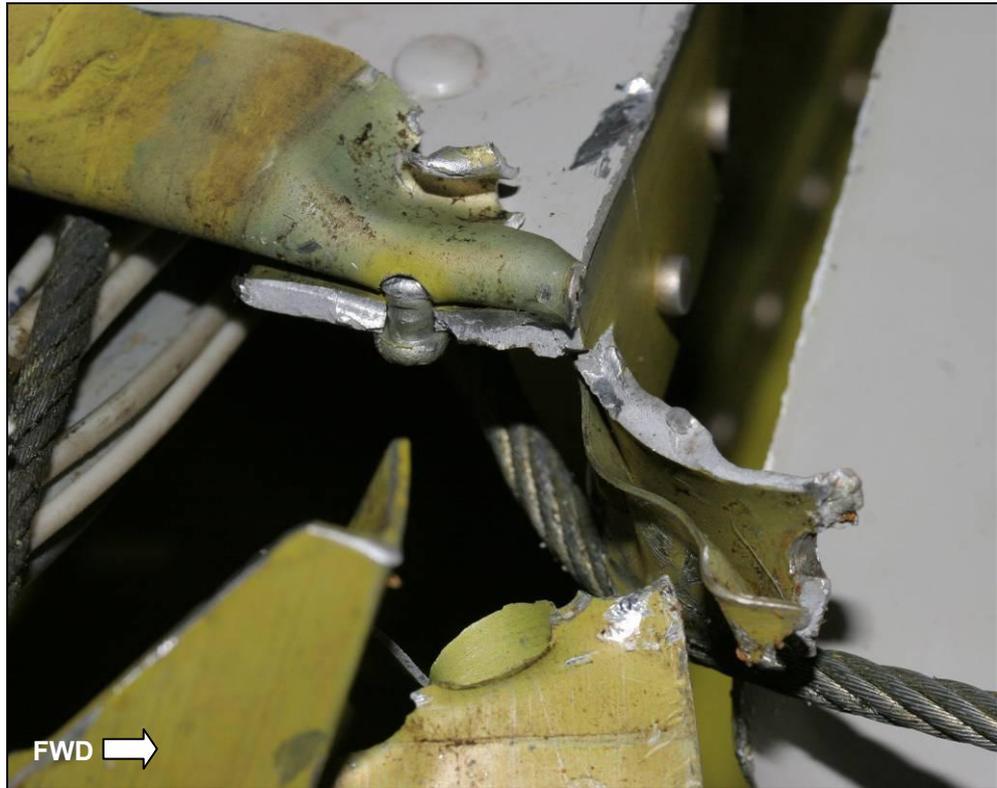
**Figure 19: Right wing rear spar lower cap fracture**

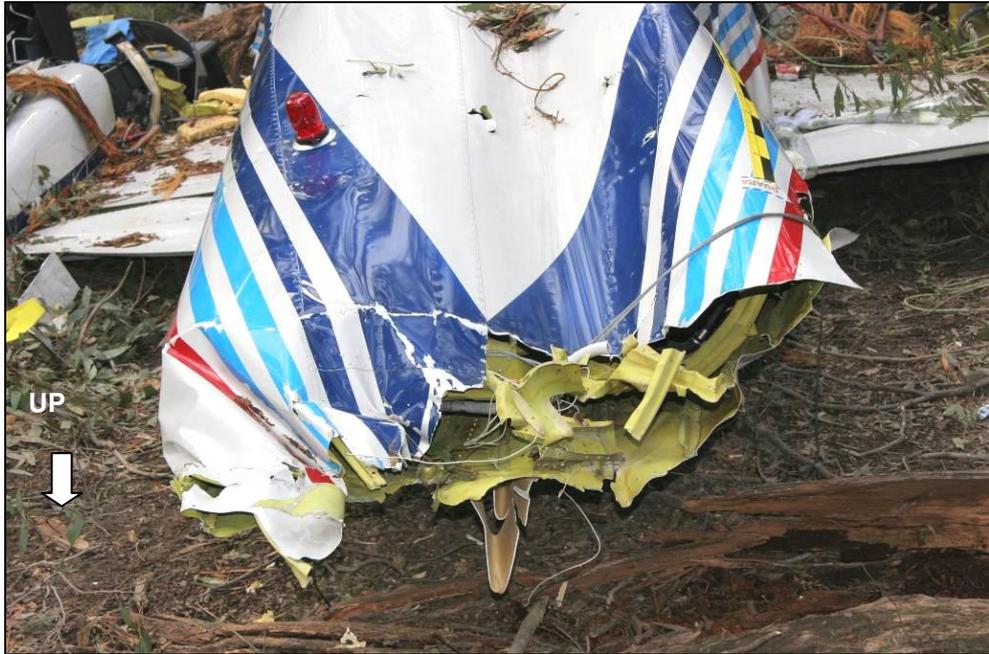
The aircraft empennage had separated from the main fuselage along a transverse diagonal plane, extending from around station 292 at the top of the fuselage, to station 312 at the fuselage base (refer to Figures 4 and 20). The separated empennage had itself broken into two principal sections – the forward-most section carrying the vertical stabiliser and sub-structure (Figure 21); the rear section comprising both horizontal stabilisers, carry-through structure, control surface rigging and tail-cone (Figure 22). Separation between the two empennage sections had occurred predominantly along the bulkhead at fuselage station 335 (Figures 23 and 24).

**Figure 20: Plane of fracture of the empennage from the fuselage (aircraft inverted)**

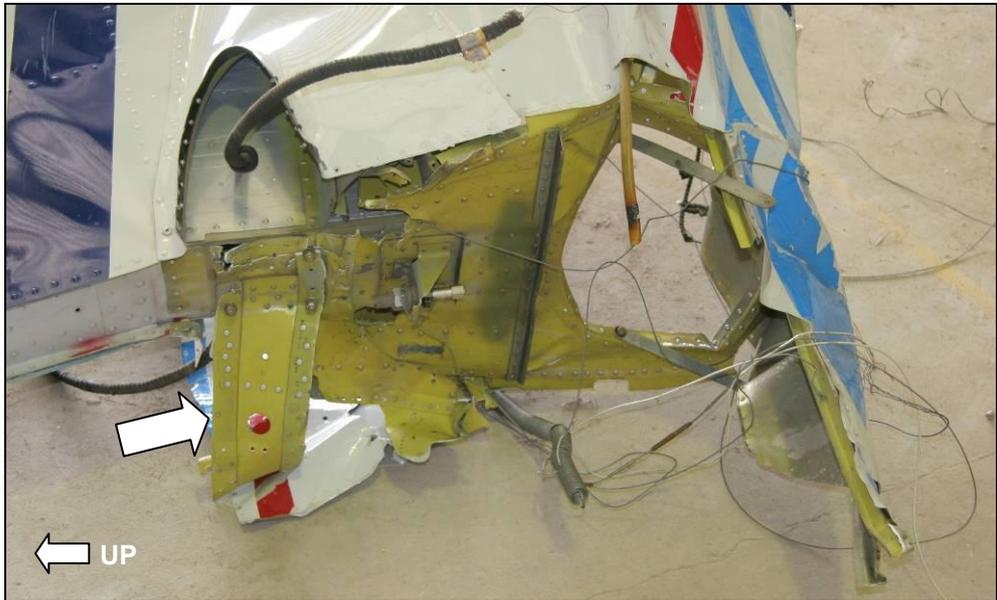
Separation between the vertical and horizontal stabilisers occurred at the station 335 bulkhead, which was aligned with the horizontal stabiliser main spar. A section of the spar webbing had been torn out of the stabiliser spar carry-through. Distortion and deformation around the tearing was toward the rear, with all fractures again typical of ductile overstress conditions.

**Figure 23:** Bulkhead at station 335.56 – plane of separation between forward and rear empennage sections. Horizontal stab tear out arrowed

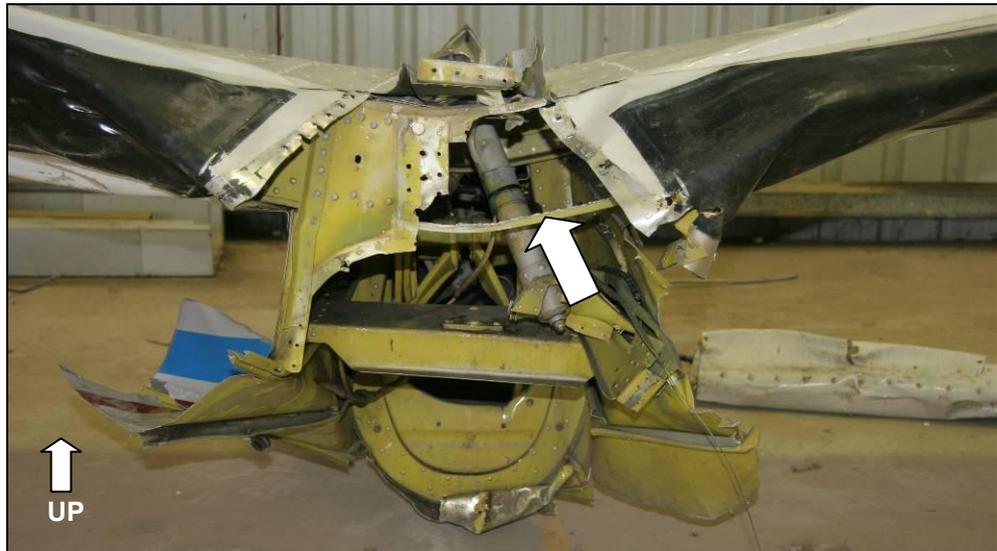
**Figure 24: Rear empennage plane of separation – horizontal stabiliser spar pull-out shown at arrow**

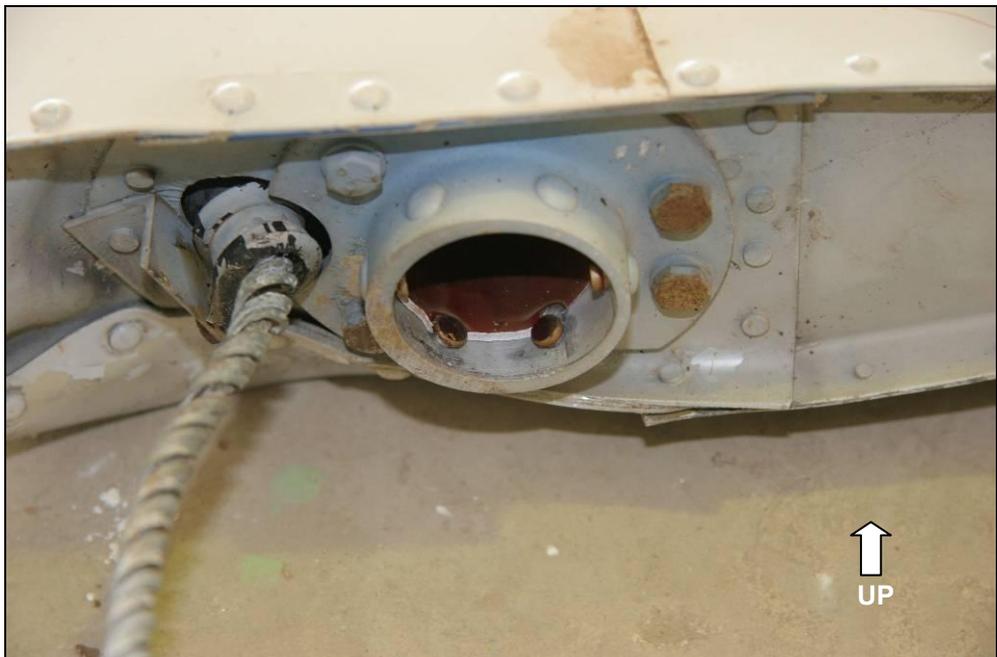
**Figure 29: Right elevator torque tube connection failure**

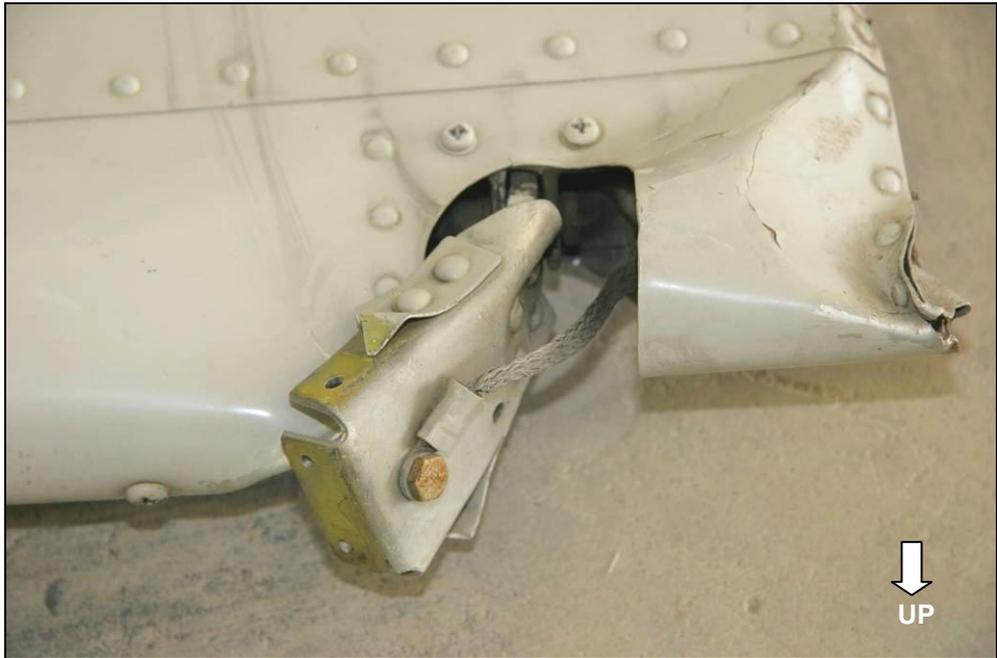
**Figure 30: Right elevator outer hinge point failure**

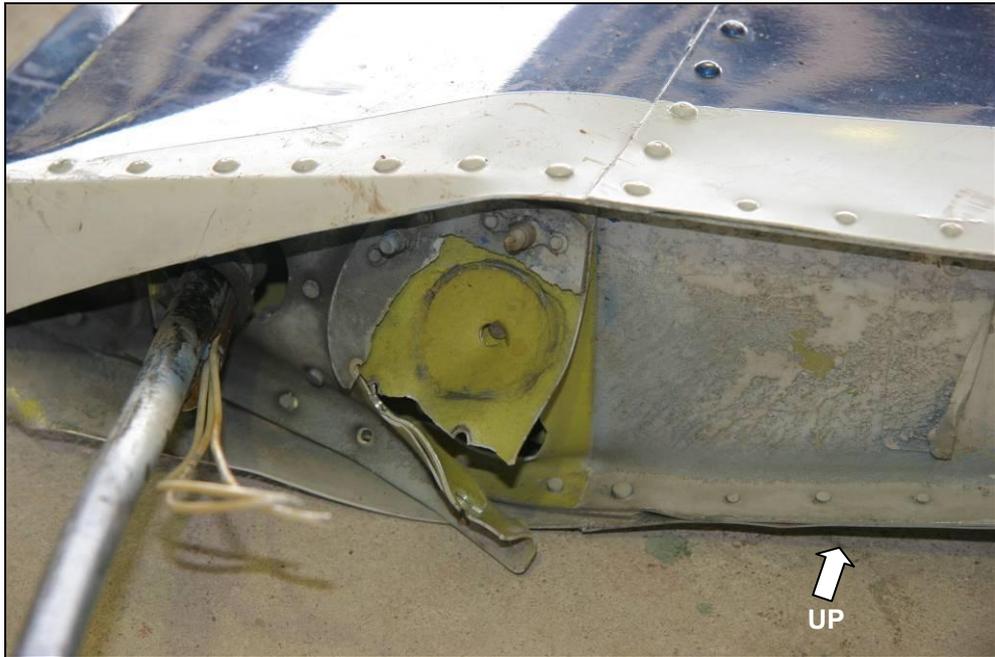
**Figure 33: Rudder base – torque tube connection failure**

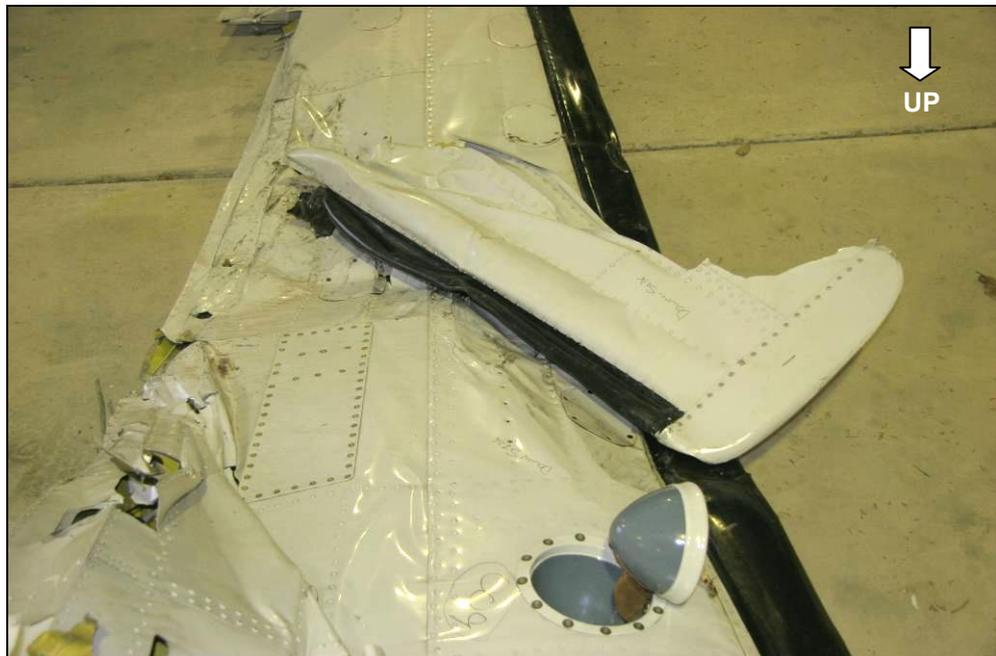
**Figure 35: Underside of right wing and right horizontal stabiliser outer section arranged to illustrate conformance of impact damage**

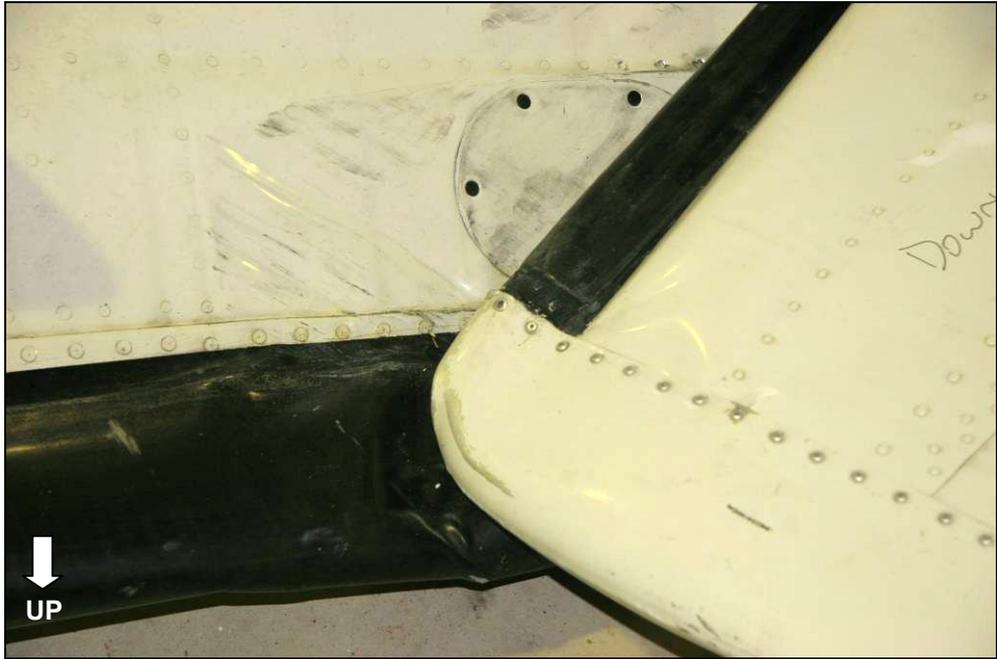
**Figure 36: Leading edge rubber smear marks on right wing underside, with outer tip of right horizontal stabiliser**

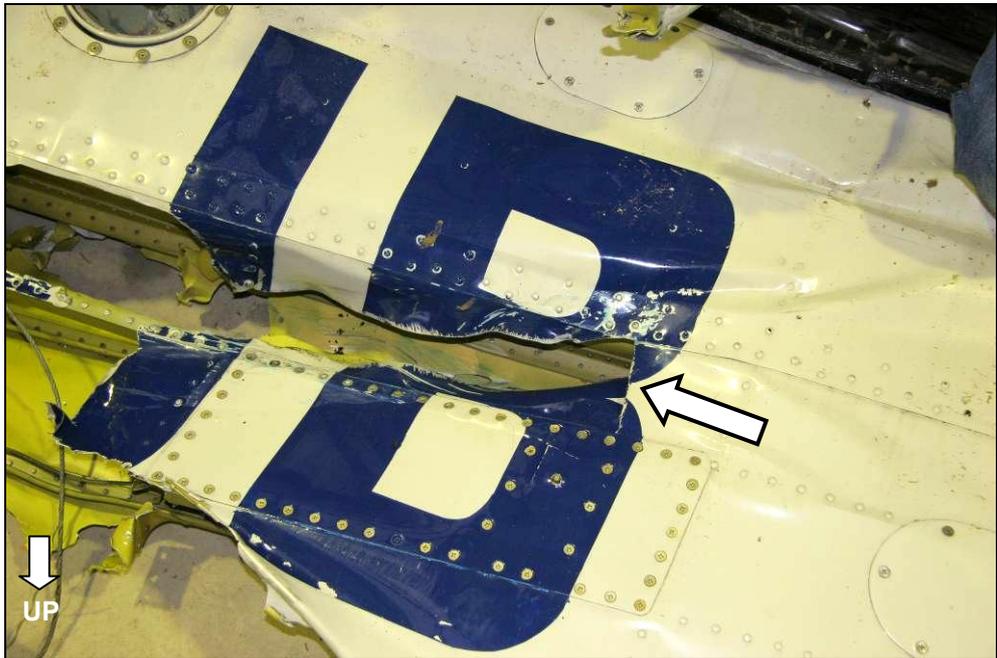
**Figure 37: Underside of left wing, with angled puncture indicated**

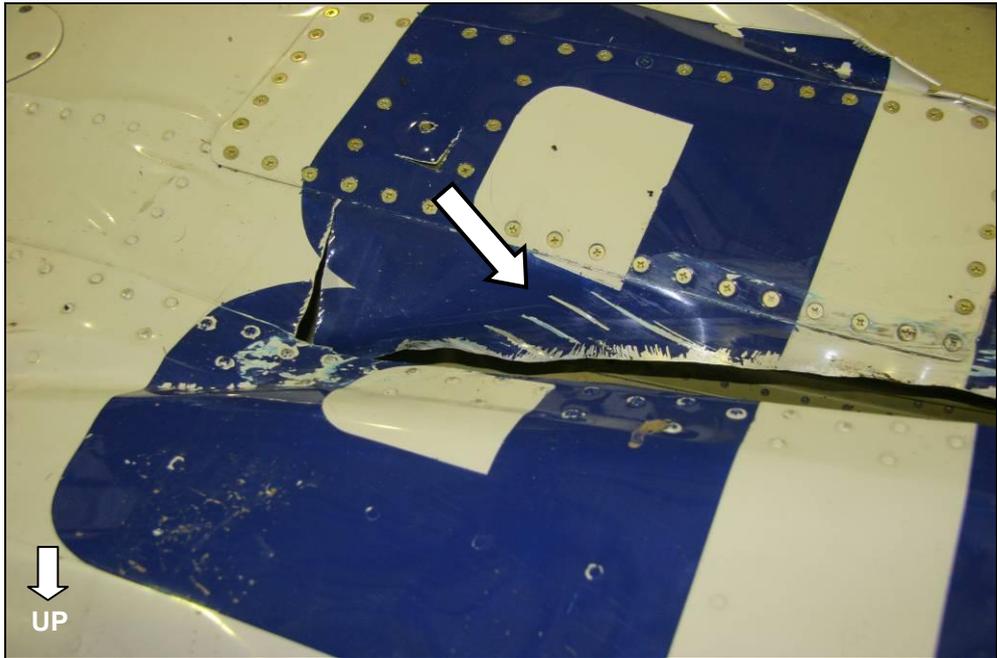
**Figure 38: Regular rivet head score marks in paintwork**

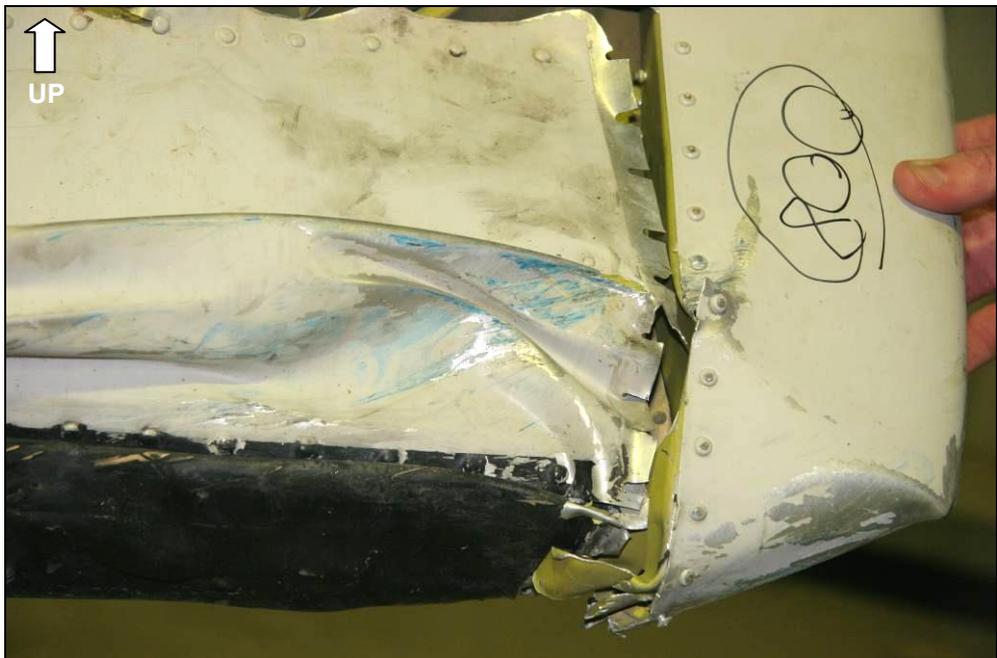
**Figure 39: Leading edge and tip of left horizontal stabiliser. Note blue paint smears**

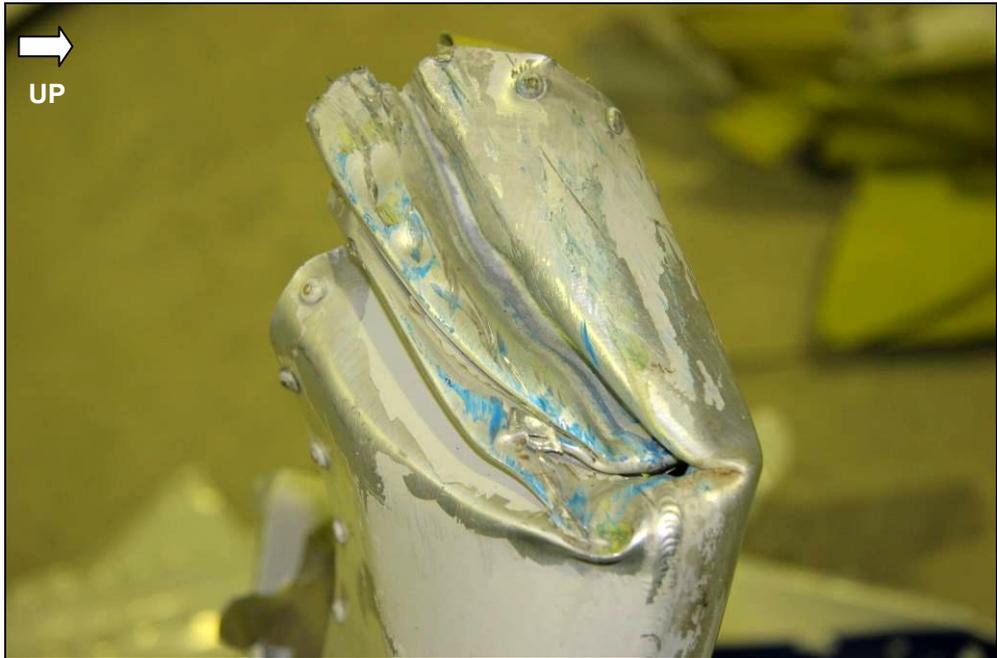
**Figure 40: Crushed left horizontal stabiliser tip with blue paint smears**

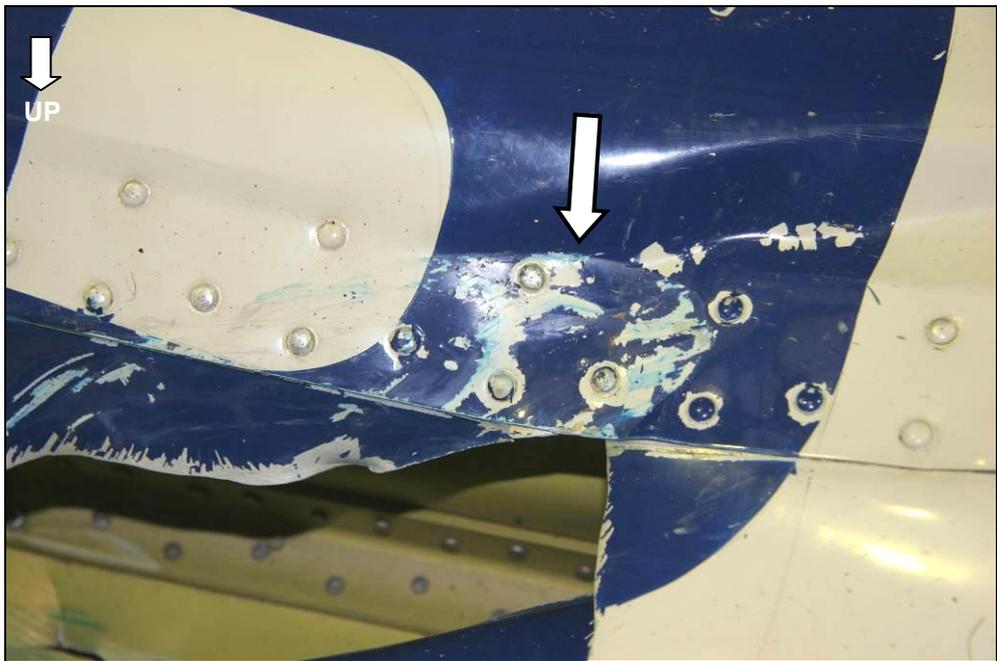
**Figure 41: Semi-elliptical impact mark at left wing skin puncture**
