**ATSB TRANSPORT SAFETY REPORT**  
Occurrence Investigation Report AO-2007-029  
Final

**In-flight breakup – Clonbinane, Vic.**

**31 July 2007**

**VH-YJB**

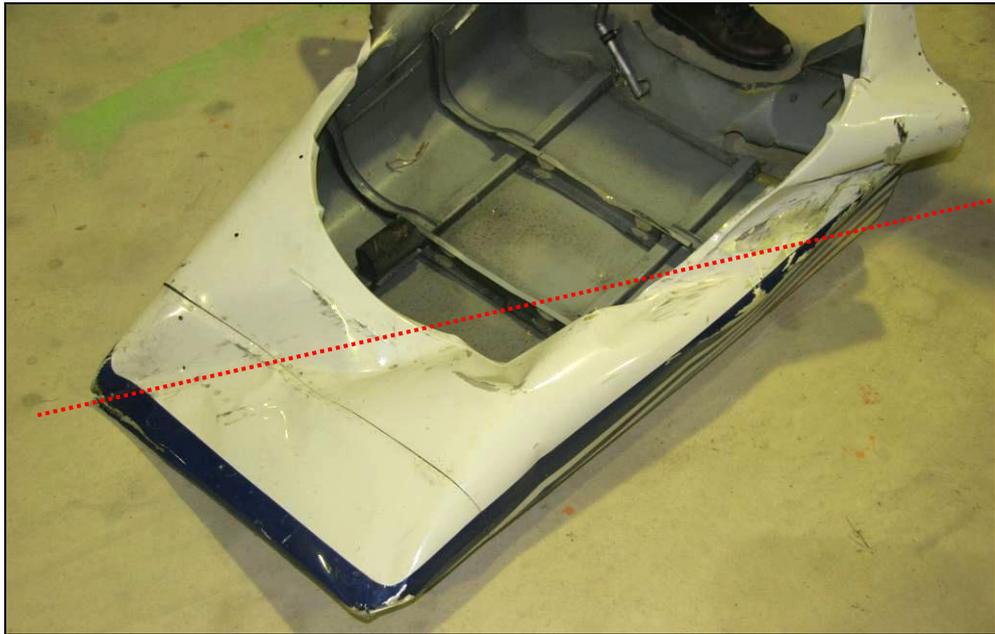
The rear nacelle fairing (canoe fairing, item 021) from the left engine / landing gear assembly had sustained a forceful impact with structure along a line extending diagonally across the wheel-well region on the underside of the fairing. Dark smears, similar to those visible along the underside of the right wing, were associated with the impact line.

**Figure 43: Left nacelle canoe fairing underside – impact line illustrated**

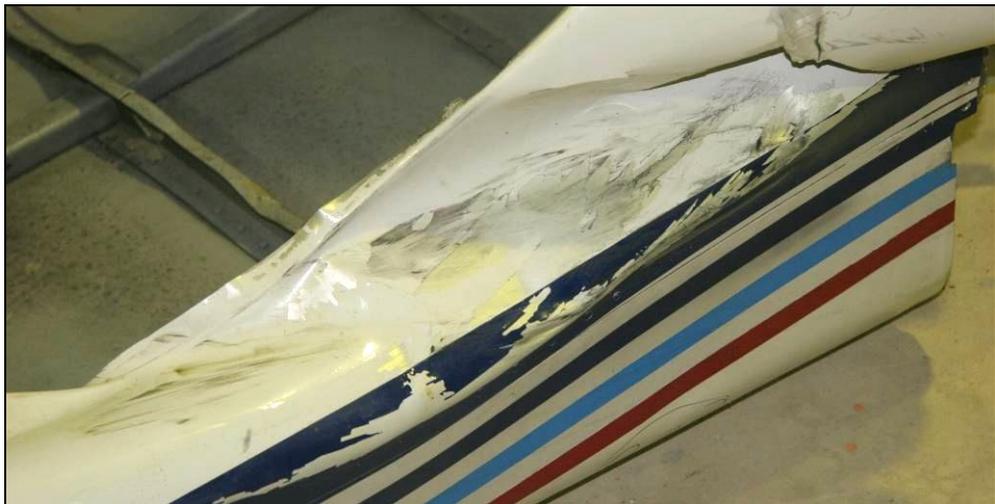
**Figure 44: Black smear / markings along impact line**
