**ATSB TRANSPORT SAFETY REPORT**

Aviation Occurrence Investigation AO-2006-001

**Loss of control – 9 km SE Raglan, Qld**

**Piper Aircraft Corporation PA-31-350**

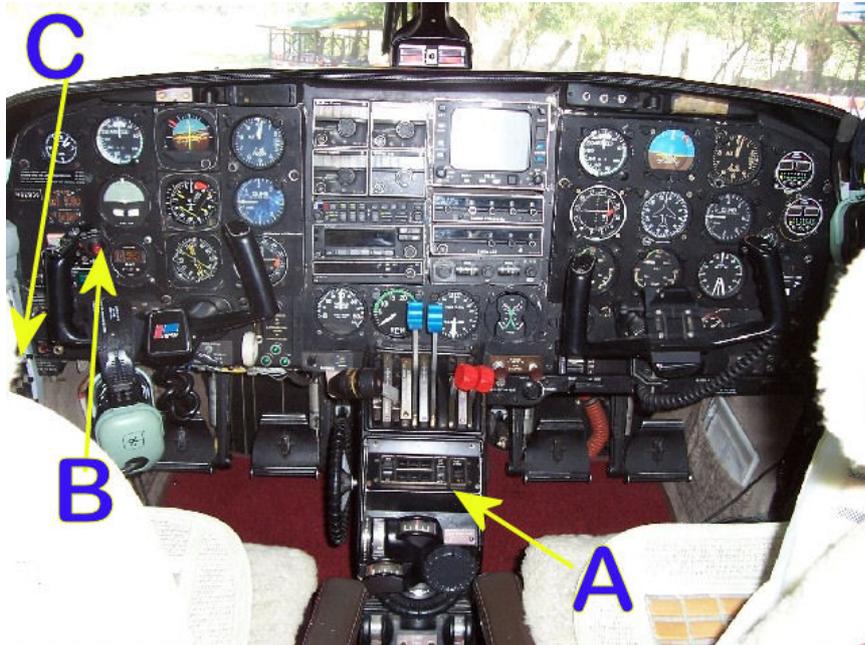
Figure 2: Cockpit instrument panel from VH-ZGZ: (A) autopilot control panel, (B) the red autopilot disengage button on the left control yoke, (C) forward section of the circuit breaker panel on the left cockpit wall

The location of the autopilot control panel, the circuit breaker panel, and the autopilot disengage button, as fitted to the aircraft, are indicated in Figure 2.

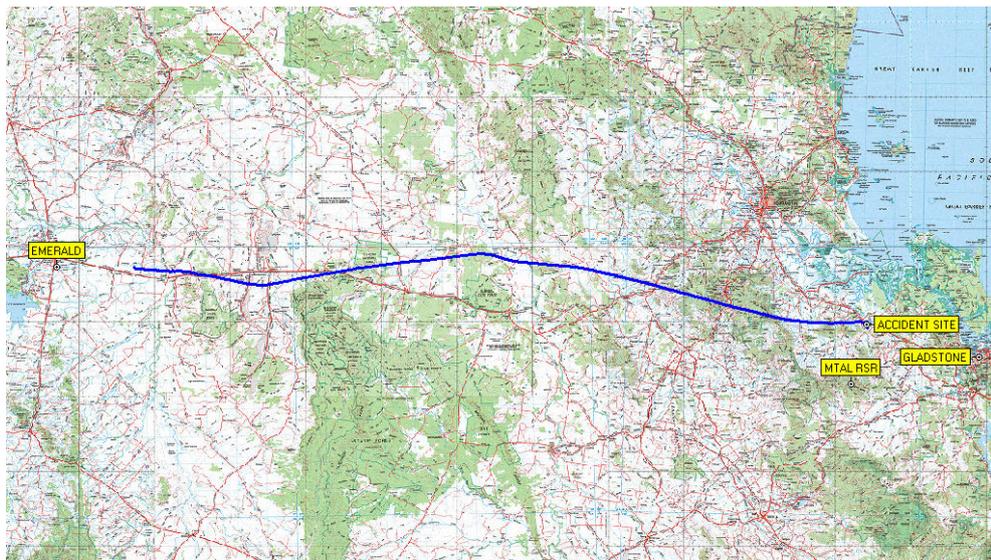
**Figure 7: Recorded radar track of VH-ZGZ**

Figure 7 shows the recorded track of the aircraft from its position when it initially entered radar coverage until radar contact was lost. The track information shows that the aircraft diverged left of the direct Emerald to Gladstone track, in accordance with the pilot's radio transmissions to air traffic control. The track information supports the conclusion that the aircraft's navigation systems were functioning normally.

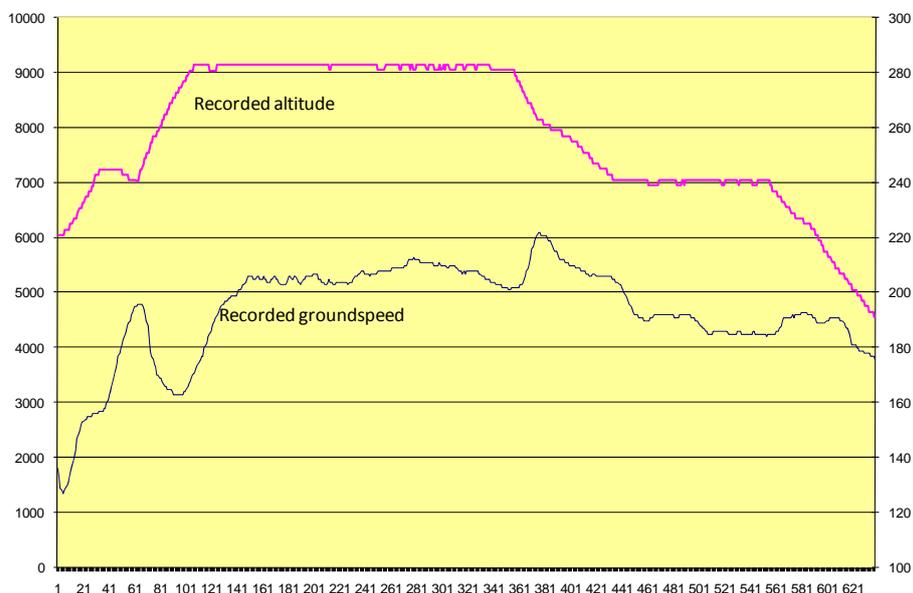
**Figure 8: Recorded altitude and groundspeed of VH-ZGZ**

The recorded altitude data (Figure 8) showed that the aircraft was first detected by the radar as it climbed through about 6,000 ft altitude. The aircraft levelled initially at about 7,200 ft before descending to 7,000 ft. A short time later, the altitude began to increase as the climb to 9,000 ft was initiated. The data showed that, after a period in cruise at that altitude, the aircraft descended to 7,000 ft and remained at that level until the descent towards Gladstone was initiated. The data showed that

the aircraft maintained a constant altitude<sup>9</sup> during the cruise segments of the flight, indicating that the aircraft was probably under the control of the autopilot during those periods.

The final 5.5 minutes of radar data showed the aircraft in a steady descent from 7,000 ft at about 450 ft per minute, with a groundspeed of about 180 kts. The last complete data record showed the aircraft at an altitude of 4,560 ft (well above the minimum safe altitude<sup>10</sup>) and at a groundspeed of 177 kts. Throughout those final few minutes of flight, the recorded track remained steady between about 091 and 094 degrees magnetic (M). There was no evidence of performance variations that might have been present had there been a failure of the primary flight instruments or one of the engines.

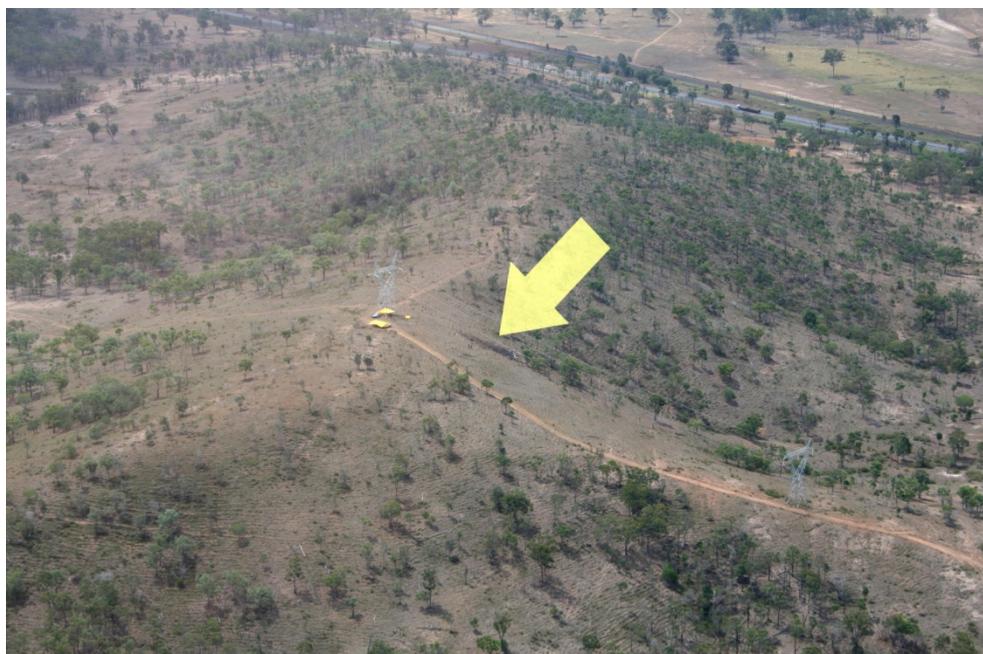
**Figure 9: Aerial view of accident site (arrowed) on the hillside**

All the aircraft extremities were identified at the impact site. It was also confirmed that all the flight controls were attached to the aircraft at impact.

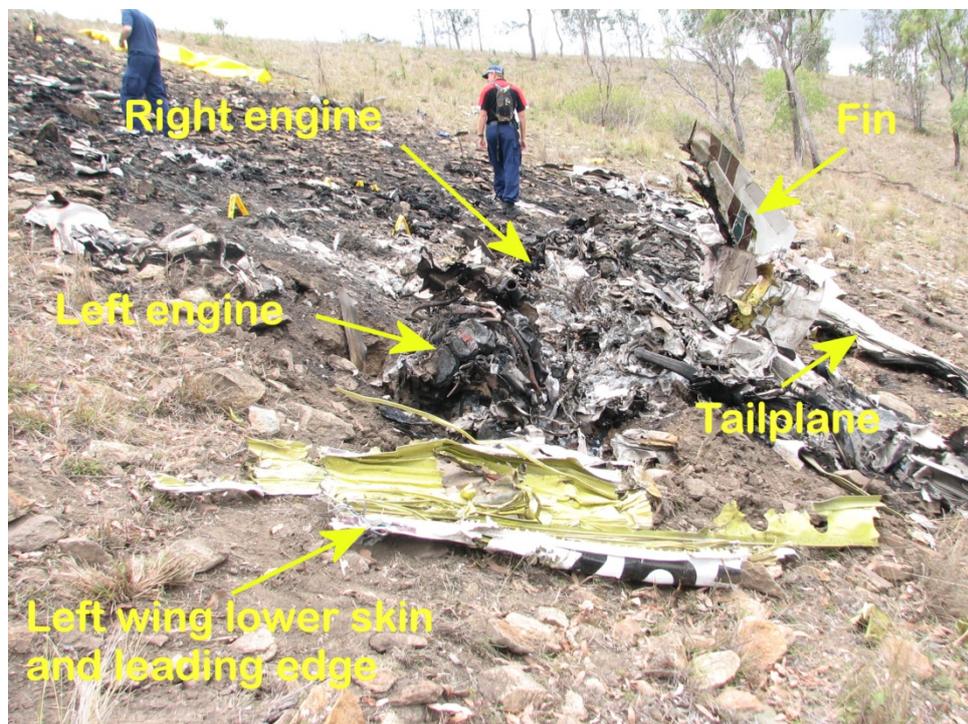
**Figure 10: Main features of the wreckage**

The force of the impact and the subsequent fire had caused the disintegration of much of the aircraft structure (Figure 10).

- There was extensive evidence of post-impact fire, indicating that there was substantial fuel on board the aircraft at impact.
- It was not possible to obtain fuel samples from the wreckage. However, there were no reports of any other aircraft using the same fuel batch being affected by fuel quality.

- It was not possible to determine the position of the wing flaps due to the extent of damage to the flaps and the flap drive mechanism.
- The landing gear was in the retracted position at impact.

- The condition of the wreckage precluded examination of the aircraft's fuel and electrical systems. The fuel tank selection panel was not found.
- The extent of damage to the cockpit area prevented any meaningful information being obtained regarding cockpit switch and control positions at impact, and the cockpit and instrument lights.

- The empennage retained some of its integrity and was predominantly unaffected by the post-impact fire, as were some segments of the wings. Examination of those items did not reveal any evidence by way of streaking or melting from sustained burning to indicate the presence of an in-flight fire.

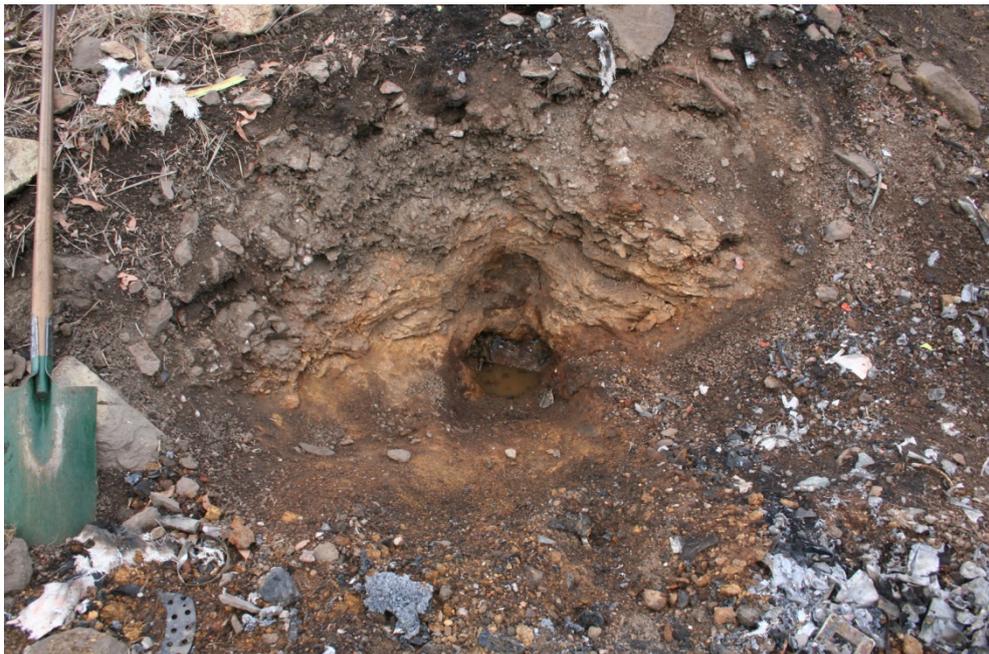
**Figure 11: After excavation of the left engine/propeller**

The left propeller hub had fractured and fragmented, destroying the internal mechanism and releasing all blades. The positions of witness marks on the preload

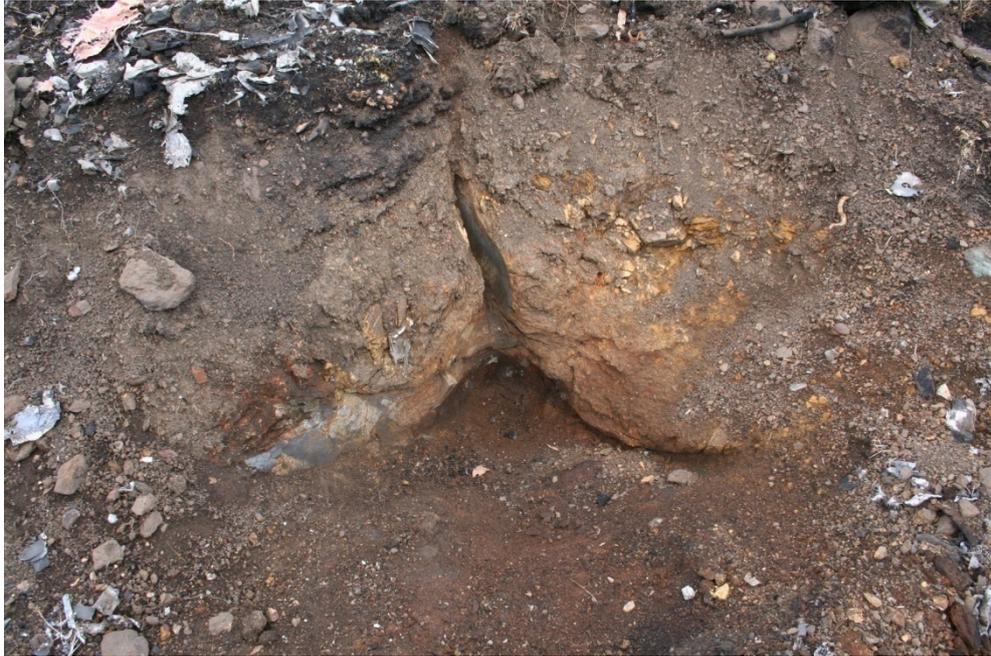
**Figure 12: After excavation of the right engine/propeller**

The right engine crankshaft had fractured in a single location through the rear-most flange adjoining the forward big-end bearing journal. There was no evidence to suggest that any latent defects, such as fatigue cracking or material flaws, were present in the crankshaft or associated forward big-end connection, nor was there any evidence suggesting that any defects or deficiencies within the crankshaft had contributed to the failure as observed. Checks against the engine manufacturer's service bulletins indicated that the right engine crankshaft was not included in the range of components identified by the manufacturer for mandatory replacement. The crankshaft failure was attributed to the combined forces of engine operation and ground impact.

The aircraft's right propeller, although having sustained extensive impact-related damage, remained essentially intact and was recovered with all but one blade retained in the hub. The forward position of the pitch change fork, the orientation of the blade butt fractures and the preload plate witness marks were all consistent with the governed, on-speed operation of the propeller at impact.

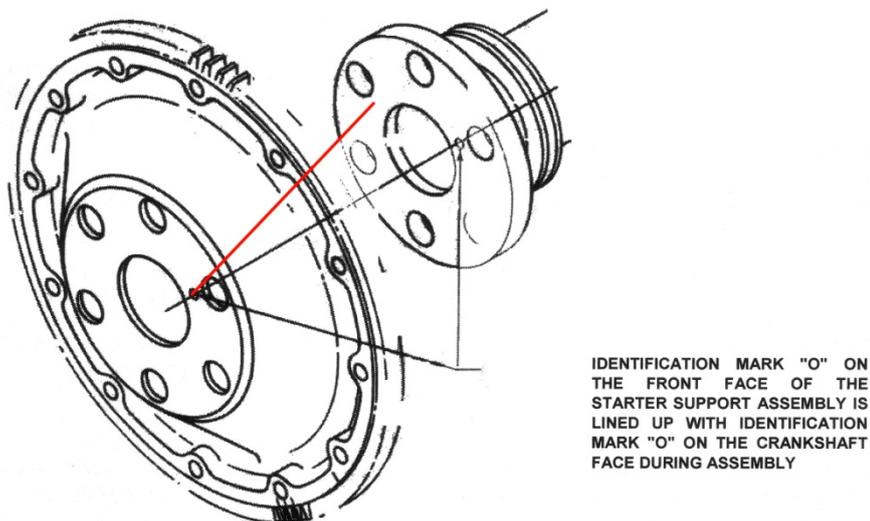
**Figure 12: Diagram showing starter support assembly and crankshaft face. The red line indicates the alignment reportedly found between the two components when the propeller was removed at Emerald on the day of the accident flight**

The Emerald LAME decided to check the engine timing and noticed that the starter support timing marks appeared to be in the incorrect position. To investigate further, the propeller was removed and it was found that the identification marks on the starter support assembly did not line up with the identification marks on the crankshaft face (see section 1.14.2); they were displaced by approximately 120 degrees (Figure 12) from the correct position. The LAME reported that he checked the starter support for damage and observed deformation on the support assembly

where the tapered dowel or flange bushing had been forced into the flange when the propeller was secured to the crankshaft. The LAME said that the dowel was undamaged and that, apart from the deformation caused by the tapered dowel, the flange showed no cracks or other damage. He reassembled the components with the flange correctly aligned with the crankshaft, refitted the propeller and adjusted the engine timing. The engine then started and ran normally during a ground run.

Discussions with a number of experienced LAMEs and an aircraft engine overhaul organisation revealed that it was possible to assemble the propeller to the crankshaft with the ring gear aligned incorrectly, as was reportedly found when the aircraft was examined at Emerald before the accident flight. If in those circumstances the engine timing was adjusted using the ring gear markings, the timing would be 'out' to such an extent that the engine would not operate. However, if the timing was correct before the propeller and ring gear had been removed, and if no adjustment was made to the engine timing, the incorrect ring gear alignment on re-assembly would have no effect on engine operation.
