Air Accidents Investigation Branch

**Report on the accident to
Beech 200C Super King Air, VQ-TIU
at 1 nm south-east of North Caicos Airport
Turks and Caicos Islands, British West Indies
on 6 February 2007**

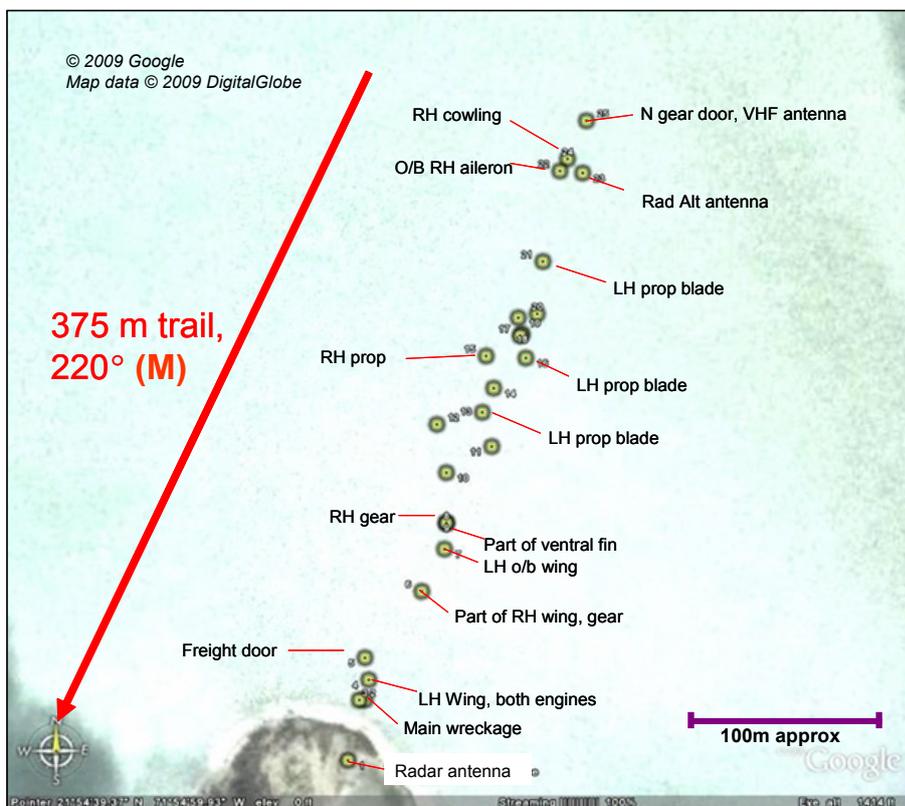
The aircraft had crashed into a shallow lagoon approximately one nautical mile southeast of North Caicos Airport. Wreckage was spread along a trail that extended in excess of 370 m along a track of 220°(M). A hand-held GPS instrument revealed that the first wreckage items were located 1,980 m on a bearing of 125°(M) from the upwind end of Runway 08. The final pieces in the wreckage trail were found on the beach of Burial Cay. Figure 4 shows a plot of the major pieces of identified wreckage.

Wreckage plot, prepared from hand-held GPS

From the air, the extent of the wreckage trail could be clearly seen, together with what appeared to be a shallow trench in the sand. However, whilst wading around the site, no discernible impact marks could be observed on the lagoon bed, such as could have been made by the wing tips or propellers. Since such contacts would have been inevitable as the groundspeed decayed, it is considered that the sand probably flowed back into any indentations during the hours following the accident and before a detailed assessment of the site was undertaken. It was also apparent that the sand, raised by water disturbance, had settled back on top of the vegetation and partially obscured it, this contributing to the appearance, especially from the air, of a scar or shallow trench across the lagoon bed.

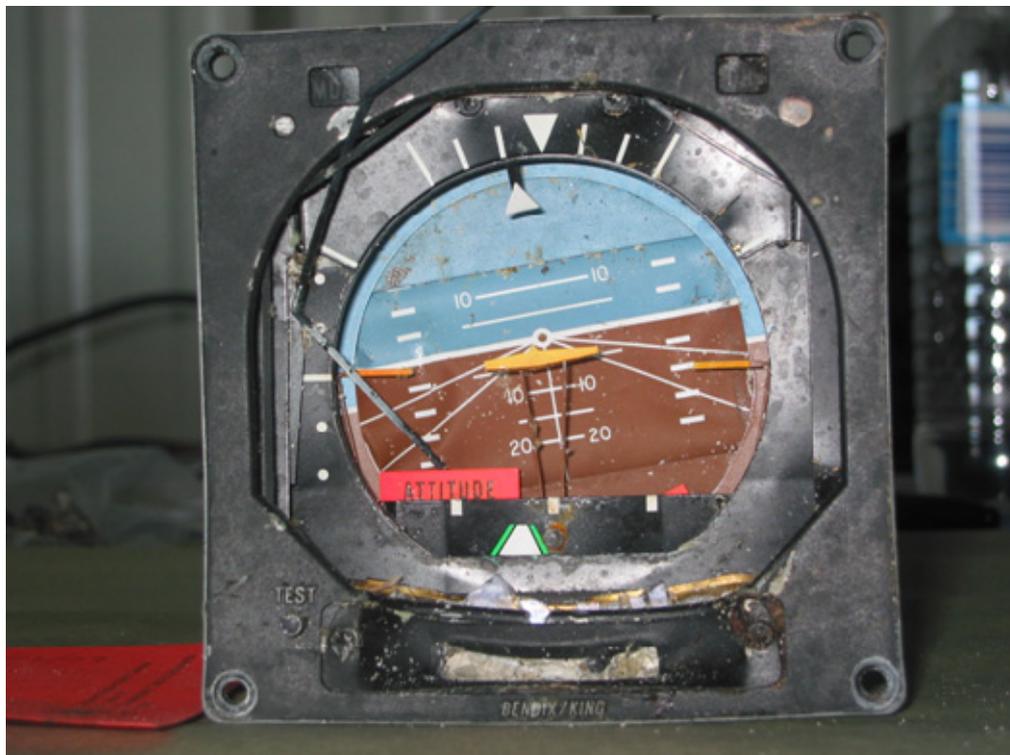
Figure 5

'frozen' as a result of being struck by an object during the impact sequence. The displayed attitude, as can be seen in Figure 5, was a right bank of around 9°, together with a slight nose-down pitch angle. This was close to the impact attitude as assessed from the on-site examination.

Pilot's main attitude indicator, showing as-found indication

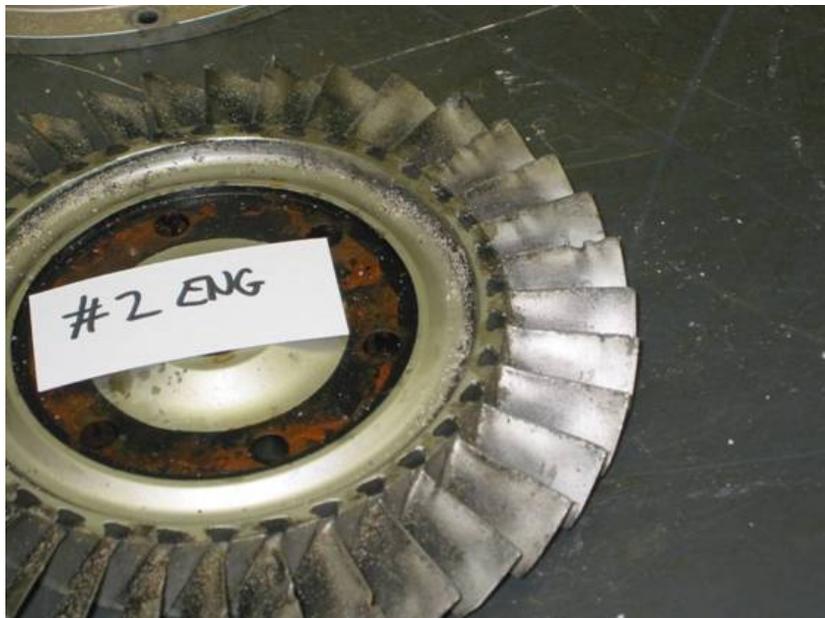
The right engine compressor stages all showed evidence of foreign object damage (FOD) on the blade leading edges. The notches and raised burrs so caused were accompanied by stream-wise streaking on the blade surfaces,

which indicated that this damage was not associated with the impact but had occurred at some time prior to the accident. Figure 6 shows a photograph of some of the damaged blades.

View of typical damage to compressor blade leading edges of No 2 engine.
Note streaking, indicating that damage pre-dated the accident

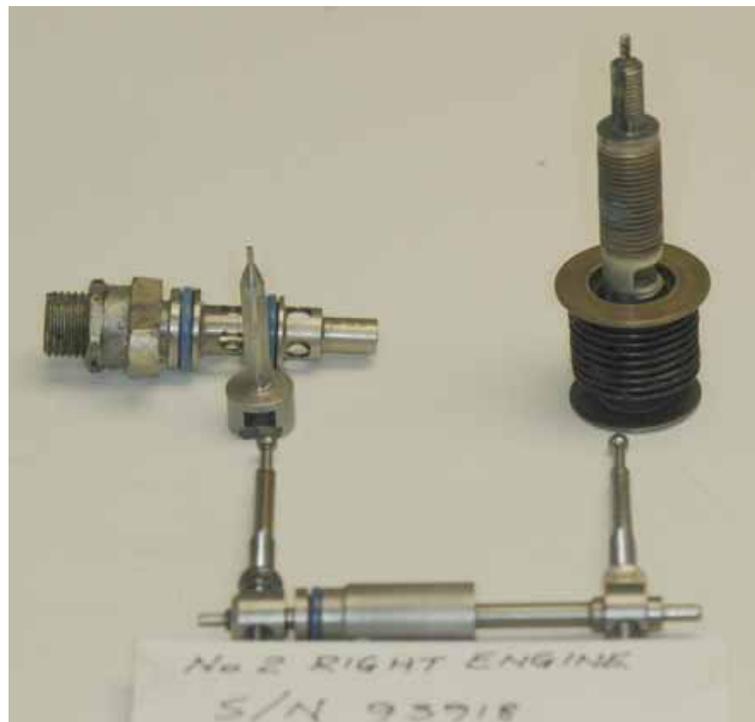
Figure 8

Bellows assembly from right engine FCU
(refer to schematic diagram shown at Figure 7)

It was found that the bellows assembly was 0.017 in longer than its manufactured length of 1.025 in, which was stamped on the component. The maximum permissible extension was 0.007 in. This indicated that the evacuated bellows had developed a leak, which had allowed ambient air inside, thereby causing the bellows assembly to expand. Furthermore, an area of green-coloured deposits was visible on the copper surface of the bellows, at a position opposite the point where the P_x tapping entered the chamber in the FCU within which the bellows had been located.

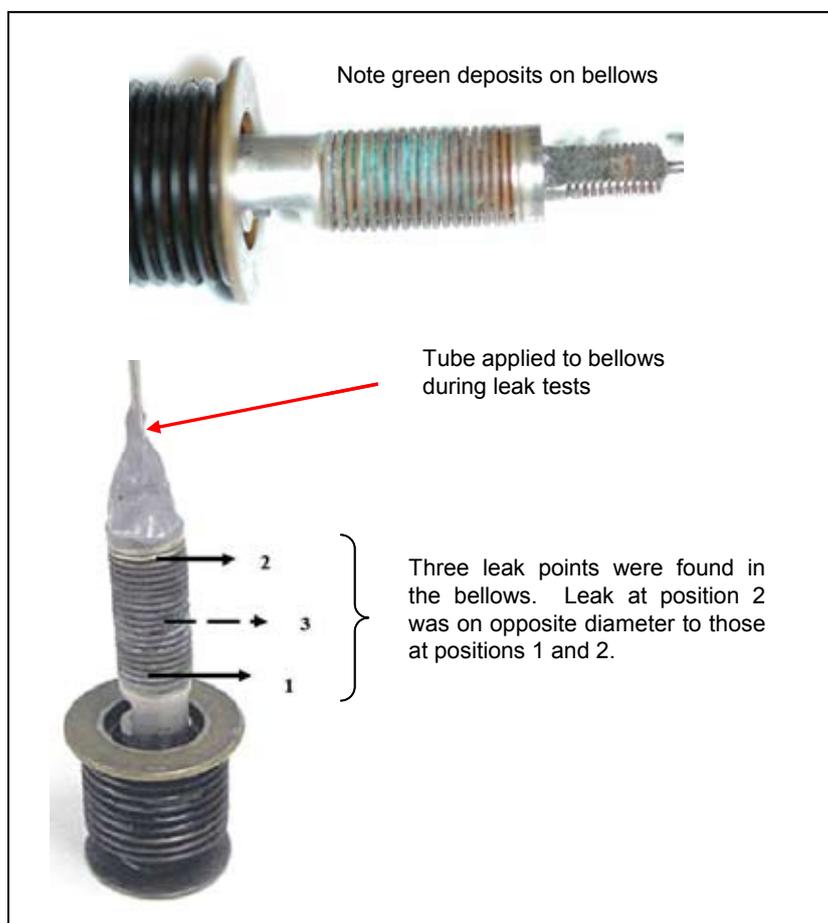
Figure 9

be applied whilst the assembly was immersed in water. This revealed the presence of three leaks; their positions are indicated at Figure 9. One of the leaks was associated with a significant pinhole, which was surrounded by pitting corrosion, as can be seen in the scanning electron microscope (SEM) images at Figure 10. The engine manufacturer noted that copper (the primary constituent of the bellows material) does not normally corrode by pitting. An energy dispersive X-ray (EDX) analysis revealed the presence of a strong chlorine signal in the contaminant material adhering to the bellows' surface. Whilst some of this would have originated from the chlorides of sodium and other metals, the level was considered to represent a concentration considerably in excess of that found due to seawater exposure and therefore was not likely to have come from the environment.

Details of bellows assembly, showing leak points

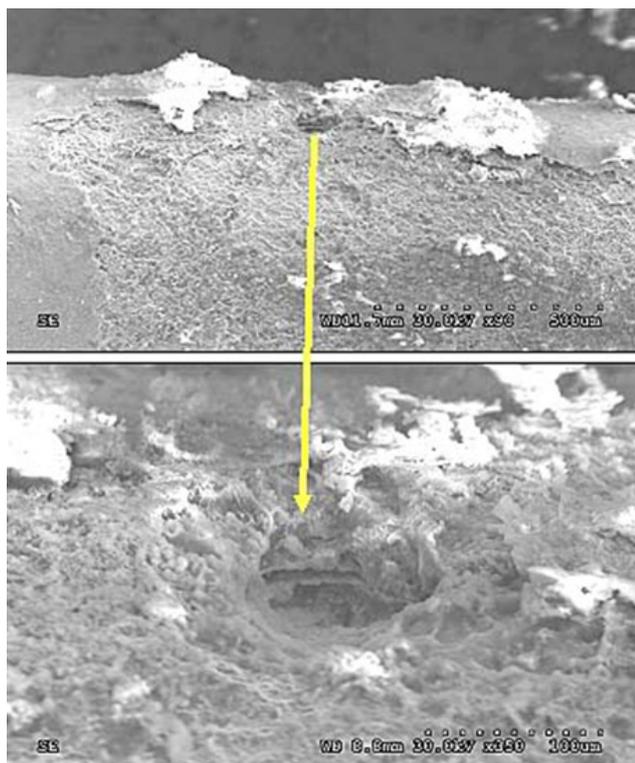
Figure 10

SEM photographs showing corrosion pit in bellows

The FCU and bellows manufacturers were consulted during the investigation and they stated that chlorine was not used in the manufacturing processes. The FCU bellows from the left engine bore no similar evidence of corrosion, suggesting that the operator was not routinely introducing a chlorine-containing chemical into the engines. Thus the origin of the chlorine and hence the reason for the corrosion was not determined.

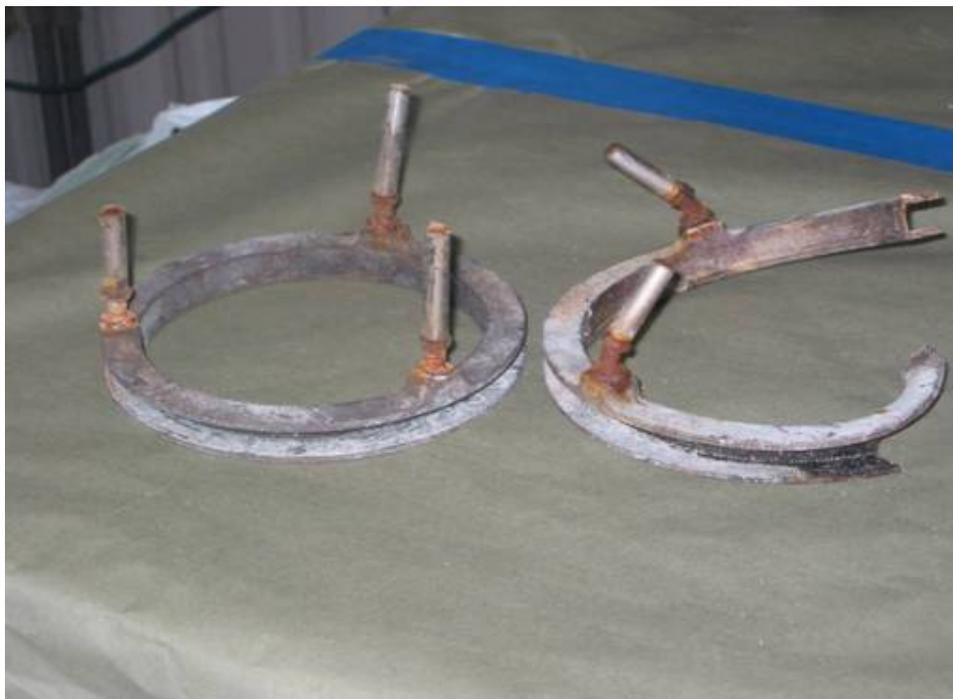
Figure 12

Both feedback collars were recovered, with all three beta rods present on one of them and two on the other as shown in Figure 12. The fracture positions of the beta rods indicated that the collars were towards their aft positions, meaning that the propellers were operating within their governed range, as opposed to flight idle or reverse.

Feedback collars, showing broken beta rods; fractures probably occurred within countersunk holes in hub

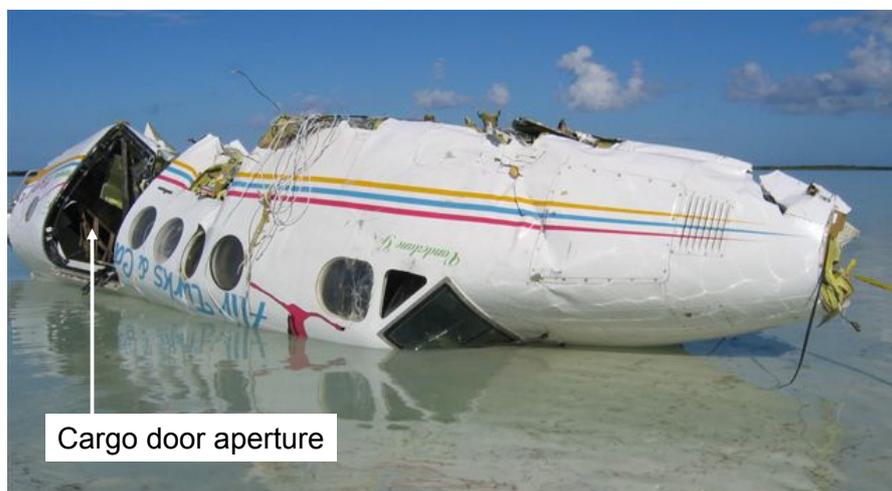
Figure 14

From passengers' accounts, all the aircraft's occupants were conscious immediately, or very soon after, the fuselage came to rest. The fuselage was in a nearly inverted attitude, but relatively intact, as can be seen from Figure 14. However, there was considerable damage within the structure; the cabin floor was heavily disrupted as described earlier, and some seats had detached from their mounting points. Numerous lightweight fixtures and panels had become detached within the cabin.

Aircraft fuselage as found on initial inspection by the investigation team,
8 February 2007

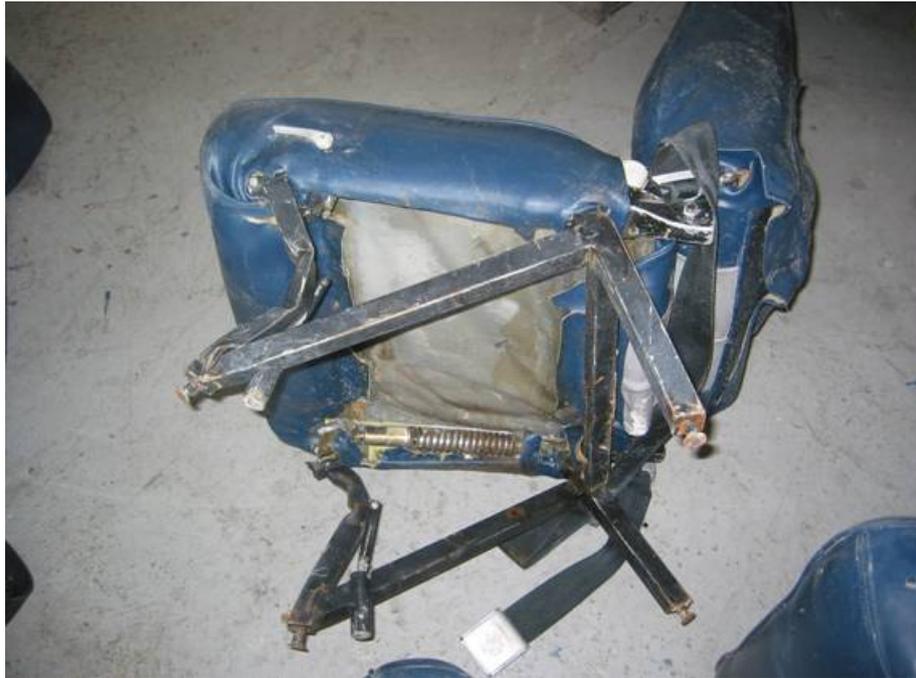
Figure 15 shows one of the seats on which the supports had remained intact, although it had become detached from its mountings. The distortion indicates that the design loads had been exceeded, although not to the point of fracture.

Typical passenger seat, showing frame distortion
