CIAIAC

Final report A-019/2008

Accident involving
a PILATUS PC6-B2H4
Turbo-Porter aircraft,
registration EC-JXH,
in Lillo (Toledo),
on 30 May 2008

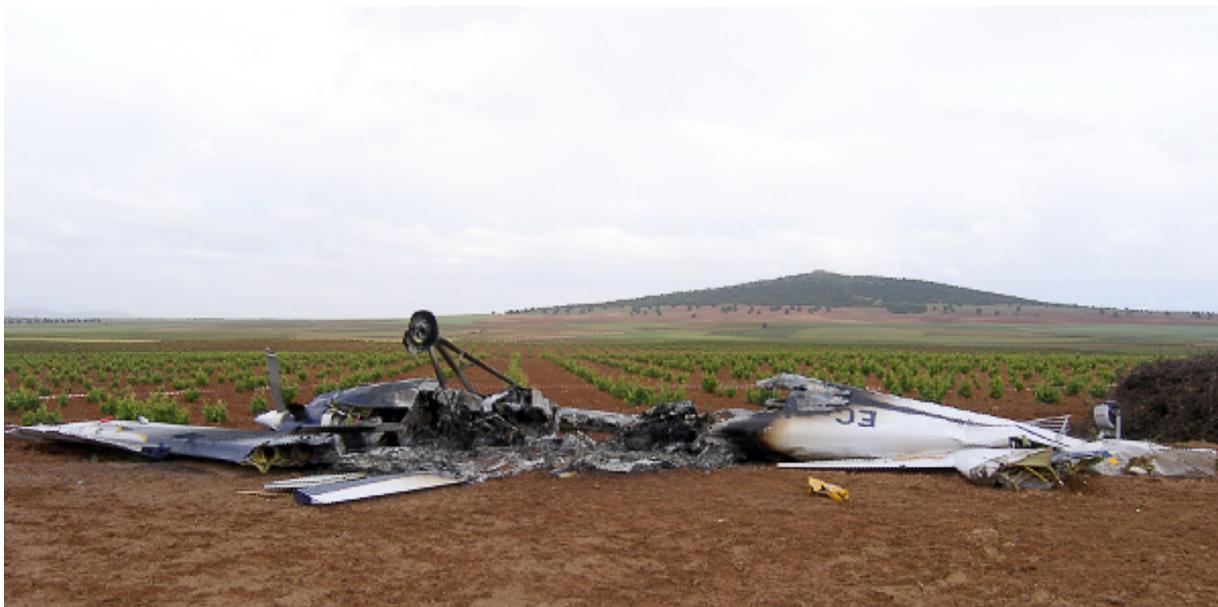
Figure 1. Photograph of aircraft at crash site

No sooner had they returned to their normal positions when the left wing broke 5.75 m away from the wing tip and detached. This resulted in the right wing rising, inverting the aircraft and causing it to fall while spinning clockwise (as seen from above).

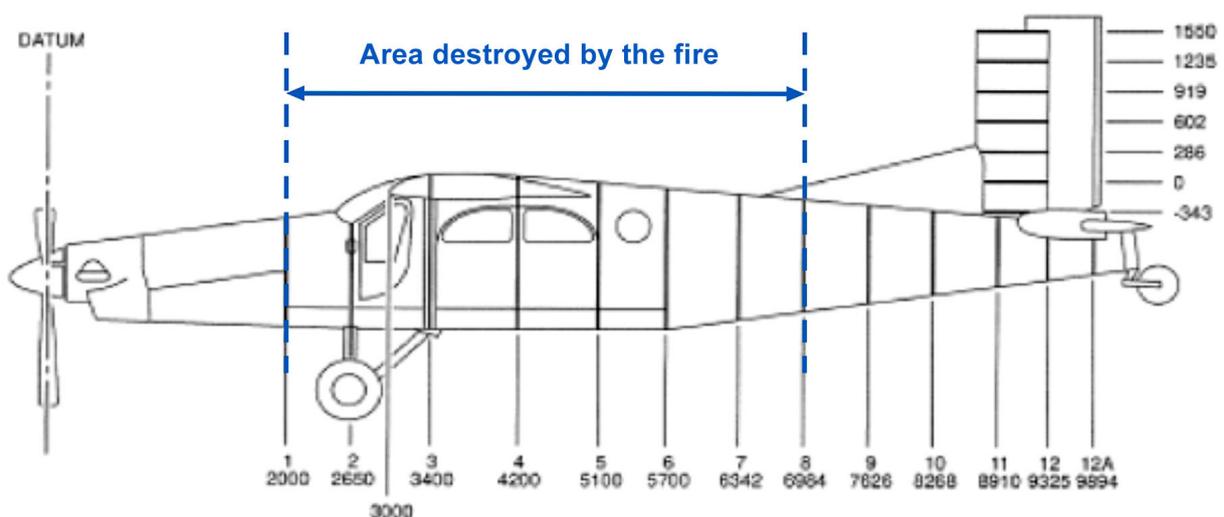
Figure 2. Section destroyed by the fire

After the impact a fire broke out that destroyed the airplane from station N.º 1 (firewall) to N.º 8 (forward part of the tail cone).

The pilot and one of the instructors were unable to exit the aircraft under their own power, nor were they ejected by the rotation. They were killed on impact and their bodies charred in the subsequent fire.

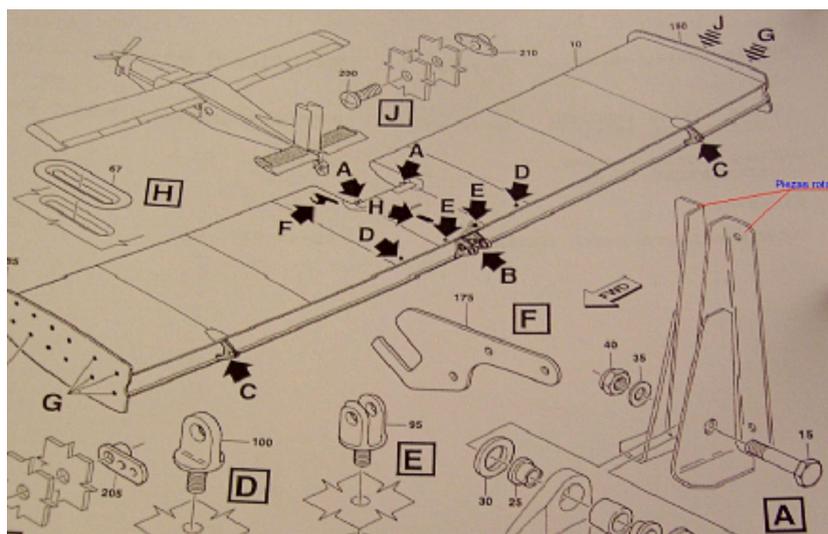
Figure 5. Stabilizer support

The previous inspection had also been done by the manufacturer’s maintenance organization, from 15 to 17 January 2008, with 15,658 h on the airplane, during which the horizontal stabilizer support was replaced due to cracking.

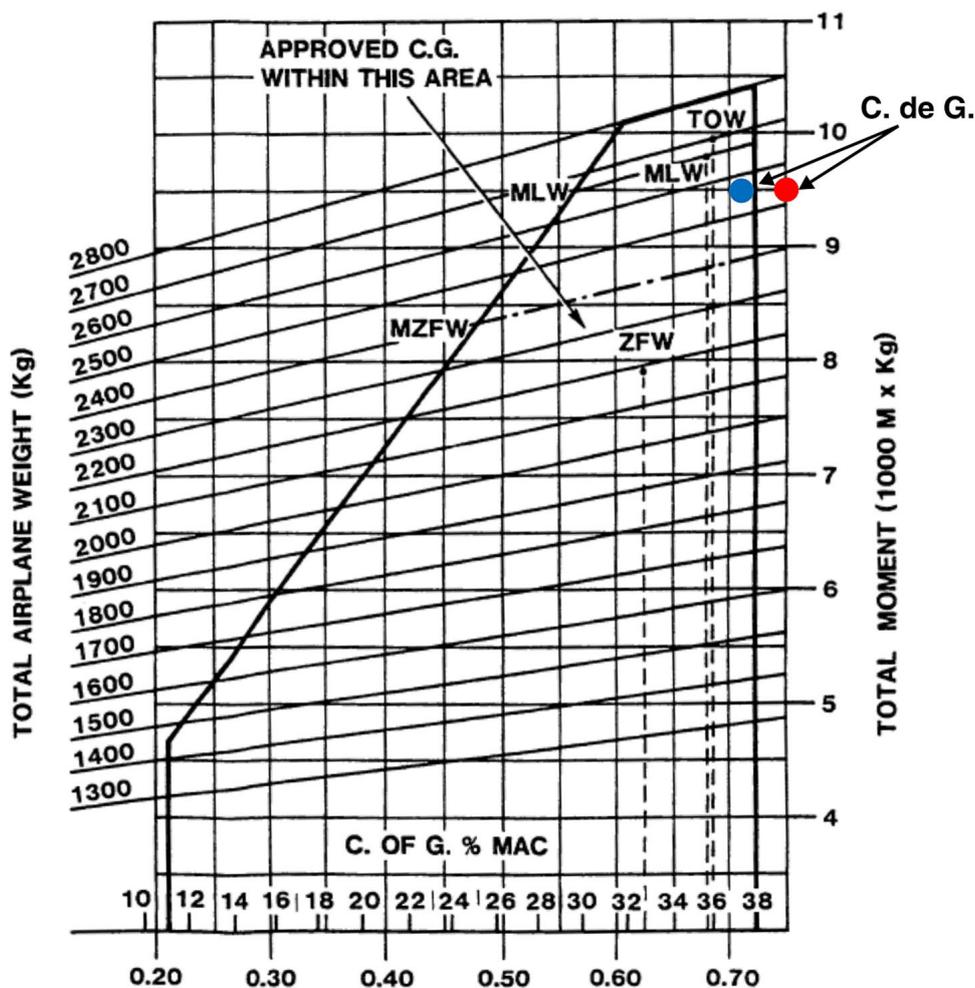
Figure 7. Position of the C.G. in load and balance graph

If we now consider the second load case, the center of gravity would be at 3.74 m (9,668.05/2,580.7) from the reference line, that is, 39.27% MAC, which is outside the limits.

In any event, for the weight and number of passengers on the airplane, small variations in their locations could cause the center of gravity to shift outside the flight envelope.

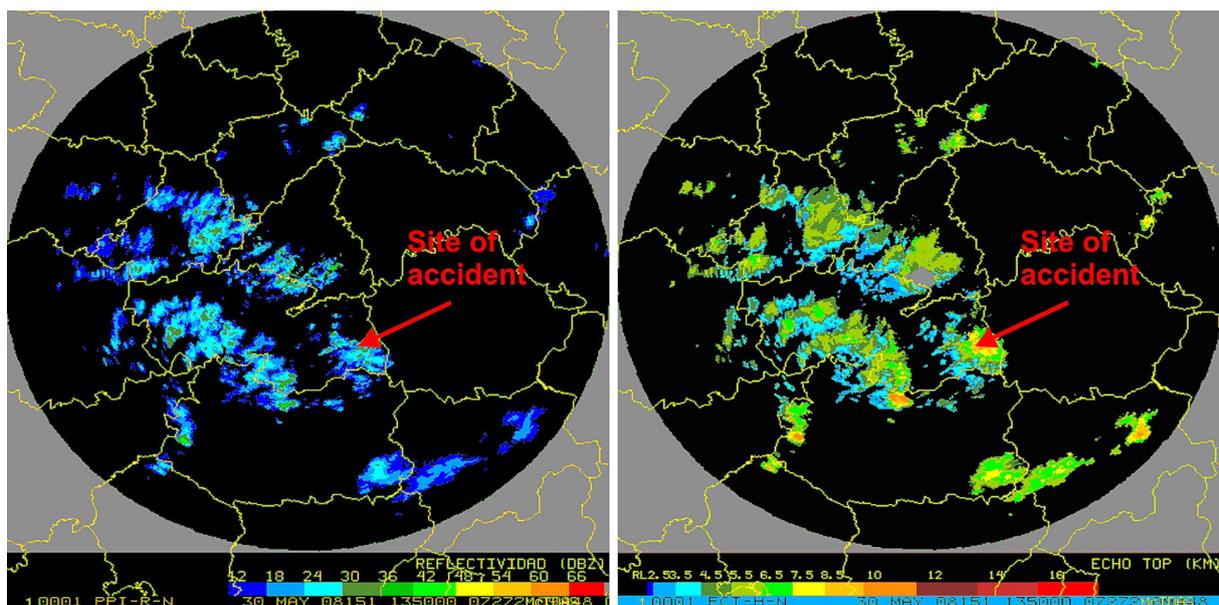
Figure 8. Reflectivity and Eco Top maps for 15:50

The reflectivity and Eco Top images in figure 8 show, respectively, the type of precipitation in the area at the time of the accident (light) and the altitude of the clouds (between 5 and 10 km).

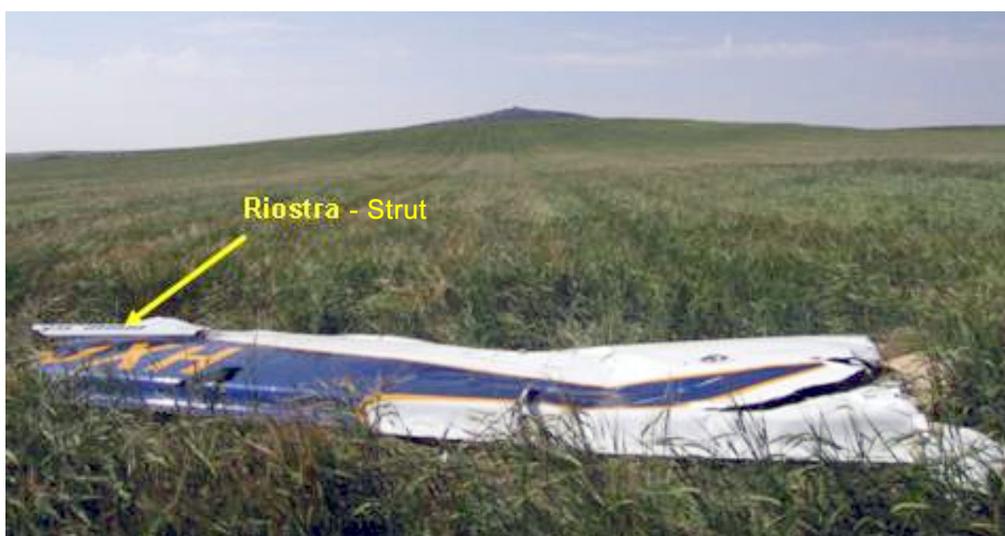
Figure 12. Left wing

The part that detached from the left wing was found alongside the Lillo-Villatobas road, in the segment that is known as the Cerrotraviesa trail, at coordinates 39° 46' 0.18" N – 3° 17' 10.8" W and an elevation of 680 m. It was oriented from east (part near the tip) to west (part near the root), and resting on its top surface. It was 5.75-m long measured along the spar closest to the leading edge. A 0.85-m long segment of the brace was still attached to it. The force of the impact had caused it to bend along its length such that it was convex along the top and concave along the bottom.

There were two dents on the leading edge. The wing tip was torn and a portion of the trailing edge had detached and come to rest in a separate area from the rest of the wing.

The inboard aileron and both flaps were found. The outboard aileron was not found. The inboard aileron, which was only slightly damaged, was the one component that was farthest away from the main airplane wreckage. Specifically, it was found alongside the road that goes from Lillo to Santa Cruz de la Zarza, at coordinates 39° 46' 33.38" N – 3° 17' 17.67" W and an elevation of 692 m. Its fittings were bent.

During the investigation a macroscopic analysis of the left wing was conducted by an expert in structures and in-service faults. A laboratory microscopic study was not considered necessary, as there were no doubts regarding the cause of the fractures present, namely static overload. The progressive fracture and failure of the material was ruled out.

The wing's spar was broken. This spar consisted of two L-shaped cords and a central metal sheet joining the two.

Both cords and the central core were fractured. Specifically, the upper cord had a 45° bevel fracture on a plane perpendicular to the spar's longitudinal axis. This fracture intersected two attachment holes drilled into the skin of the wing. The lower cord had a flat fracture that extended along two different planes, one parallel to the length of the wing and the other perpendicular to it. The entire spar near the fracture area was bent downward, meaning that the wing detached downward. There were several compression lines in the upper cord of the spar.

- The macroscopic analysis of the fractures found on the left wing concluded that they had been caused by a static overload. Progressive fracture mechanisms and material failure were ruled out.

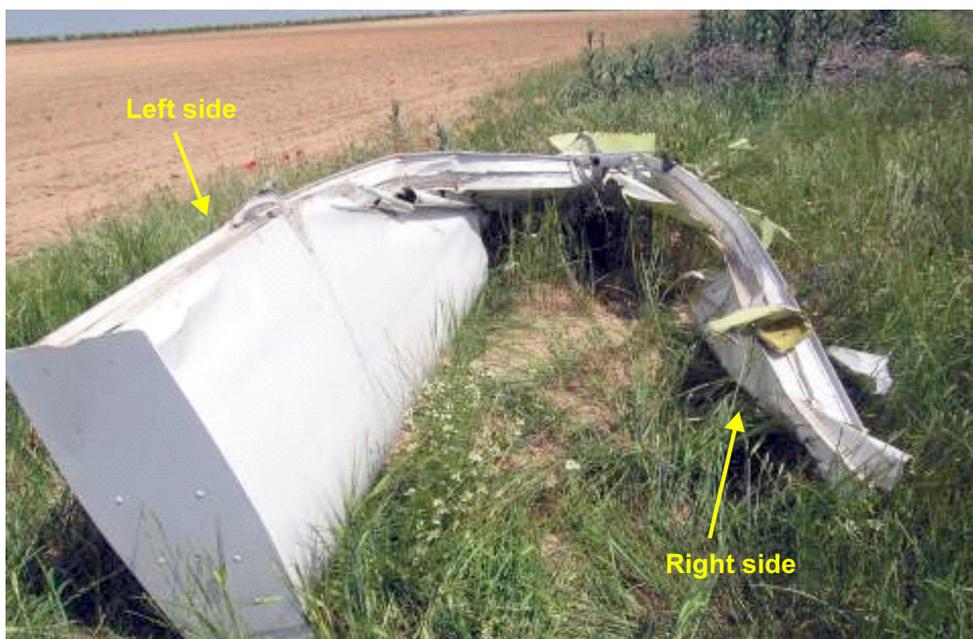
Figure 13. Horizontal stabilizer

Like the left wing, the horizontal stabilizer was also found near the Cerrotraviesa trail, at coordinates 39° 45' 48.66" N – 3° 17' 47.58" W and an elevation of 700 m. It was bent at the center in a U-shape (see Figure 13) and ripped from its fittings at the center. The left side was practically intact. The right side was heavily damaged. It was missing the piece that had remained attached to the main wreckage. A part of the right side of the leading edge was found alongside the La Guardia-Corral de Almaguer road, at coordinates 39° 46' 16.2" N – 3° 17' 26.64" W and an elevation of 690 m.

A fragment from part of the left elevator closest to the tip was found halfway between the left wing and the horizontal stabilizer, also near the Cerrotraviesa trail, at coordinates 39° 45' 53.22" N – 3° 17' 44.7" W and an elevation of 700 m. It had a significant tear with loss of material and there was a heavy impact mark on its top surface.

At the conclusion of this study, the INTA determined that the findings of the macrofractographic and microfractographic characterizations indicated that all of the fractures analyzed were ductile in nature and had progressed along their entire lengths due to static overload, there being no progressive fatigue or stress corrosion mechanisms involved in the process.

The study eventually concluded that the fracture and partial disintegration of part of the structure of the left wing and horizontal stabilizer, as well as their subsequent detachment, occurred as a result of a load being placed on these components that at one point exceeded the structural strength specified for the maneuvering envelope.

- The analysis of the horizontal stabilizer revealed that the fractures found on it occurred as a result of a load being placed on it that at one point exceeded the structural strength specified for the maneuvering envelope.

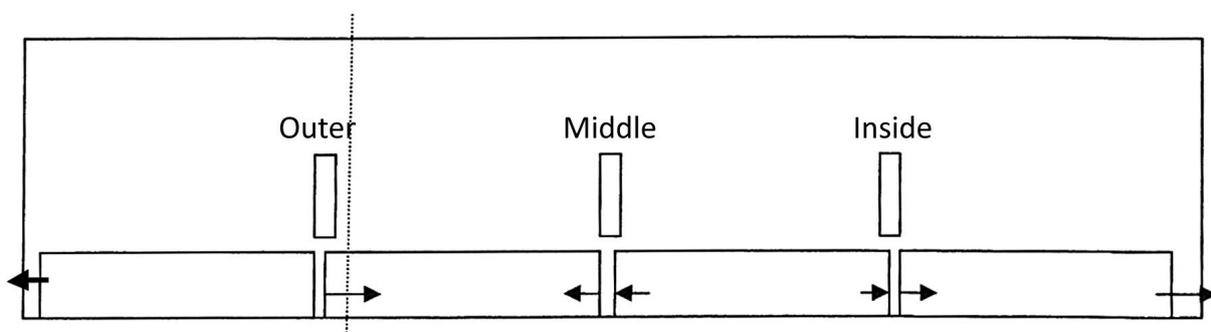
Figure 14. Position of fittings on left wing

The left wing had three attachment fittings distributed along its length. These are used to attach the ailerons and flaps. The two ailerons are attached to the outboard fitting. The intermediate fitting supports the inboard aileron and the outboard flap, and the inner fitting supports two flaps. Both the outboard aileron and the inboard flap are also attached to the wing and fuselage by their corresponding fittings.

The outboard fitting was practically intact. The middle one was bent significantly to the left as seen from behind and below, and the inboard one was missing. Since it was located very close to the area where the wing broke, it is fairly likely that it remained attached to the part of the wing that did not detach; however, it was not found in the wreckage, meaning it must have burned completely in the fire.
