**DIRECTORATE OF AIRCRAFT ACCIDENT
INVESTIGATIONS**

CIVIL AIRCRAFT ACCIDENT REPORT

ACCID/111509/01-06

OPERATION	:	COMMERCIAL
AIRCRAFT	:	ZS-OTU
LOCATION	:	PROSPERITA AREA
DATE	:	15 NOVEMBER 2009

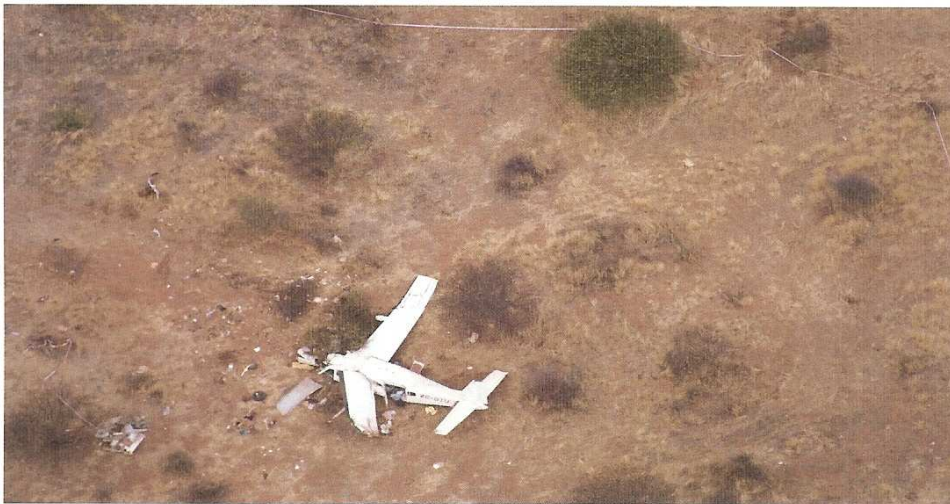
Figure 3: Aircraft wreckage facing the approach direction and part of the cargos could be seen scattered around.

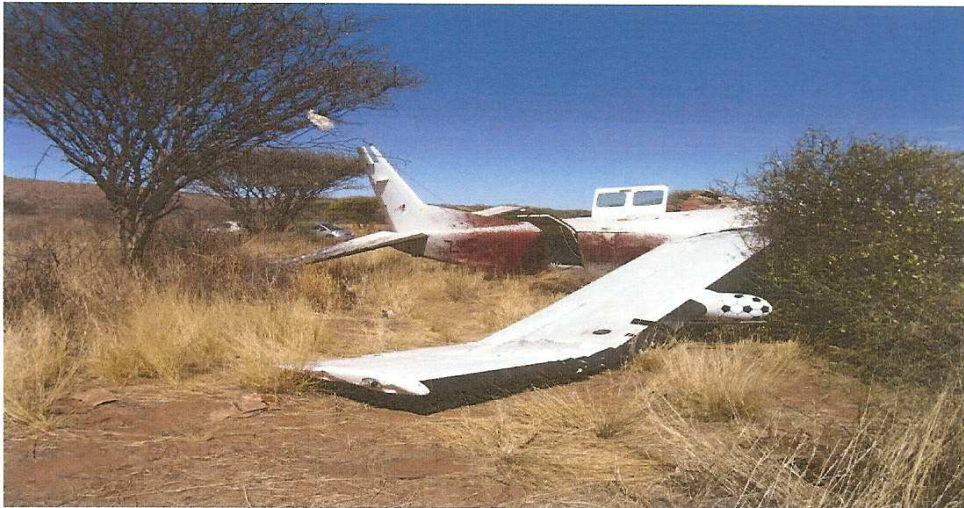
1.12.1 The aircraft impacted with bush type terrain 1.2 nautical miles from the threshold of Runway 01 on a heading of 225°. The aircraft impacted the ground in a nose down left wing low attitude. Following the ground impact the left wing outer section departed the wing structure. The aircraft ground looped and skidded along the ground for a distance of 150 m before coming to rest facing the approaching direction.

Figure 1: Aircraft wreckage were found facing the approach directions.

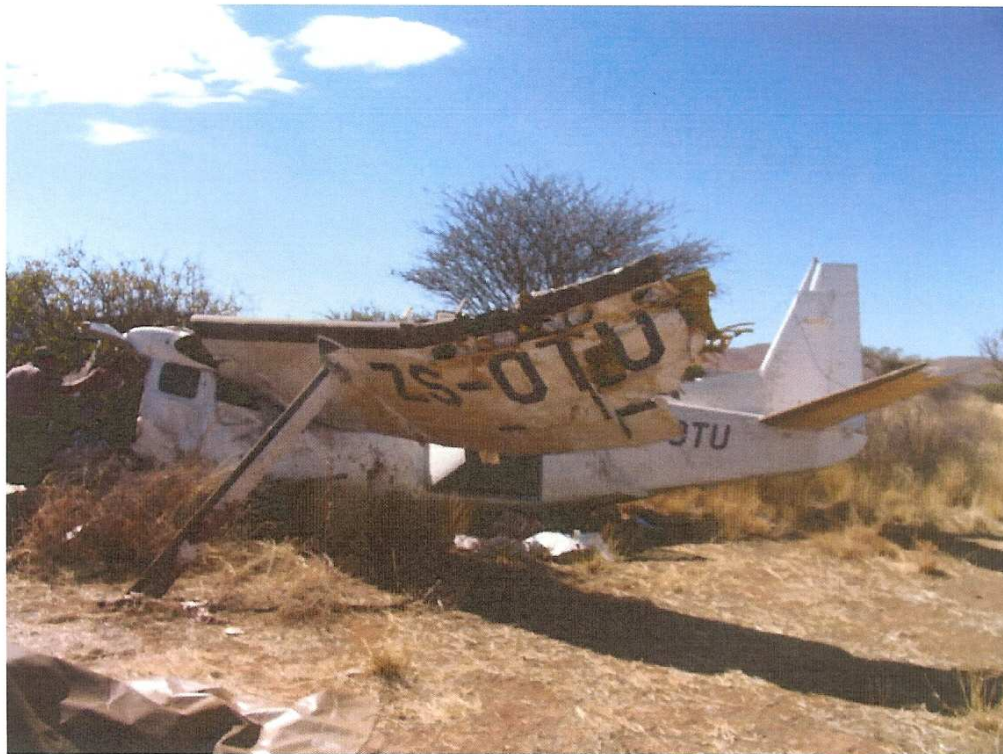
Figure 2: The aircraft cockpit on the left hand side and the left hand wing badly damaged during the accident.

1.15.1 Due to the destruction of the cockpit area and the impact on the left- hand side of the aircraft , which caused a substantial amount of deformation on the front and left side of the aircraft the three occupants sustained numerous blunt force injuries and were unable to sustain life as a result thereof.

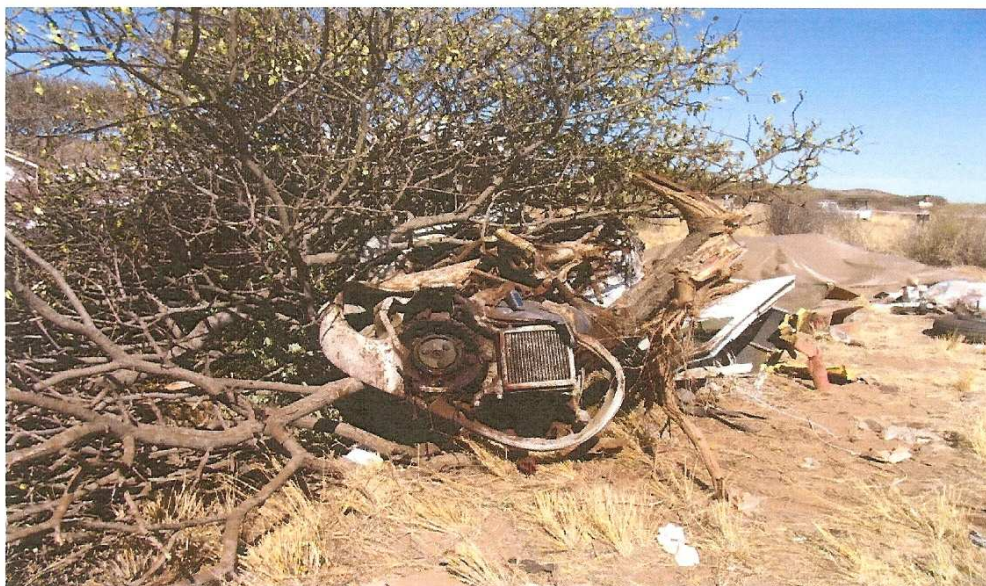
Figure 3: Shows some trees which were uprooted by the aircraft during the impact.

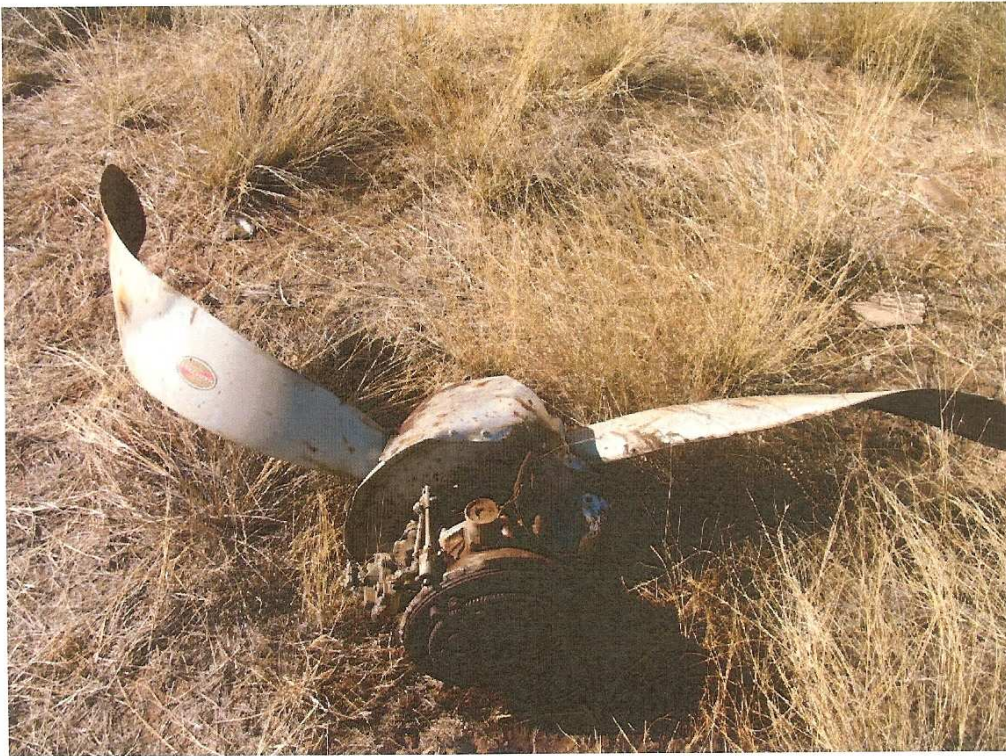
1.12.2 The propeller separated from the engine during the impact sequence and were found downstream along the impact path approximately 100m from the point of impact. The engine, cockpit and nose gear assembly was found in an inverted attitude in front of the main wreckage. The cockpit area was severed from the main fuselage with the pilot seat still forming part of the main wreckage. The right wing outer section showed evidence of buckling on the outer section, which could be associated with ground impact along the wreckage path.

Figure 4: Propeller hub completely disintegrated from the engine a distance away from the main wreckage.

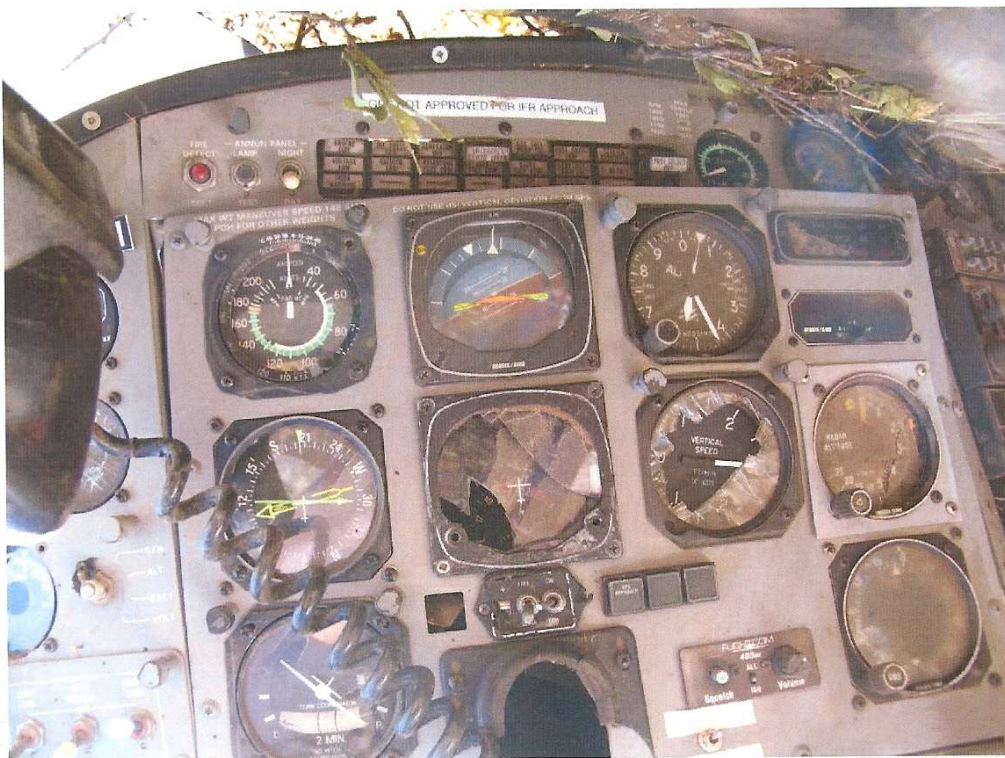
Figure 5: Shows aircraft cockpit instrument.

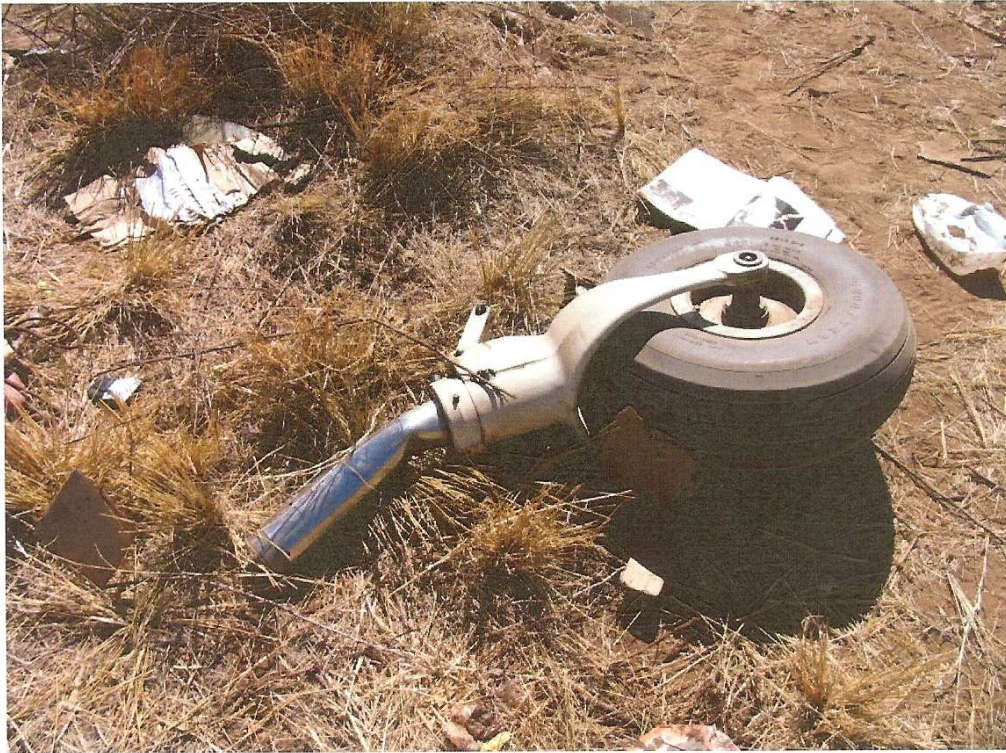
Figure 6: The nose landing gear was broken off from the aircraft and was found a distance from the main wreckage.

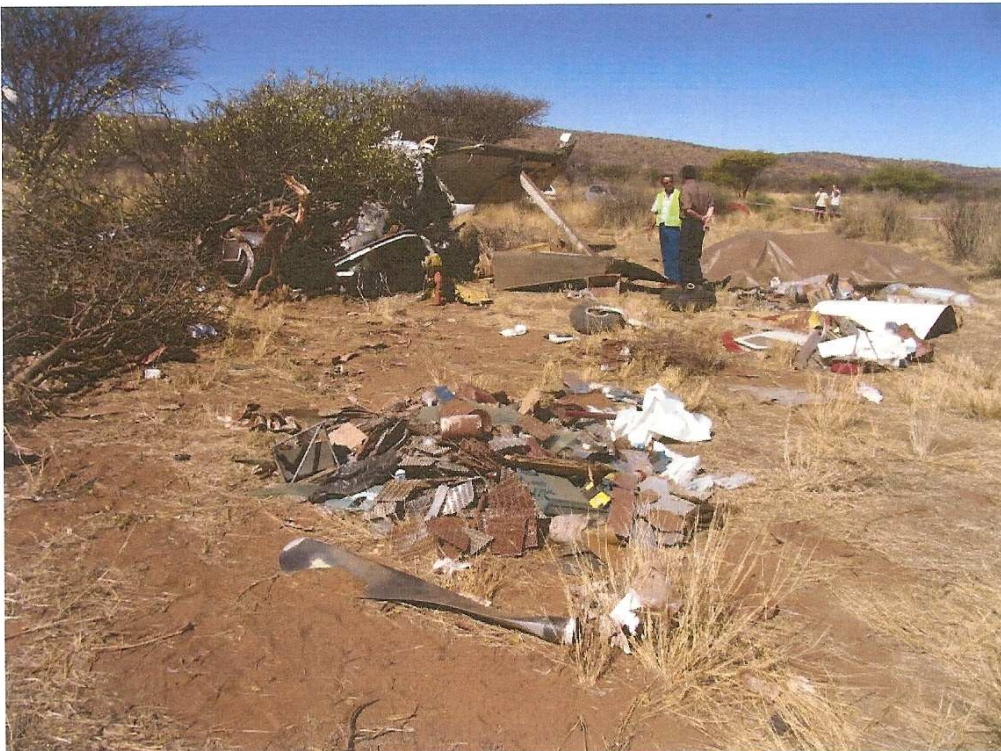
Figure 7: The recovered cargo which was inside the accident aircraft and the aircraft wreckage on the left side behind the trees.

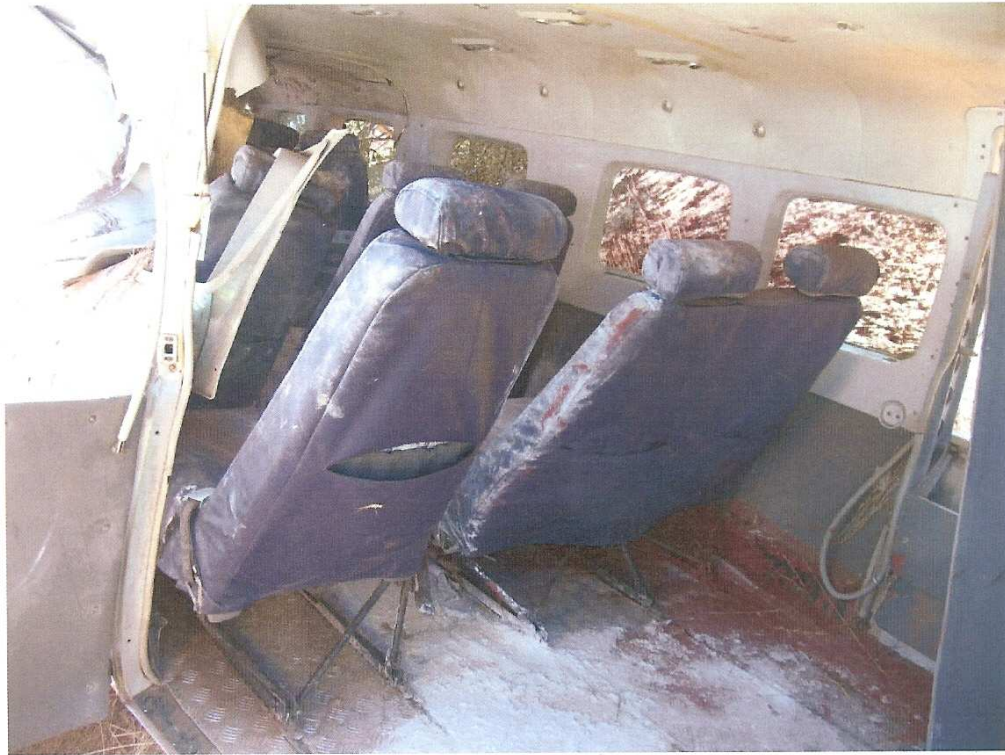
The cargo that was in the cabin was packed between and underneath and on top of the seats and not secured.

Figure 8: Inside the aircraft cabin where the cargo was placed on top and under the seat and not secured.

the right-hand side behind the co-pilot seat. He sustained a spinal injury and according to him a substantial amount of cargo (which was not secured) struck him from behind during the impact sequence and was lying on top of him when the aircraft came to halt.

- 4.1.3 It is strongly recommended that aircraft operators should ensure that aircraft carrying cargo should be provided with proper means of securing the cargo.
