FINAL REPORT

AIRCRAFT ACCIDENT INVESTIGATION INTO M/s BHOJA AIR FLIGHT BHO-213, BOEING 737-236A, REG # AP-BKC CRASHED ON 20th APRIL, 2012 NEAR BBIAP, ISLAMABAD

Synopsis

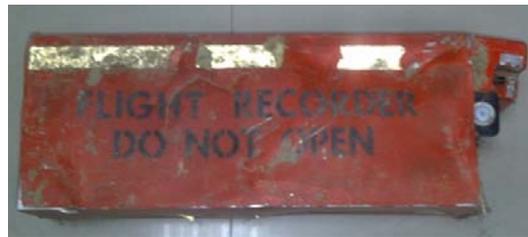
1.19.4 Recorder Condition

1.19.4.1 As per the NTSB report, the FDR and CVR recorders had suffered moderate impact damages. However, the memory modules were removed from the units at NTSB facilities and the respective data was successfully downloaded.

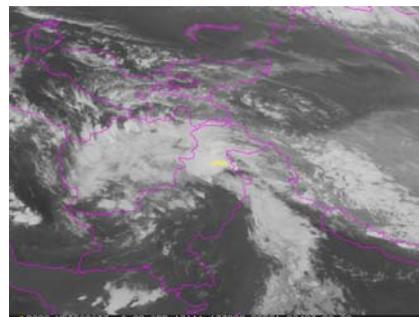
13:30 UTC 20 April 2012 Meteosat7 infrared satellite image

2.1.301 According to the above mentioned weather picture, BBIAP Islamabad (OPRN) was covered by a large canopy of bright white (cold topped) clouds. This cloud system appeared to be a convective system given the round shape and tight cloud gradient seen on the southern edge.

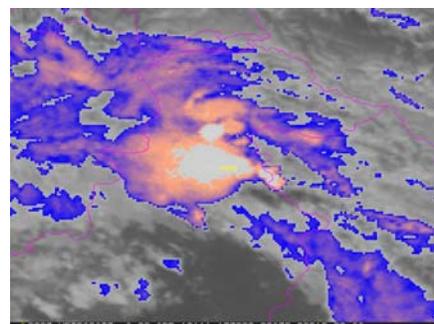
2.1.302 Colour Enhanced IR Satellite.

The enhanced colour satellite imagery of Meteosat7 infrared satellite for 18:30 PST on 20 April 2012 image also highlighted areas of deep convective clouds. The colour scheme used to identify the most intense (cold deep cloud tops) as bright white. BBIAP, Islamabad sat under deep convective clouds at the time of the accident.

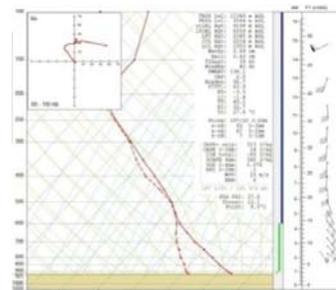
2.1.304 **GDAS model atmospheric sounding OPRN 1700 PST.** The GDAS model atmospheric sounding was carried out for 1700 PST BBIAP Islamabad. The model appears to be resolving a convective cloud environment that is characterized by a dry sub-cloud layer (ie high based convection). The surface inflow to the convective system had a temperature / dew point spread of 35⁰ Fahrenheit (90F/55F), which results in an inverted-V type sounding and the potential for **Model Atmospheric Sounding**

strong convective downdrafts. Also, the downdraft convective available potential energy (a parameter called DCAPE) can be used to assess downdraft strength potential. There was 348 J/kg of DCAPE on this sounding. DCAPE values can be converted to theoretical downdraft magnitude potential which results in 40-50 knots of potential downdraft in this case.

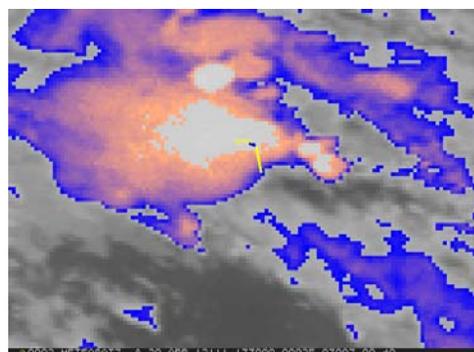
Plot of Flight Segment

2.1.306 The final segment of the flight (yellow / blue) over the colour enhanced IR satellite image from 18:30 PST. The colour have been arranged so that blue / beige are associated with cirrus anvil clouds below the tropopause and white is where the deepest convective clouds have penetrated into the tropopause and / or stratosphere. Enhanced white areas are associated with the deepest convective clouds and greatest potential for heavy precipitation generation. The flight path has been colour coded such that the yellow segment represents warm recorded outside temperatures and the blue segment represents cold recorded temperatures. The transition from warm air to cool air occurred under the deep convective cloud and likely represents an evaporatively cooled downdraft.

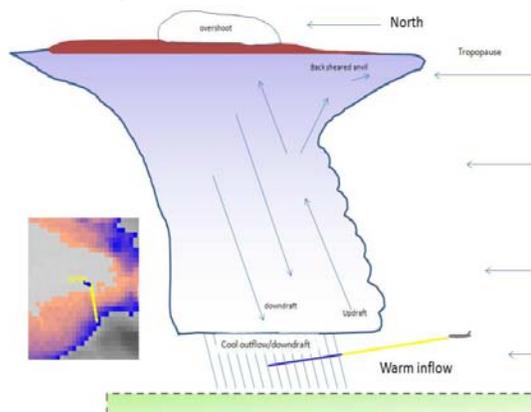
2.1.307 Conceptual Model of Convective Cloud. The conceptual model cross section of the convective cloud is shown below. Due to increasing southerly winds with height, the convective cloud would have been vertically sheared towards the north with height. As the aircraft entered the convective system from the south, they would have likely flown under the back sheared anvil cloud (blue and beige areas) while in warm inflow. Then as they continued to enter the convective system, they would have entered the downdraft region. Given the high cloud bases on this day, there was potential for considerable sub-cloud evaporative cooling resulting in significant cold downdraft production. Therefore deteriorated weather condition was one of the factor in the causation of this accident.

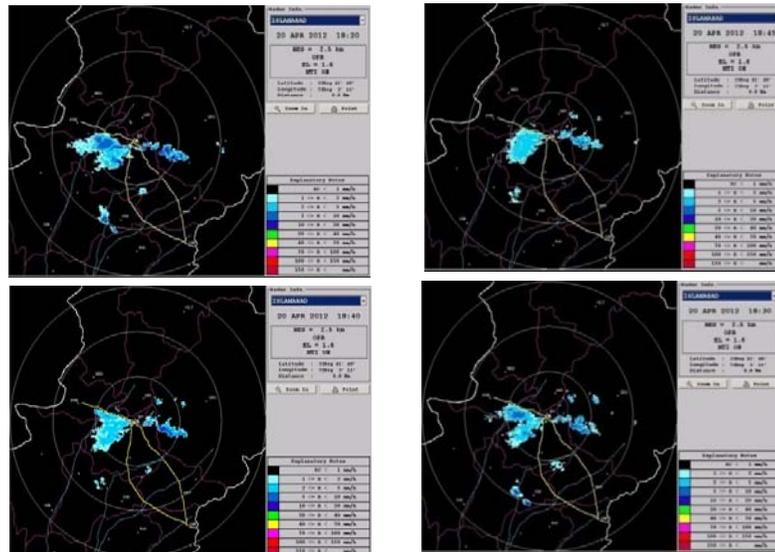
2.4.19 Radar echoes of weather system depict frontal weather activity that generated severe turbulence and caused high wind shears that were responsible for the microburst.

2.4.20 Radar echoes from 1820 PST to 1845 PST of 20th April 2012 inserted above depicted that weather activity over BBIAP and east of Islamabad & Kashmir was more severe and embedded Cb clouds producing updrafts and downdrafts were mapped by radar system during the period.
