**AVIATION INVESTIGATION REPORT
A11H0002**

CONTROLLED FLIGHT INTO TERRAIN

**BRADLEY AIR SERVICES LIMITED (FIRST AIR)
BOEING 737-210C, C-GNWN
RESOLUTE BAY, NUNAVUT
20 AUGUST 2011**

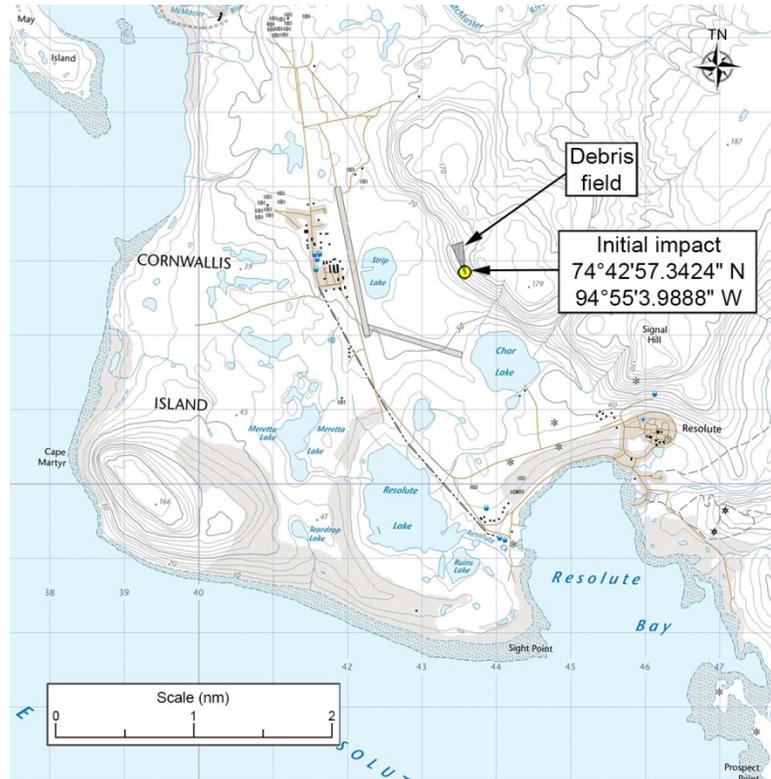
Figure 4. Accident site

The debris trail developed in a NNW direction, following a bearing of approximately 344°T. The debris trail had an overall length of 1400 feet from the point of initial impact to the cockpit. The widest section of the debris trail was about 320 feet. One wheel came to rest at the bottom of the hill east of Strip Lake.

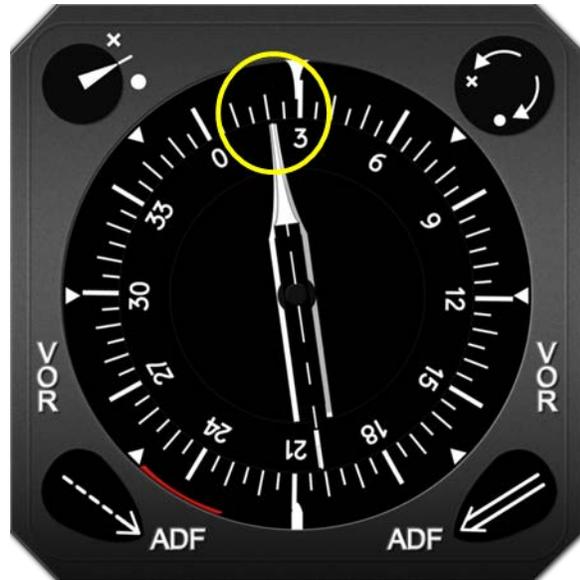
Figure 13. 1625:07: FO RMI (no. 2 compass) showing presumed indications with -8° heading error

However, on completion of the procedure, the recorded heading from the no. 2 compass was 029°, which indicates that the RMI lubber line heading should also have been 029°. Therefore, the indicated bearing to the RB beacon displayed to the crew on the FO's RMI should have been 021° (Figure 13).

On completion of the heading setting procedure, the heading should have been 037°T . The recorded heading was 029° , an error of -8° . At least 2 reasons for this error were possible. First, it is possible that the pilots incorrectly executed the final step in the procedure, setting the bearing to RB NDB, 029° , under the lubber line rather than the head of the ADF pointer. Second, it is possible that the heading setting was affected by inaccuracies inherent to the ADF/NDB system. Either scenario is considered equally likely.

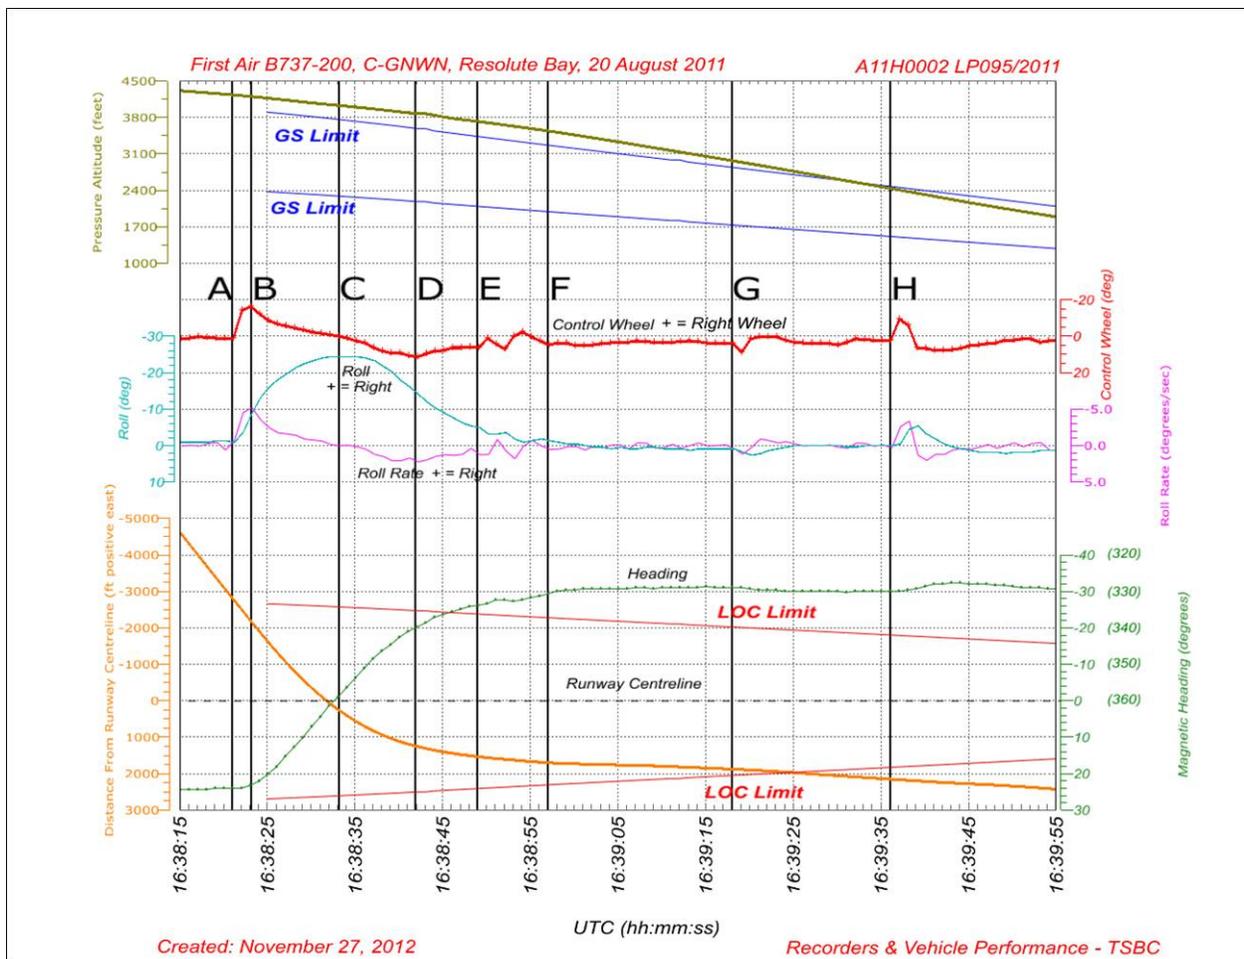
Figure 14. Flight data recorder (FDR) plot showing overview of turn at MUSAT

The curve smoothness of the roll angle plot between points A and E in Figure 14 is consistent with a turn initiated and executed by the autopilot. Control wheel movements made by the pilot would result in a jagged curve for the roll angle plot.

However, if VOR/LOC had been engaged before the turn and remained engaged throughout the turn, the autopilot should have captured and tracked the localizer. Simulator testing showed that use of autopilot VOR/LOC mode resulted in either intercepting and tracking or convergence with the localizer in every case.

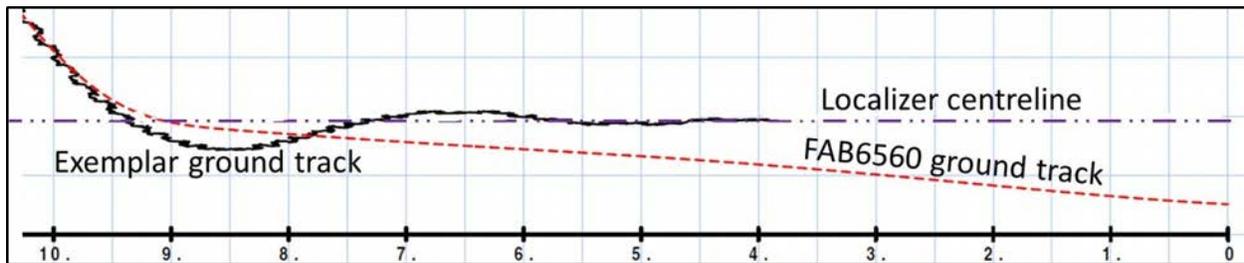
Figure 15. Example of VOR/LOC localizer capture (scale represents miles from the threshold)

At F, the aircraft was approximately 1.5 dots right of the localizer. Had the autopilot remained in VOR/LOC in localizer capture submode, the aircraft should have continued rolling further to the left, to a heading that would provide a suitable intercept angle back to the localizer from the right side. Once the aircraft returned to the localizer, the aircraft should then have turned slightly back to the right, to a heading that would maintain the localizer centreline (Figure 15).

The FDR data show that the CWS roll inputs ceased at 1638:53. At this time, the roll attitude was 1° left bank, and recorded heading was 332°. The aircraft continued rolling, and stabilized at 1° right bank at 1639:05, with the recorded heading of 330°. The compass error was -16°; therefore, the true heading was 346°. During final approach, the wind would have resulted in 3° of right drift. With the wind drift, the resultant radar track of FAB6560 diverged progressively further to the right of the localizer, as shown in Figure 15.

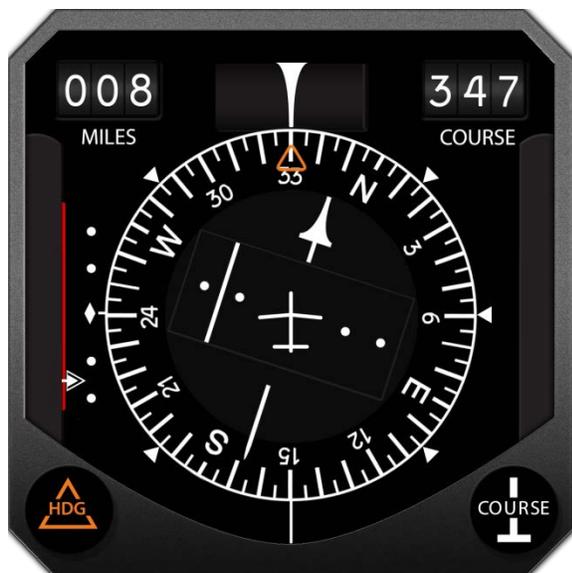
Figure 16. 1639:10: Captain's horizontal situation indicator (HSI), indicating 17° intercept angle (no. 2 compass with -16° heading error)

Once the autopilot was in HDG HOLD mode, the autopilot would have rolled the aircraft to a wings-level attitude and maintained wings-level unless further CWS inputs were made by the pilot flying (PF). FDR data show that the flight rolled approximately wings-level at 1639:05, with a recorded heading of 330°. This heading would also have been displayed on the captain's HSI.

As shown in Figure 16, the indicated heading of 330° would have given the captain the perception that he had a 17° intercept angle to return to the localizer centreline track of 347°.

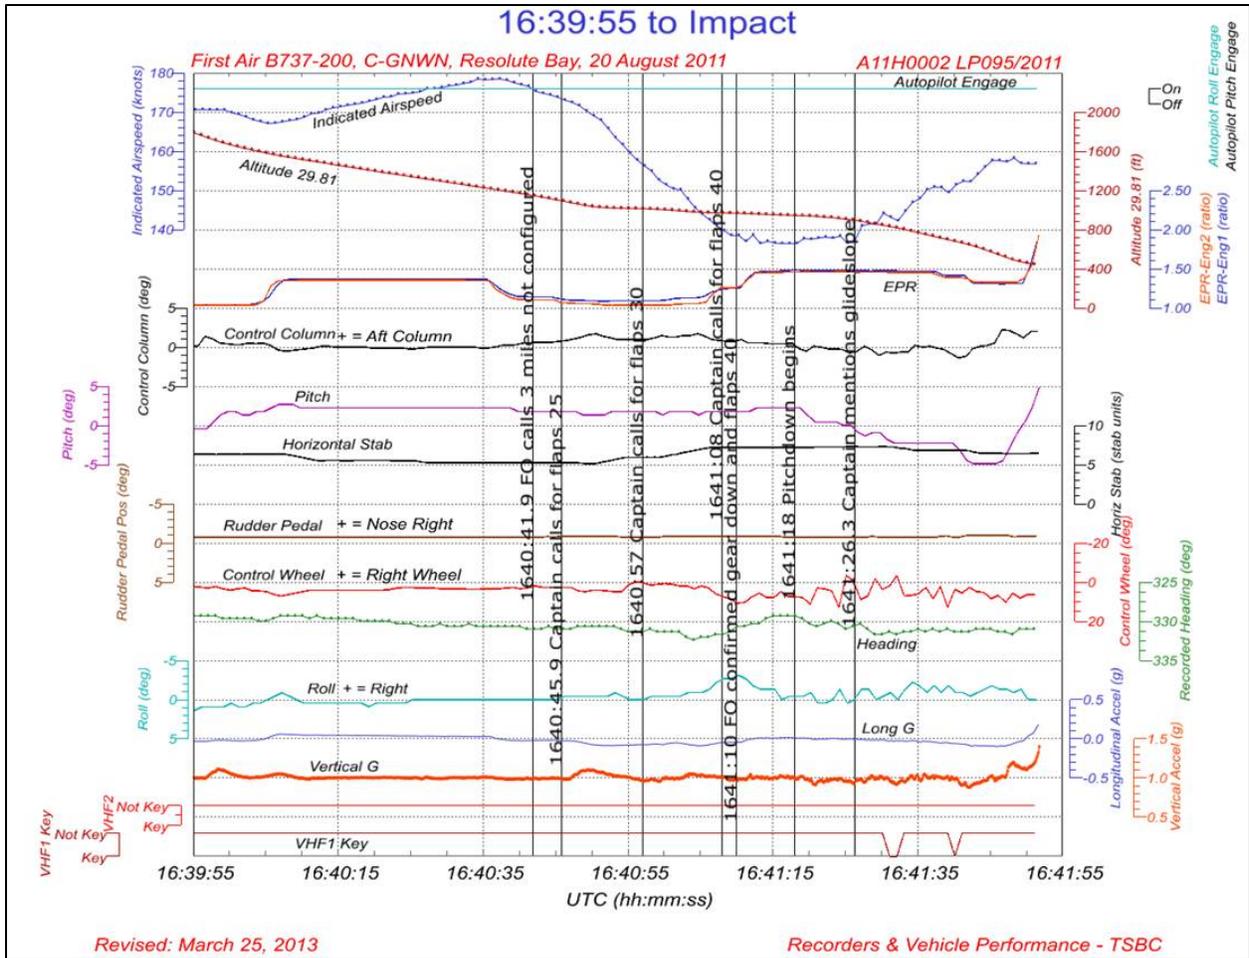
Figure 18. FDR plot of the final approach

At 1640:45.9, the captain instructed the FO to select flaps 25 (Figure 18), and the FO did so. The SOPs required the FO to call out confirmation that the requested flap selection was made, and also a confirmation that the flaps had reached the selected position. However, the FO did not make either of these calls for the flaps 25 selection.

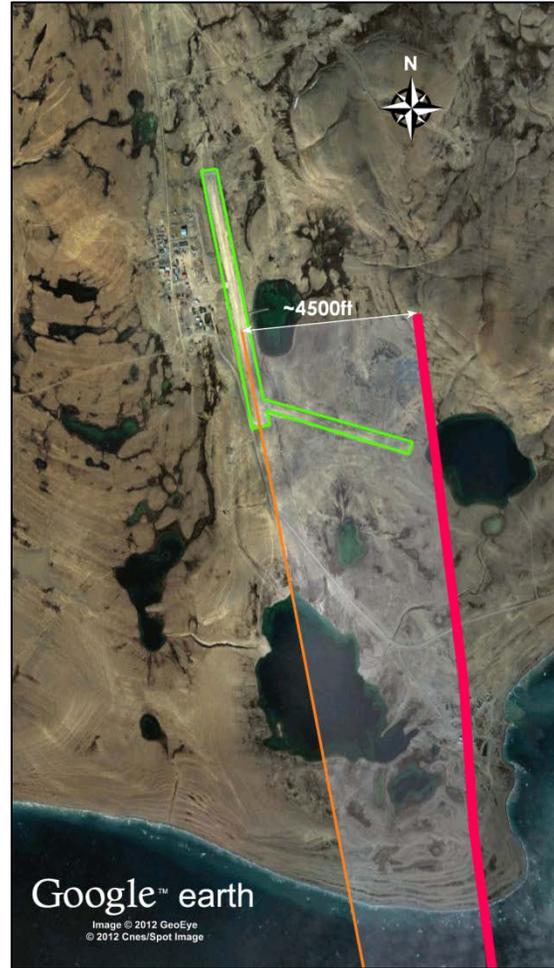
Figure 19. Final approach track relative to runway (image: Google Earth, with annotations by TSB)

The FO’s non-application of the two-communication rule highlights a deficiency in the rule, in that the rule relies on the judgment of the PNF to determine whether subtle incapacitation exists. Recognition of subtle incapacitation may take considerable time, and it may not occur at all. Outside of the two-communication rule, there was no guidance provided to address a situation in which the PF is responsive but is not changing an unsafe course of action. This
