Untersuchungsbericht

Type of Incident:	Accident
Date:	2. November 2010
Location:	near Gubin / Poland
Aircraft:	Airplane
Manufacturer / Model:	The New Piper Aircraft Inc. / PA 46-350P
Injuries to Persons:	Two persons fatally injured
Damage to Aircraft:	Aircraft destroyed
Other Damage:	Terrain damage
Source of Information:	Investigation by BFU
State File Number:	BFU 4X040-10

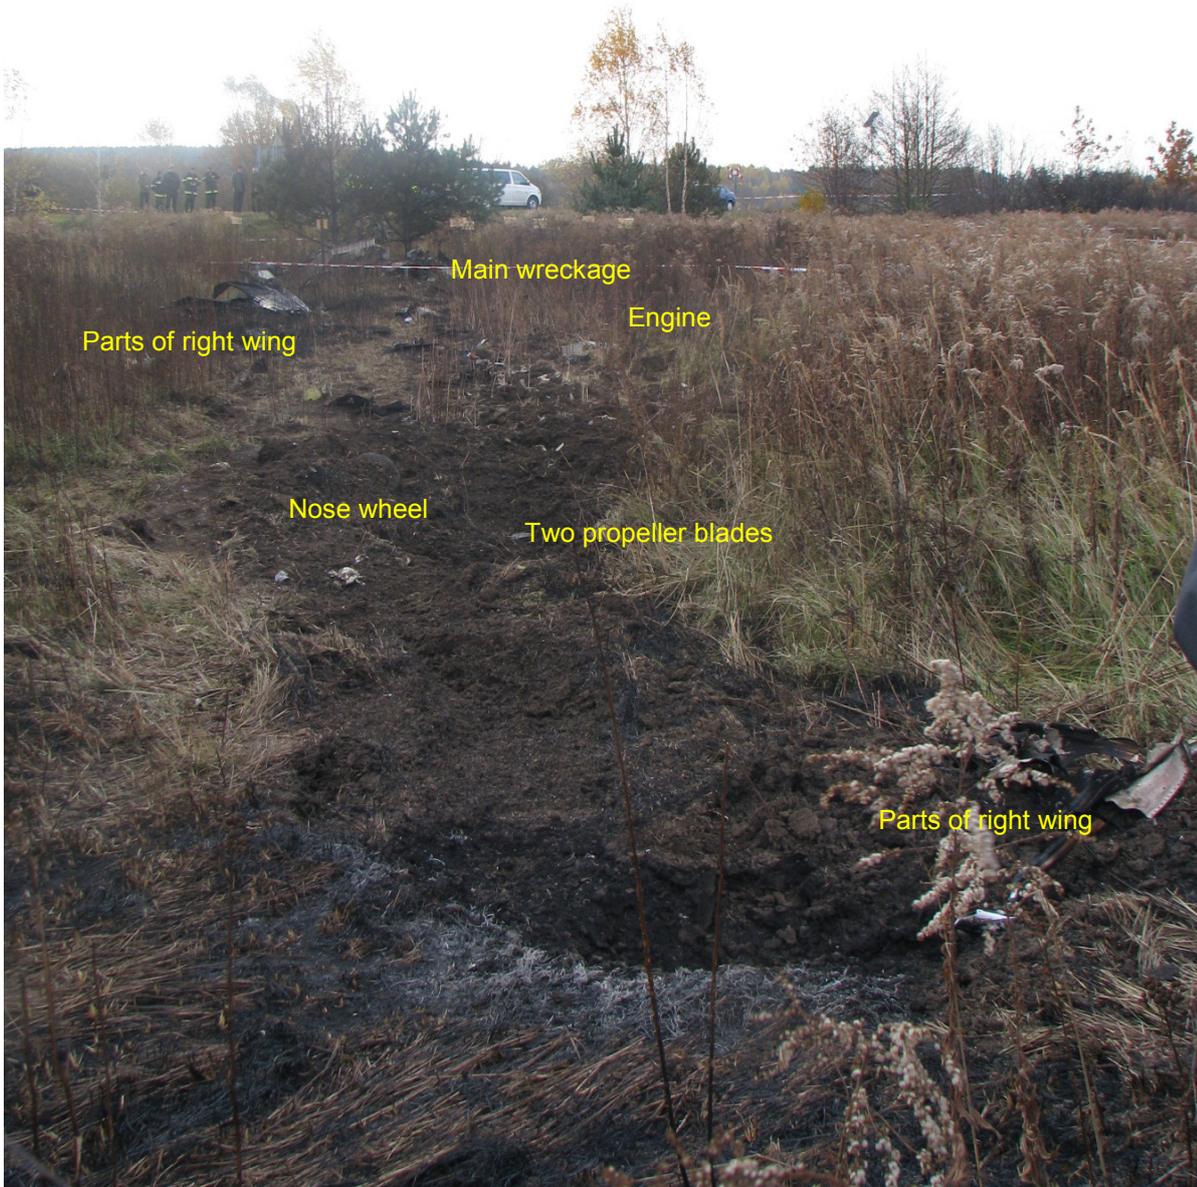
The outer area of the right wing hit the ground first. From the place of initial impact wreckage parts were spread out over a distance of about 60 m in a direction of approx. 190°.

Approx. 6 m behind the initial ground contact, the nose wheel was found, and two of the three propeller blades were stuck in the ground. The third propeller blade was found approx. 40 m away in southeasterly direction. The engine was found approx. 30 m behind the initial ground contact and 5 m to the west. The burnt out main wreckage had come to a stop after approx. 52 m against the impact direction, stopped by two trees.

Initial ground contact in viewing direction towards the main wreckage

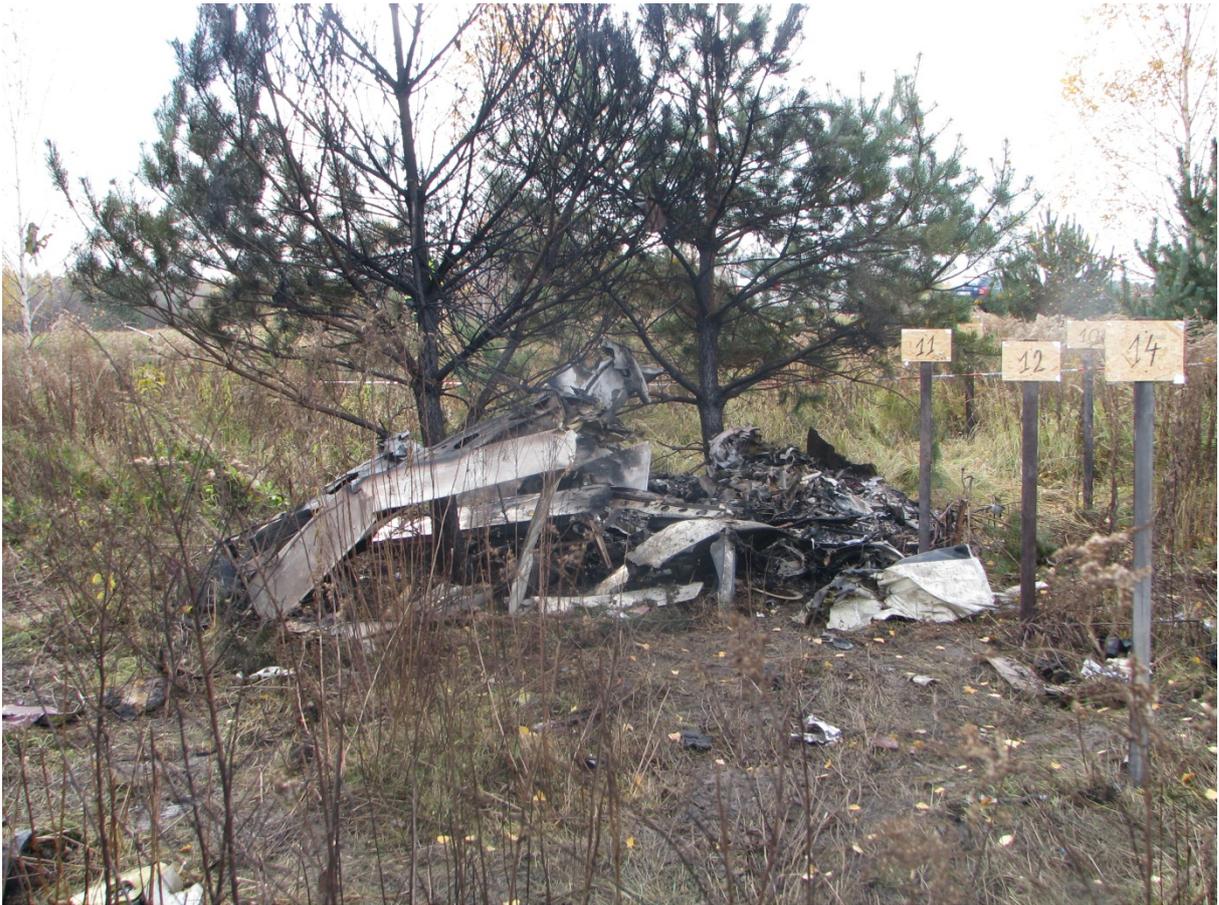
Main wreckage

The fire of the main wreckage destroyed large parts of the cabin and instrument panel.

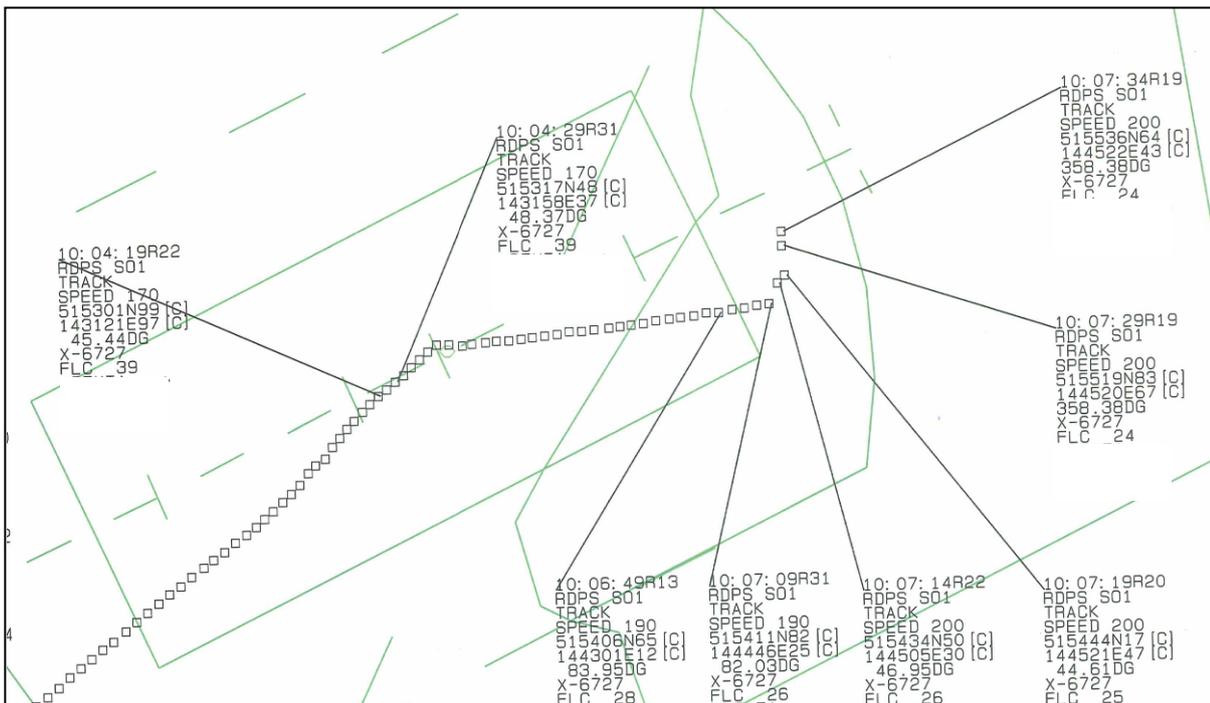
According to radar recordings of the German Federal Armed Forces, the airplane was captured several more times within the turn radius: at 1107:50 hrs in an altitude of 1,200 ft AMSL, at 1108:01 hrs in an altitude of 2,700 ft AMSL, and finally in 1,700 ft AMSL and 1,000 ft AMSL. The recording ended at 1108:21 hrs in an altitude of 600 ft AMSL.

The radar data showed a conspicuously high speed during the landing approach. The recorded speed data were significantly above the speeds normally flown for an approach of this kind with the aircraft type PA 46. The high speed during the turn towards the final approach required manual control of the aircraft when flying without visual reference, in order to not overshoot the final approach. The autopilot could not control the high bank angle needed. The flight track recorded up until the turn suggests that flight control was performed by the autopilot until the beginning of the turn.

Radar recording
