AAIS Case Reference: 02/2011

AIR ACCIDENT INVESTIGATION REPORT

CRASH SHORTLY AFTER TAKEOFF

McKinnon G-21G
Registration Mark: N221AG
Triple S Aviation
Al Ain International Airport
The United Arab Emirates
27 February 2011

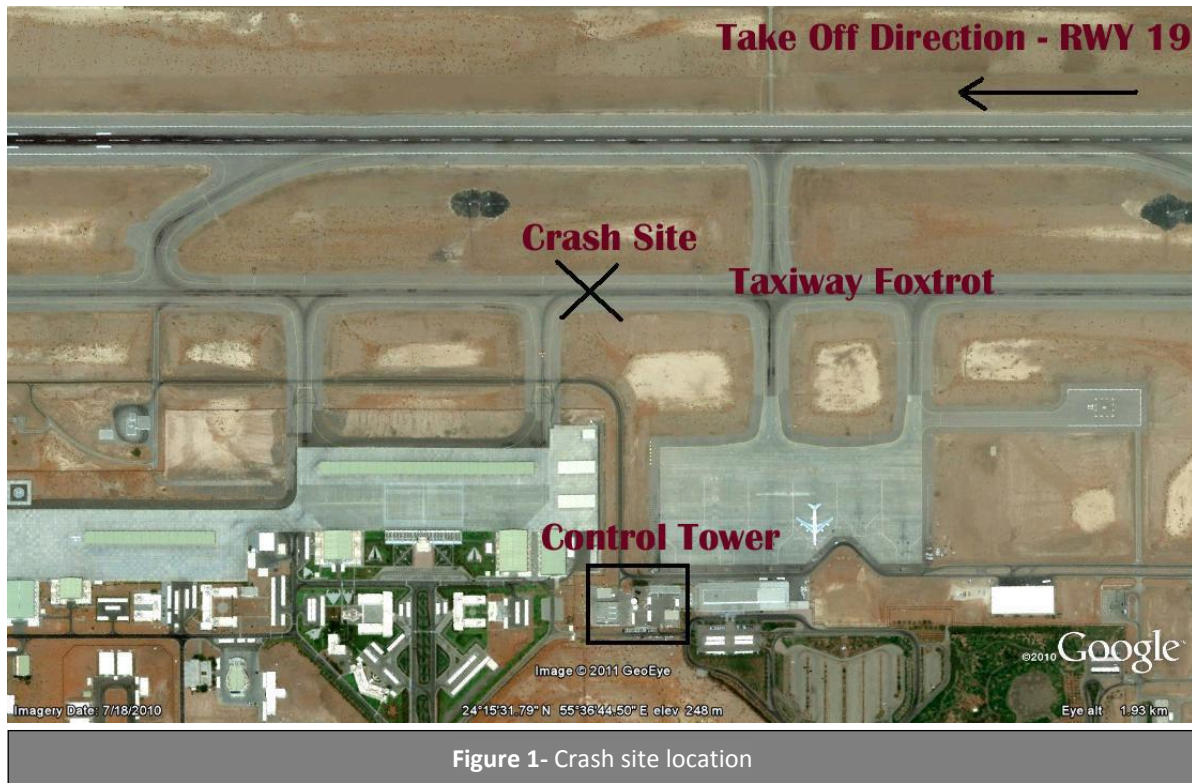
Figure 1 illustrates the departure runway and the point of initial impact.
