KOMITE
NASIONAL
KESELAMATAN
TRANSPORTASI

Aircraft Accident Investigation Report

PT. Lion Mentari Airlines (Lion Air)
Boeing B737-400 ; PK-LIQ
Supadio Airport, Pontianak, West Kalimantan
Republic of Indonesia
2 November 2010

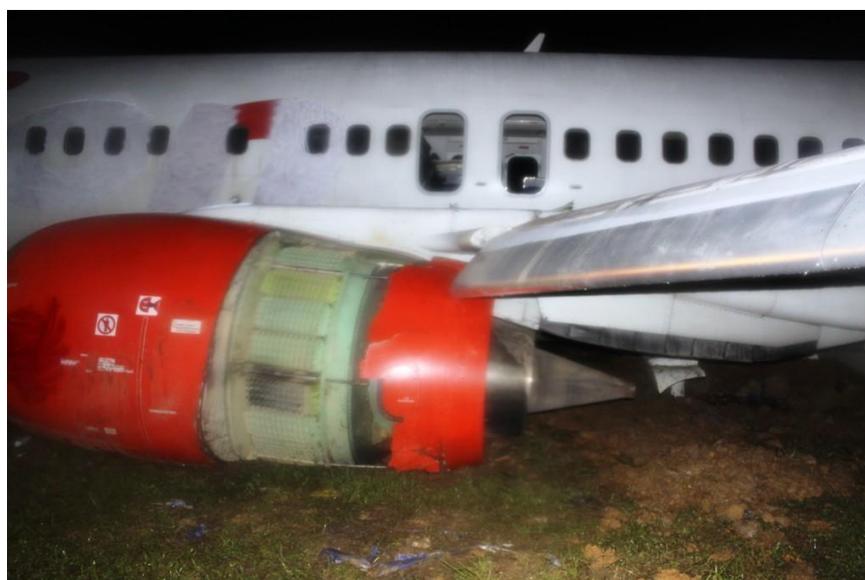
Field observation found that the aircraft severely damage, the damages were on the following sections: nose landing gear, right engine, nose section lower fuselage (aft of the nose wheel bay) and right engine.

Figure 1: The damage of the left engine

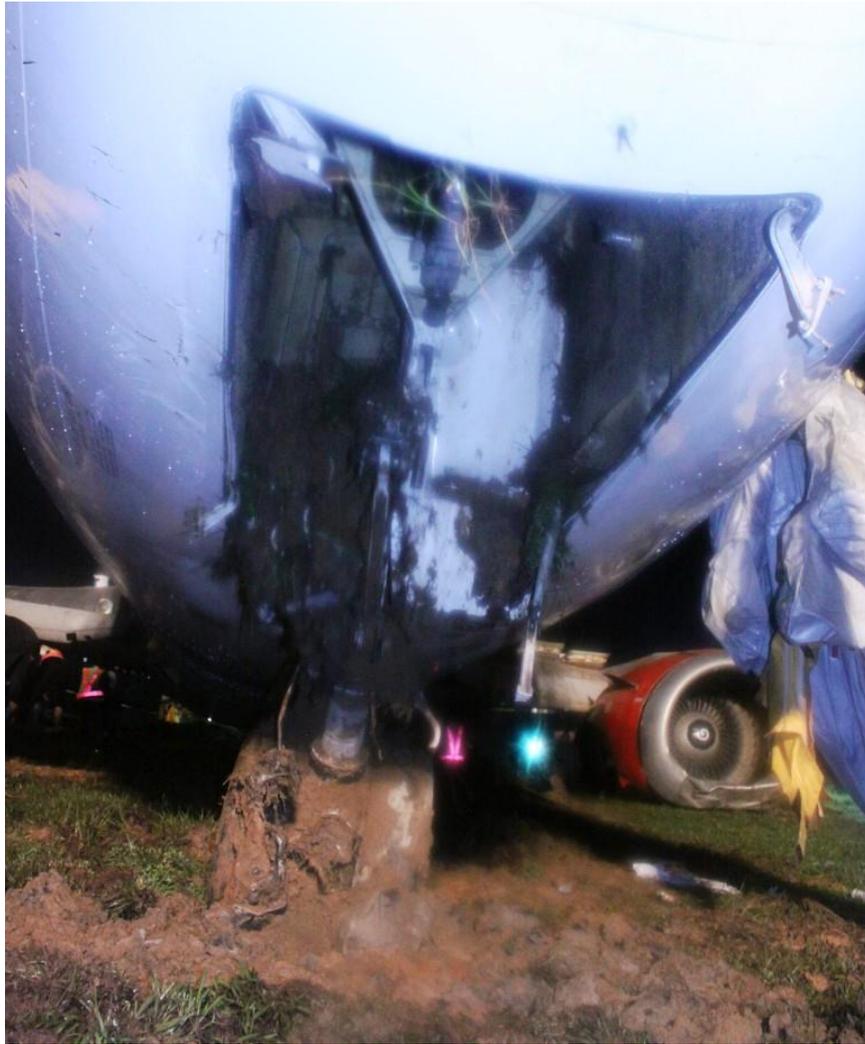
Figure 2: The damage on the nose landing gear

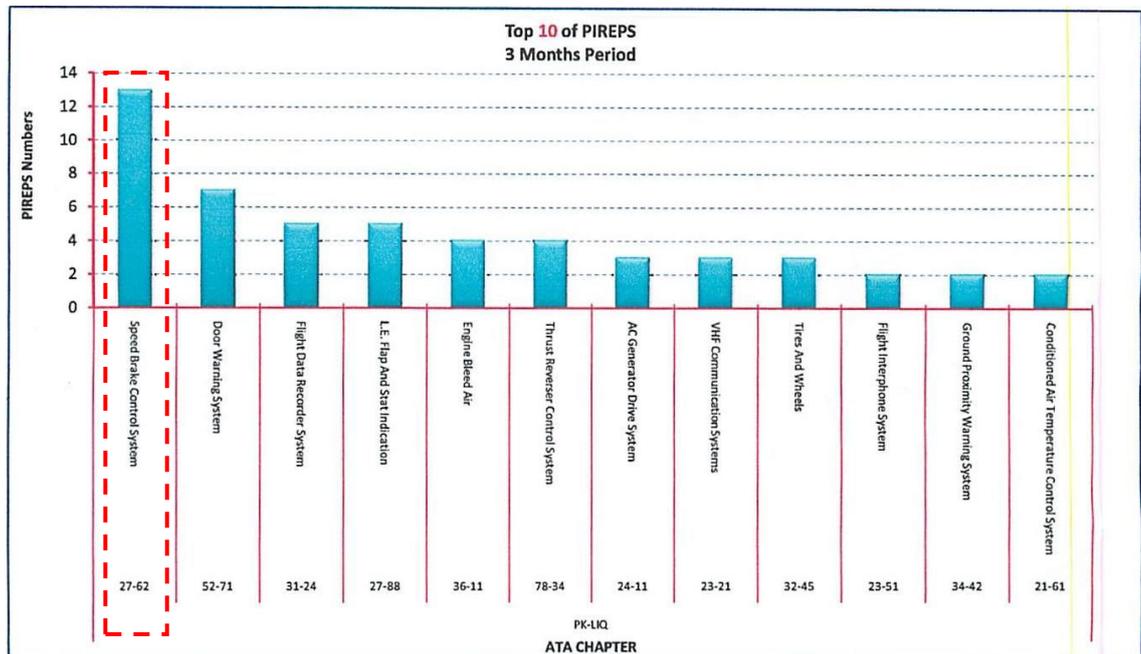
Since 03 September to 27 October 2010, 13 PIREP recorded related to the speed brake failure to auto deployment (ATA 27). The rectifications carried out were;

- Clean the electrical plug of speed brake actuator motor,
- Repositioned control module,
- Clean and reposition relay R280 and R283, and
- Repositioned and clean control plug actuator control speed.

Figure 3: Top 10 PIREPS indicated that there were 13 PIREP related to speed brake control system (red dash box).

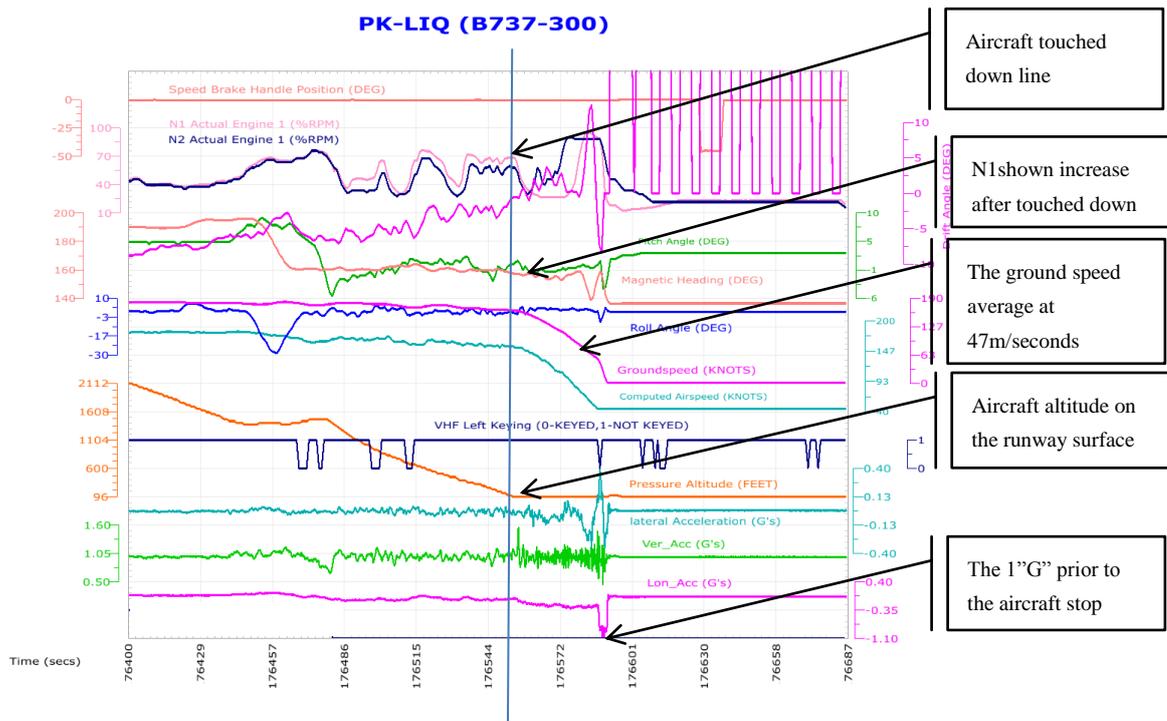
Figure 5: Parameters selected from the FDR

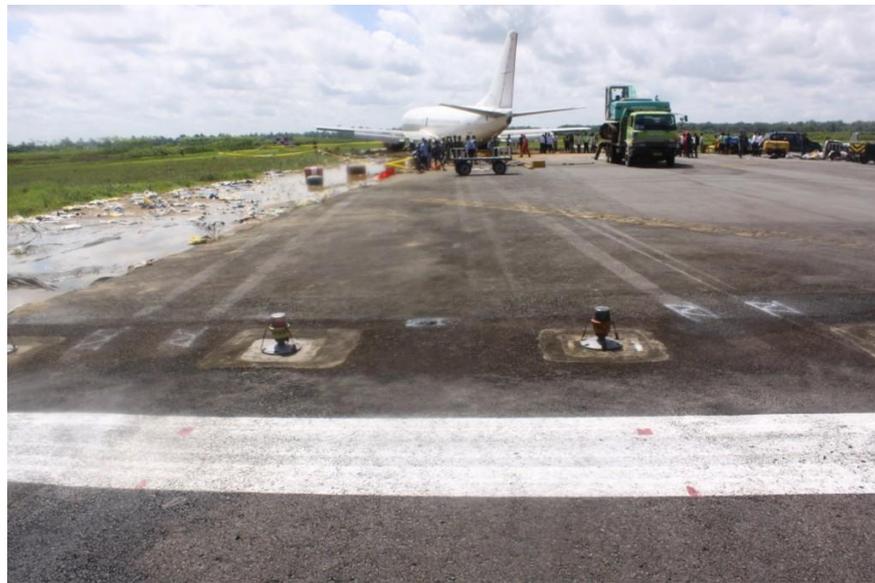
The front left escape slide flatted and the tire no 3 ripped and also there were scratches as an indication of hydroplaning of the four wheel tires which shown along the stop way area of runway 15.

Figure 6: Aircraft track and hydroplaning marks

There were indications of hydroplaning on No 3 tire and mark of all tires on the paved surface after the runway end. This condition is classified as a hazard that might contribute and endanger the safety of the flight. Therefore, the KNKT recommends to airport authority to be aware and takes necessary safety action to minimize the risk.

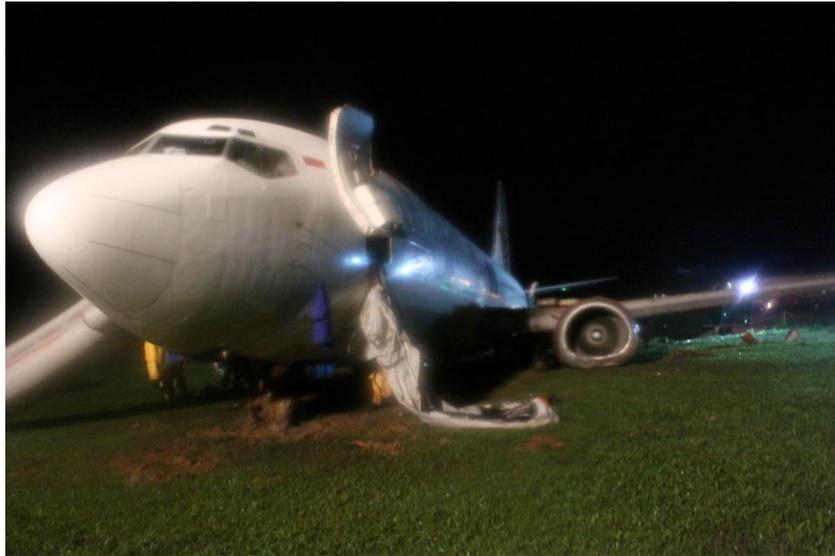
Figure 7: The front left escape slide flattened

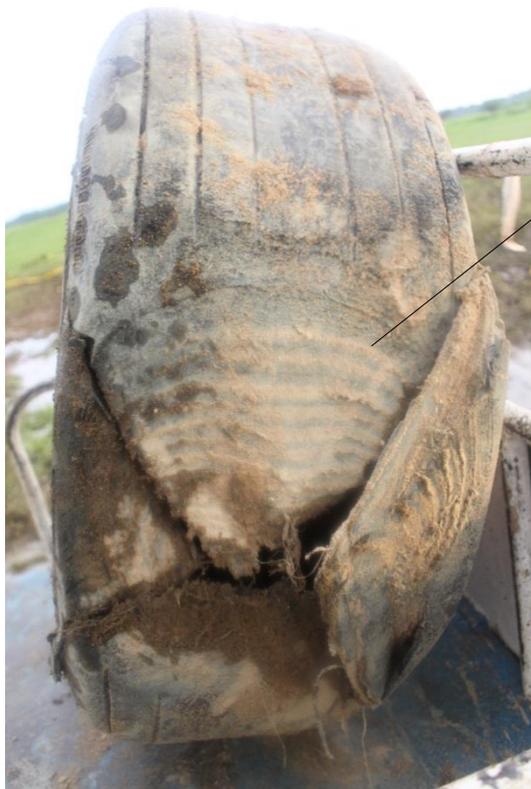
Ripped and an indication of hydroplaning

Figure 8: The number 3 tire ripped and scratched

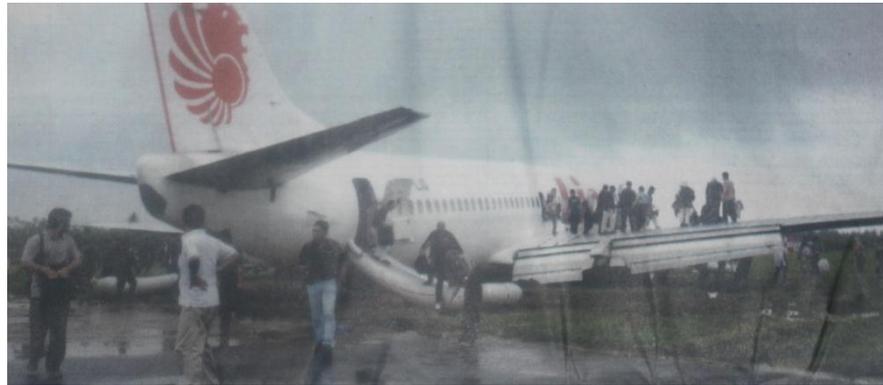
Refer to the picture taken during the evacuation process (see figure 9), some passengers were standing on the wing carried their luggage and there was no person who assisted or guided the passengers. The flaps were full down and speed brakes were on retracted position.

Figure 9: Passengers evacuation process (picture courtesy of local newspaper)
