Aircraft Accident Investigation Report

Yayasan Jasa Aviasi Indonesia (YAJASI)

Pilatus PC6/B2-H4; PK-UCE

**Yahatma Village, Yalimo District – Papua
Republic of Indonesia**

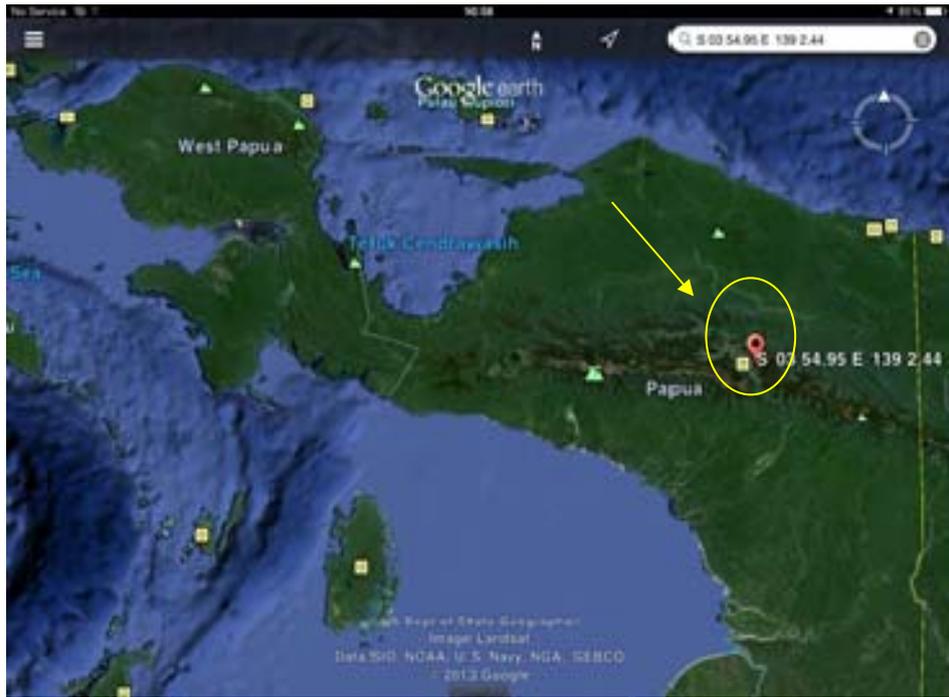
Figure 1. Accident site at the North Gap

The accident site was at coordinate S 03⁰ 54' 54.4'', E 139⁰ 02' 24.3'', the aircraft was hit the trees and the ground where the elevation was about 7500 feet, the propeller blades was not on feather and bent rearward, the left wing was broken and the aircraft stopped on heading about 85°.

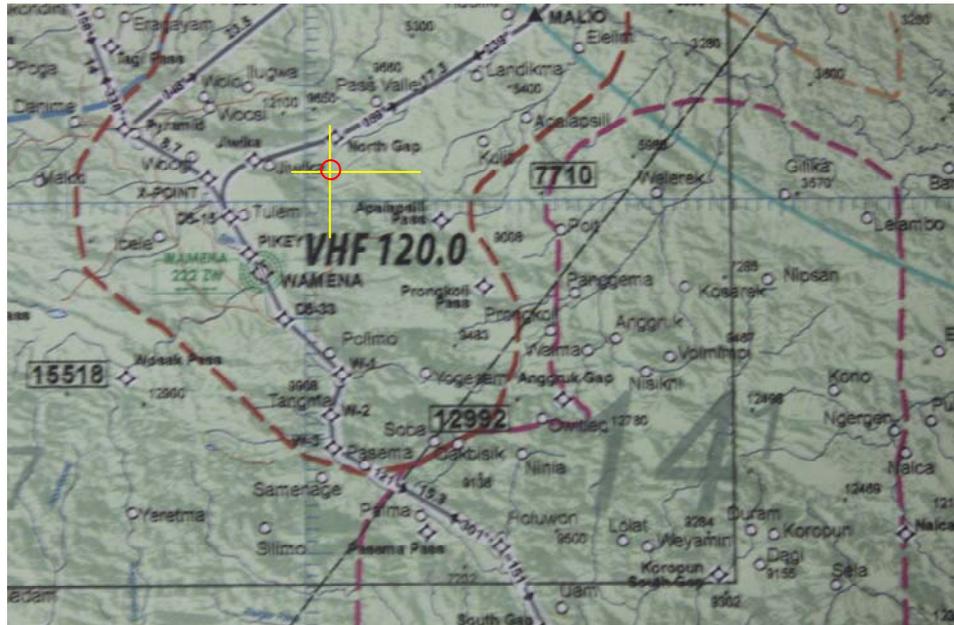
Figure 3. The route guidance and accident site

The aircraft was found few miles on the left of the VFR route guidance at the North Gap, while the VFR weather minimum stated on Class F are clearly mentioning the requirement of the vertical and horizontal distance.

The investigation concluded that the pilot avoided the cloud to the left of the VFR route guidance and most likely that the space available was less than the requirement stated for the Weather Minimum class F.

As the growing rate of the VFR flight in Papua is become significant, it is necessary that a standard VFR route guidance should be made available. As such, the NTCS recommends, that the draft of VFG (Visual Flight Guide) proposed by the Indonesian DGCA which had not been officially issued, can be processed and to be issued at the soonest possible time.

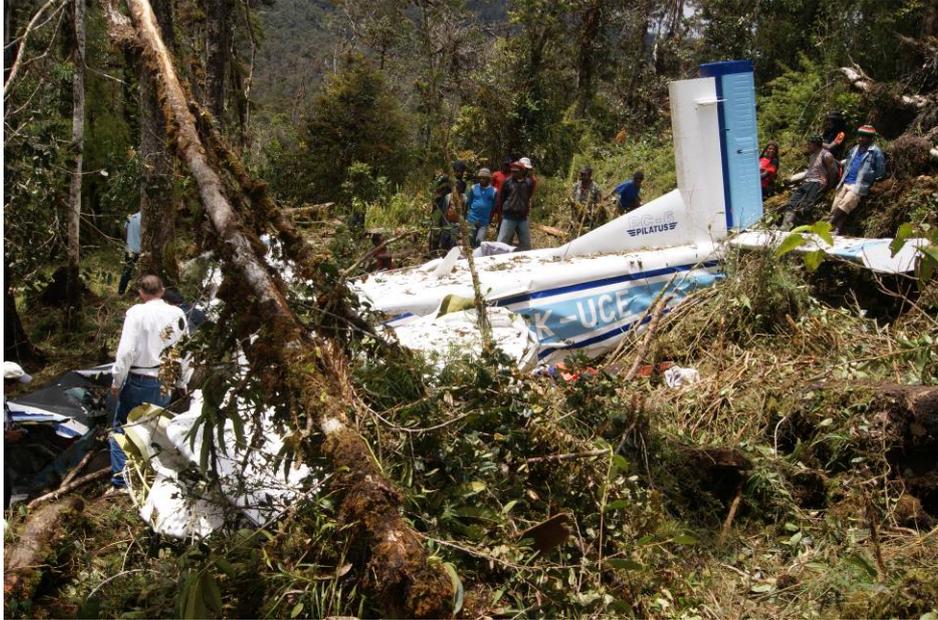
Figure 4. Aircraft left side

The aircraft was substantially damaged, the propeller blades were bent rearward, and the flange C was buckling /twisted

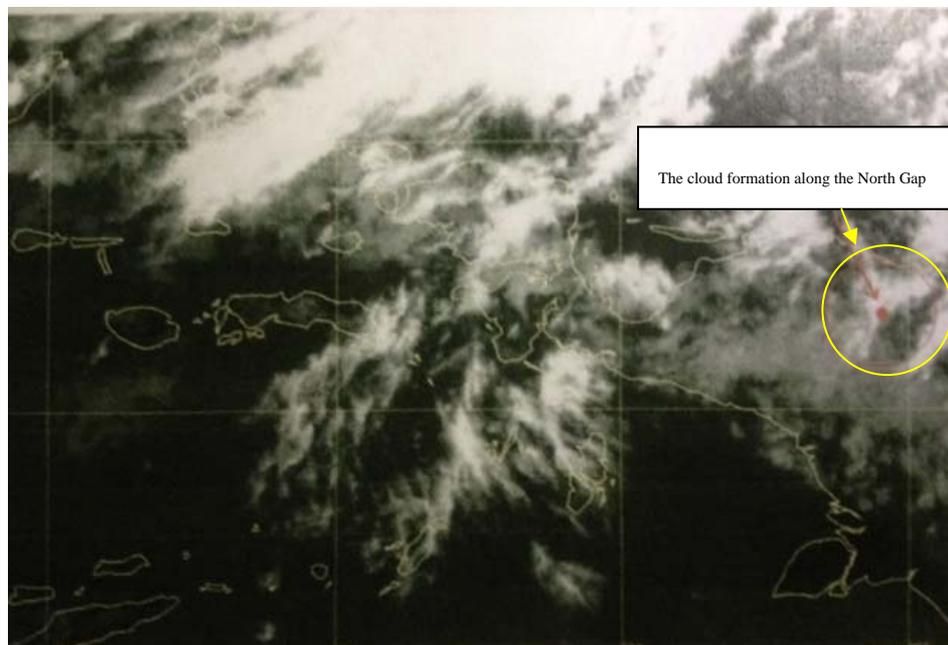
Figure 6. Satellite Image at 04:00 UTC, 22 September 2013

Refer to satellite image time 04:00 UTC on 22 Sep'11 shown that the cloud formation was laid down along the North Gap.

Those two areas of particular weather condition above were most likely generated marginal in visibility and the manoeuvre space along the North Gap.

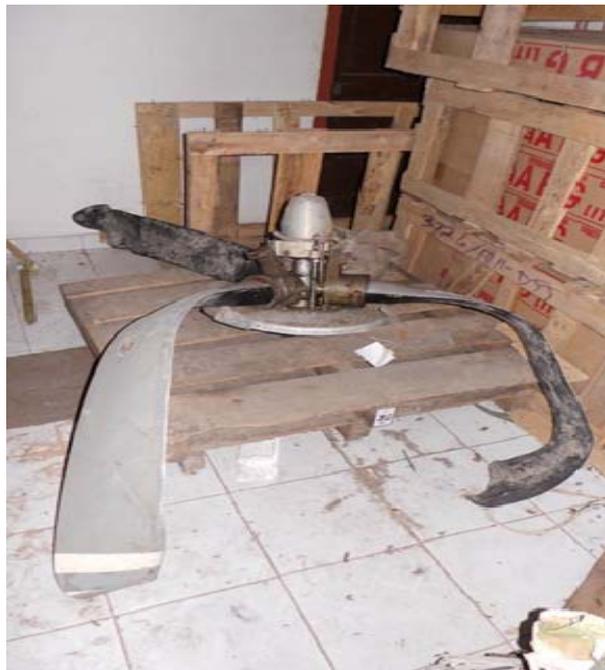
Figure 7. The accident aircraft propeller

- m. The aircraft was substantially damaged, the propeller blades were bent rearward, the flange C was buckling /twisted.
