COMANDO DA AERONÁUTICA
CENTRO DE INVESTIGAÇÃO E PREVENÇÃO DE
ACIDENTES AERONÁUTICOS

FINAL REPORT
A-606/CENIPA/2014

OCCURRENCE:	ACCIDENT
AIRCRAFT:	PR-ART
MODEL:	B200
DATE:	14JAN2011

This is the final report of the 14 January 2011 accident with the B200 aircraft, registration PR-ART, in the municipality of *Senador Canedo*, State of *Goiás*. The accident was classified as “Controlled Flight into Terrain”

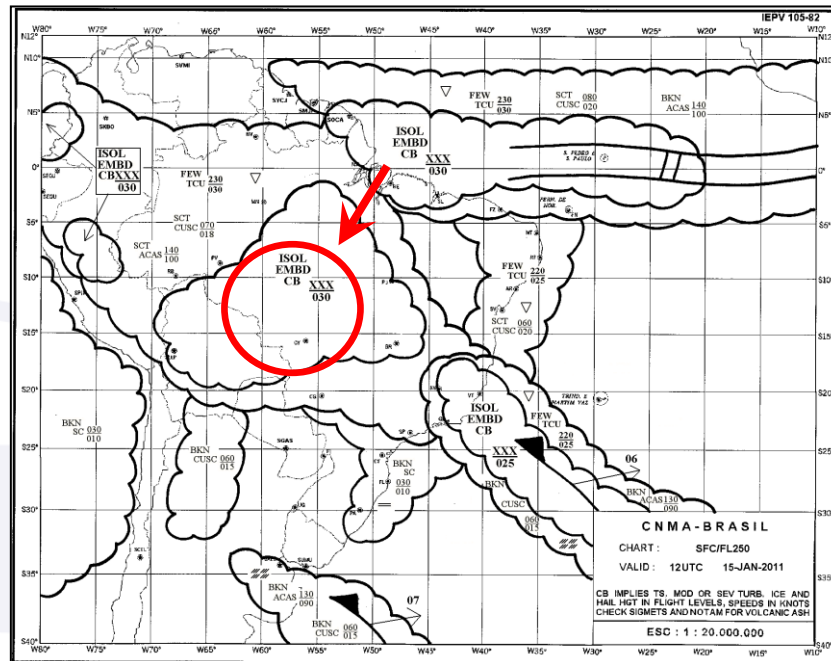
Similarly, the Upper Air Prognostic Chart of 18:00 UTC also forecast nebulosity with *cumulonimbus* clouds (CB) embedded in practically all the Midwest region of the country.

Figure 1 – 18:00 UTC PROG Chart. In highlight, information on nebulosity with embedded CBs in the vicinity of the route between *Brasília* and *Goânia*.

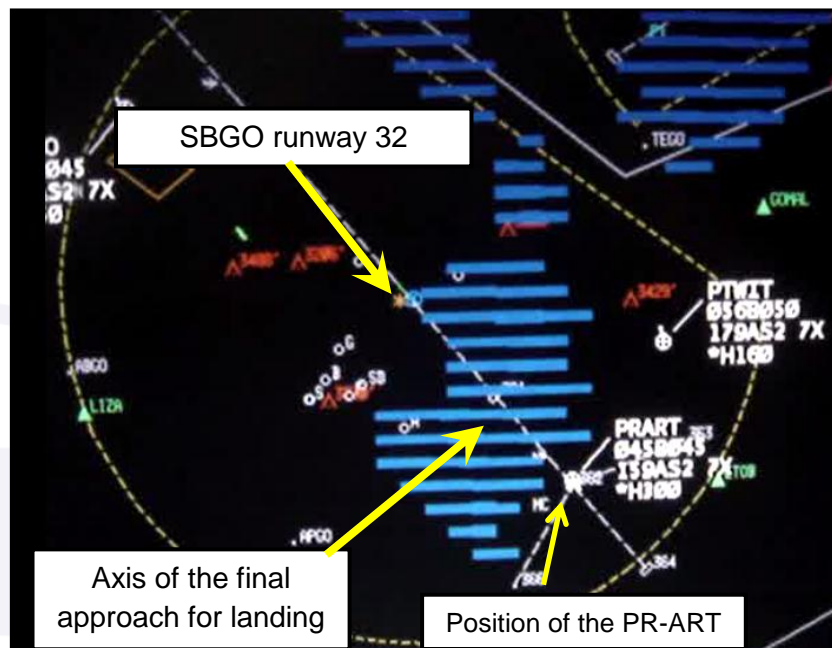
Figure 2 – Radar image showing the PR-ART stabilized on the final approach. The blue stripes indicate the presence of build-ups between the aircraft and the threshold of SBGO runway 32.

The commission also verified that the characteristics of the heavier build-ups existing between the aircraft and the threshold of SBGO runway 32 favored the occurrence of the meteorological phenomenon known as *windshear*.

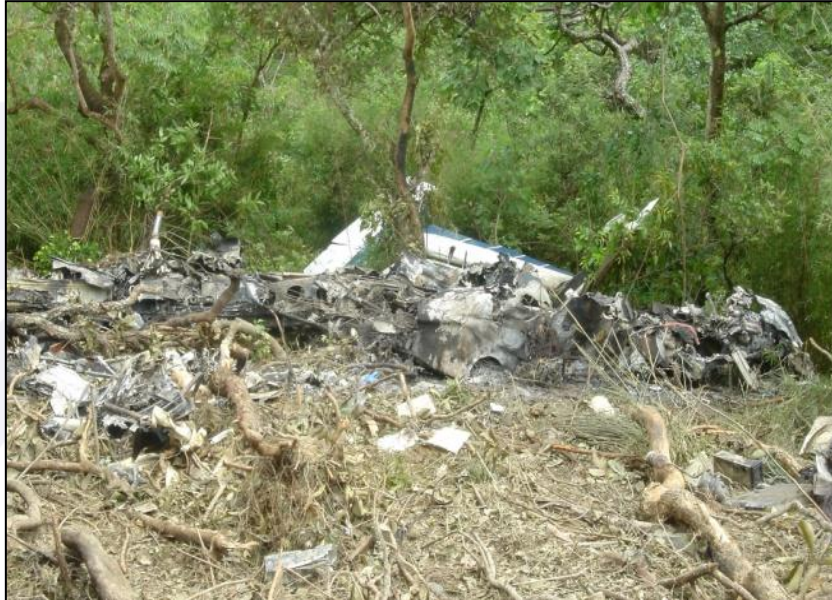
The first impact occurred when the right wing hit a few trees on top of the Mount *Santo Antônio*, with detachment of the right flap. The right wing was found 150 meters ahead of the point of first impact, with other parts of the aircraft getting spread downhill along a stretch of 400 meters (Figure 4).

Figure 4 – View of the aircraft wreckage downhill.

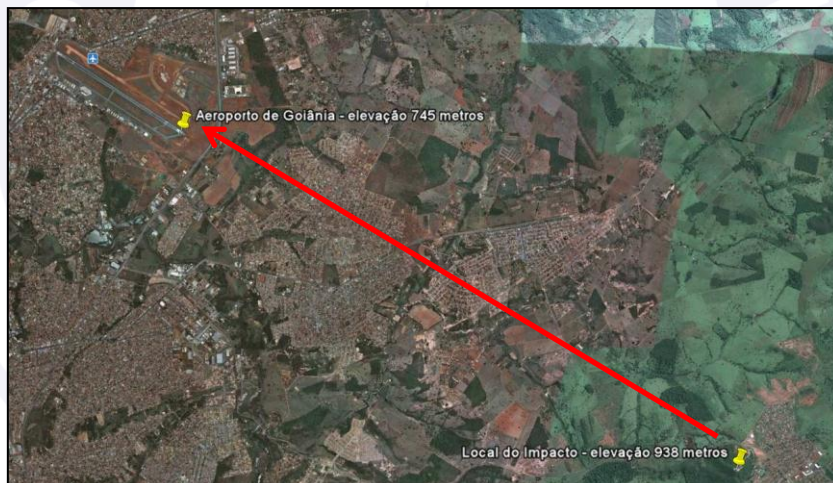
Figure 5 – Aircraft crash-site along the alignment of the SBGO runway 32 axis.

The analysis of the wreckage showed that the aircraft was configured for landing, with the landing gear down and locked. The fractures of the propeller shafts were an indication that the engines were developing power at the moment of the collision with the ground. The altimeter was set for the landing in SBGO (1,011 mb), with the ailerons and elevator moving freely and unlocked.

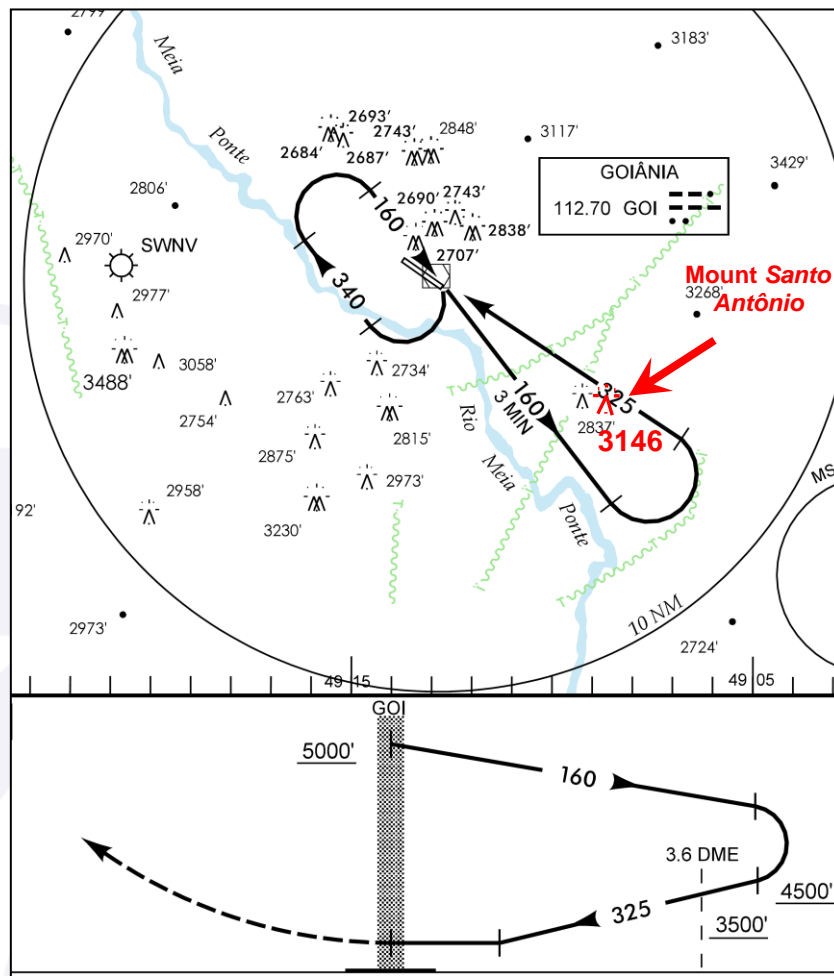
The VOR procedure for the runway 32 of SBGO (Figure 7) prescribed, after the aircraft passed overhead *GOI* VOR at 5,000 ft., an outbound leg of three minutes followed by a turn to the left to track 325° with descent to 4,500 ft. In the sequence, after stabilizing on track 325°, the aircraft had to make a descent restricted to 3,500 ft as far as 3.6 NM from *GOI* VOR. Finally, after reaching 3.6 NM DME, a 700 ft/min descent (B200 aircraft) had to be made toward the MDA at 3,040 ft.

As can be seen in Figure 7, the control obstacle relative to the final approach (Mount *Santo Antônio*), whose elevation is 3,146 ft., was not represented in the chart. Nonetheless, based on the records of the elaboration of the procedure, the commission verified that such elevation was taken into consideration for calculation of the minimum altitude to be maintained on the final approach (Table 2). The execution of this procedure within the correct parameters would allow lateral and vertical separation with the hill (.5 NM and 350 ft., respectively).

Figure 7 – Part of the VOR procedure for the runway 32 of SBGO. In the highlight, the approximate location of Mount *Santo Antônio* is indicated.

However, the investigation commission observed that Mount *Santo Antônio* was not depicted in the runway 32 VOR procedure approach chart, in spite of indicating the final approach control obstacle. Relatively to this aspect, in a way similar to what occurred in the HB-IXM accident (see item 1.19 – Known Precedents), one cannot rule out the possibility that the pilot would re-consider a possible decision to descend below the MDA without sufficient visual references if this obstacle had been represented in the approach chart.

The Swiss agency recommended the elevations immediately below the glide path to be included in the approach charts, and this recommendation was accepted (and complied with) by providers of route manuals, such as Jeppesen and Lido.
