COMMAND OF AERONAUTICS
AERONAUTICAL ACCIDENT INVESTIGATION AND
PREVENTION CENTER

FINAL REPORT
A - 004/CENIPA/2014

<u>OCCURRENCE:</u>	ACCIDENT
<u>AIRCRAFT:</u>	PR-DOC
<u>MODEL:</u>	B200GT
<u>DATE:</u>	28 JULY 2012

This is the Final Report of the 28 July 2012 accident involving the B200GT aircraft, registration PR-DOC. The accident was classified as Controlled Flight into Terrain (CFIT).

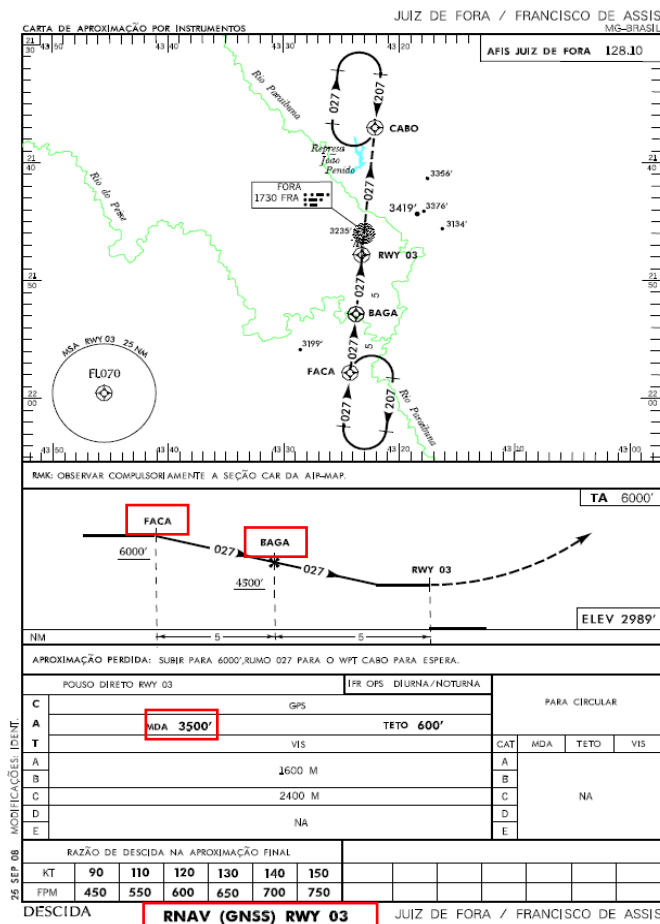
Figure 1 - RNAV(GNSS) Approach Chart for RWY 03.

According to the post-accident Inflight Inspection Final Report issued by the Special Group of Inflight Inspection (GEIV), the SBJF RNAV procedure utilized by the crew was considered satisfactory, and in accordance with the requisites and prescribed standards.

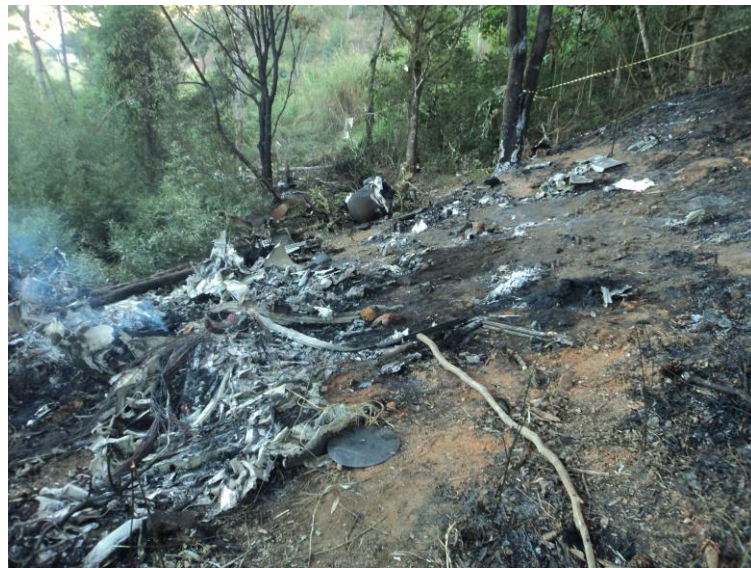
The first impact of the aircraft was against a tree at a distance of 245 meters from the runway threshold, at an elevation of 3,000ft.

Then, it collided with the ceiling of a kiosk of a resort known as *Pousada Hotel Aconchego de Minas* (at this moment, part of the right wing apparently detached, causing a leak of fuel). In the sequence, the aircraft hit the high voltage wires of the referred resort (with the resulting sparks igniting the fuel in the aircraft).

After moving approximately two hundred meters farther, the aircraft collided with the ground, and exploded on impact. The severity of the damage and the charring of the aircraft hindered a better verification of the aircraft equipment and instruments.

The final impact occurred 50ft below the level of the runway 03, with the trajectory of the aircraft aligned with the runway axis.

Figure 2 – Aspect of the wreckage.

The distribution of the wreckage was of the linear type.
