ACCIDENT INVESTIGATION FINAL REPORT

AN-26B, SP-FDP

Tallinn, Estonia

25. August 2010

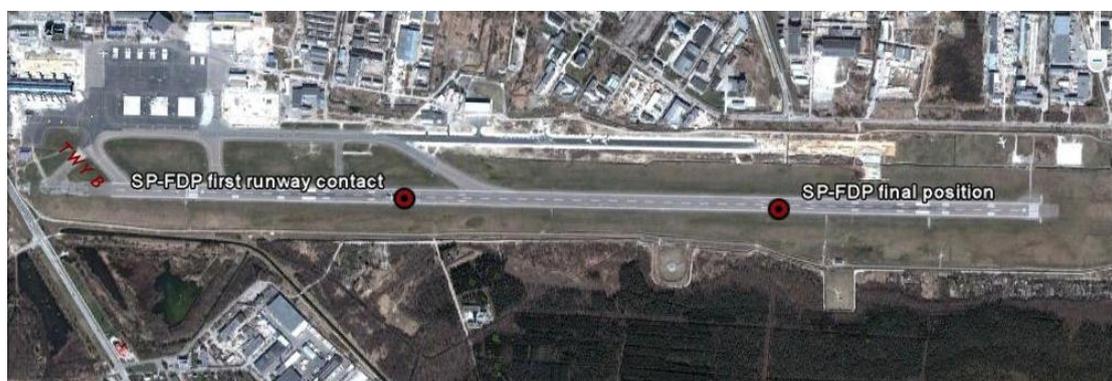
Based on pilots statements and FDR/CVR recordings the aircraft entered runway 08 from taxiway B on the West end of the runway and lined up for takeoff. On 16:47:22 the aircraft started its takeoff roll. The calculated V_1 was 182 and V_r was 201 km/h. 10 seconds later PF started rotation without V_r callout at 123 km/h. The aircraft pitch angle increased to 4.6° 2 seconds later. At 16:47:38 the navigator made V_1 call-out at 160.5 km/h. 1 second later flight engineer called “Retracting” in Polish. The aircraft started to pitch down and 3 seconds later it contacted the runway and continued on its belly for 1,228 m before coming to its rest position 3 m right from the runway centerline.

EETN runway with indicated aircraft position

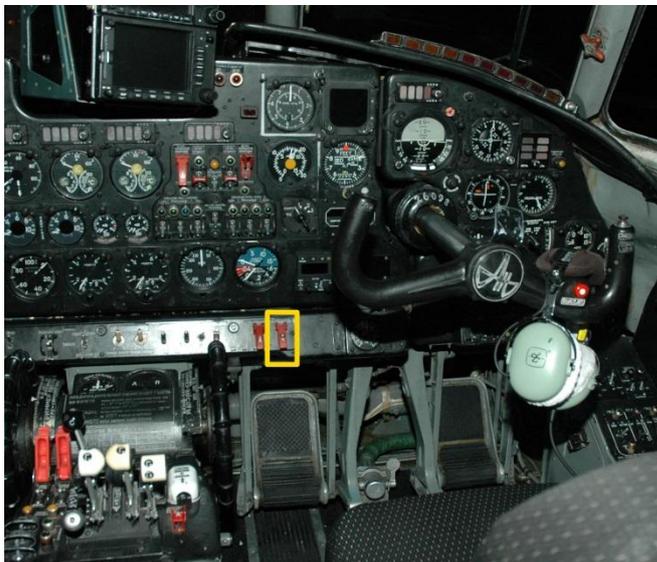
The main landing gear is located under the engine gondola. The landing gear extension and retraction is actuated by electro-hydraulic system controlled through control in the cockpit. Main hydraulic cylinders are actuated through electric solenoid valves. The circuit is fitted with WOW switches on the main landing gear support to block the undercarriage retraction while on ground. The circuit also consists of an override switch to override the WOW blocking in case of malfunction. The override switch is located on the right lower side of the central

instrument panel. The switch is protected with a cap and is spring loaded in OFF position. To actuate the switch it must be held in ON-position by hand.

Blockage can be overridden when holding the override switch by hand. This cannot be done unnoticed by other crew members since the switch is located on the front panel. The override switch remained in OFF position during the event.

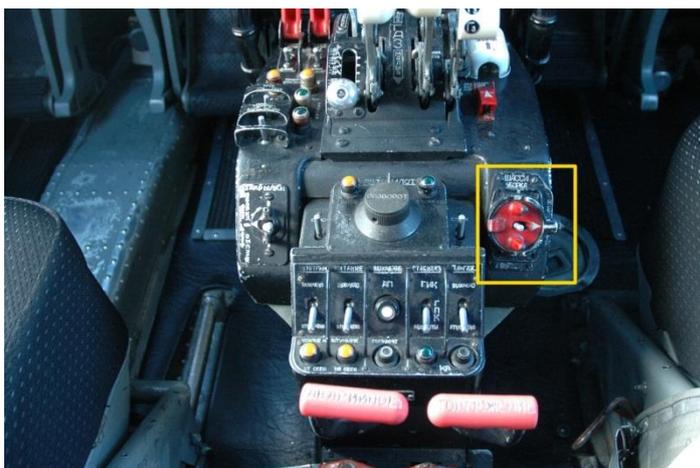
Landing gear control switch is located in the cockpit central console aft right corner. It is operated by flight engineer by turning it from neutral position counterclockwise to retract the landing gear.

The landing gear control is located out of the field of view of the pilots and therefore are operations not observable by the captain and first officer, specifically during take-off and landing, when both pilots are engaged with forward view and instrument scan.

The position of the landing gear selector on the central console is not considered as a contributing factor to the accident. However, investigation finds necessary to point it out as a safety concern, specifically in situations, where crewmembers are trained and/or used to operate the aircrafts with gear selector location according to the EASA Certification Standards CS-25. Positioning of the gear lever to the location which is compliant to EASA document CS-25, would create additional safety barrier to avoid similar occurrences, specifically in aircrafts where landing gear is operated by FE.

4.1.1. To set up and implement the procedure to assure, that gear operations on takeoff are made in accordance with AFM. Due to the lack of visual control over the gear switch handle by captain and first officer during takeoff it is recommended to set up and implement procedure with clear verbal exchange between pilot flying and flight engineer confirming the gear operations.

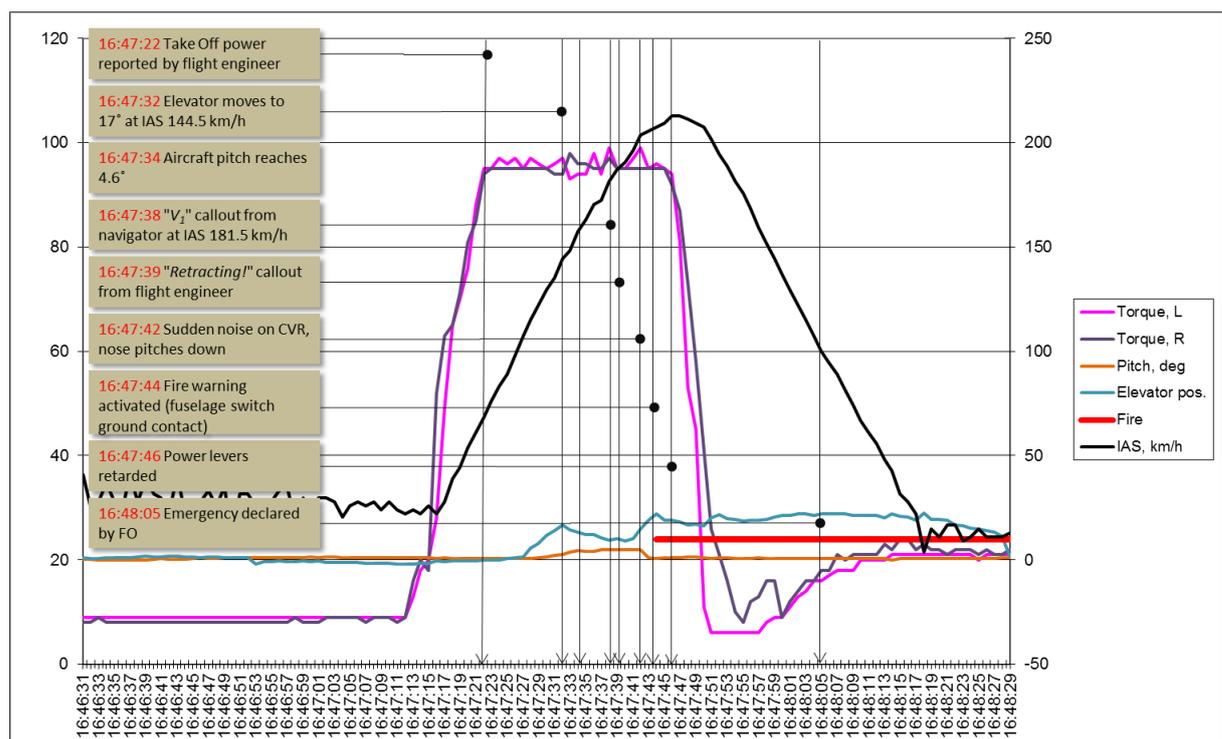
It is significant, that elevator position changes start from neutral at IAS 107.4 km/h and reaches 17° at IAS 144.5 km/h. During the next seconds the elevator position changes to 12° and later to 9.2°. The calculated V_r was 201 km/h.

The relevant values from FDR are plotted on the graph.

According to the FDR data PF started rotation at IAS 144.5 km/h, significantly below the V_r , which was 182 km/h. The elevator was initially positioned in high angle of 17° and released to 9.2° during next 7 seconds. The aircraft pitched up by 4.6° increasing lift and possibly creating sufficient lift to close the WOW switch, allowing the actuation of the gear retraction mechanism.
