**UNITED STATES AIR FORCE**  
**AIRCRAFT ACCIDENT INVESTIGATION**  
**BOARD REPORT**

**KC-135R, T/N 63-8877**

**LOCATION: 6 MILES SOUTH OF CHALDOVAR,**  
**KYRGYZ REPUBLIC**

**DATE OF ACCIDENT: 3 MAY 2013**

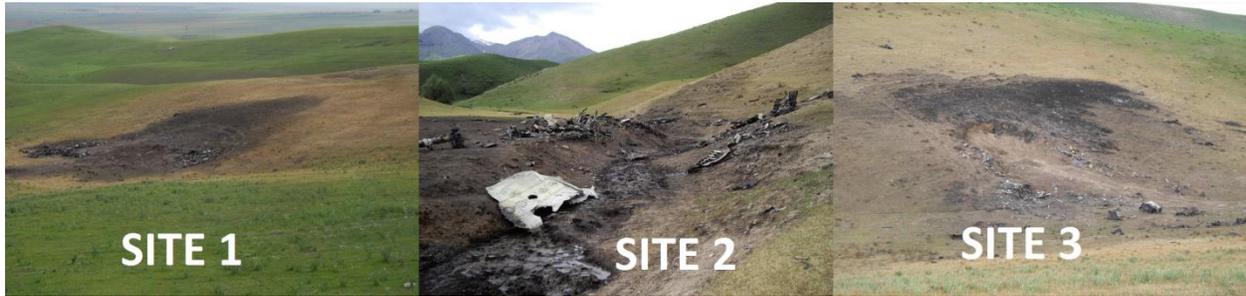
Figure 1. Impact Craters (Tab FF-7 to FF-8, FF-11)

On 3 May 2013, at approximately 1448 hours local time (L), the mishap aircraft (MA), a KC-135R, tail number 63-8877, assigned to the 22d Expeditionary Air Refueling Squadron (22 EARS), 376th Air Expeditionary Wing (376 AEW), Transit Center at Manas, Kyrgyz Republic, crashed approximately 6 miles south of Chaldovar, Kyrgyz Republic (Tabs K-4, Q-5, Q-7). The mishap crew (MC), which consisted of the mishap pilot (MP), the mishap co-pilot (MCP), and the mishap boom operator (MBO), perished during the accident (Tab Q5 to Q-6). Following the loss of its tail section, the MA exploded inflight and further separated into three main sections, impacted the earth, and burned (Tabs J-28 V-24.2, V-25.2). The three impact points were craters in hilly terrain used for grazing livestock (See Figure 1) (Tab FF-5). Approximately 228 cubic meters of soil were contaminated with jet fuel and each crater contained a pattern of burned grass and trees about 35 meters diameter on average (Tab FF-6 to

FF-11, FF-17). The MA was destroyed upon impact, with total loss to government property estimated at \$66.3 million (Tab P-4).

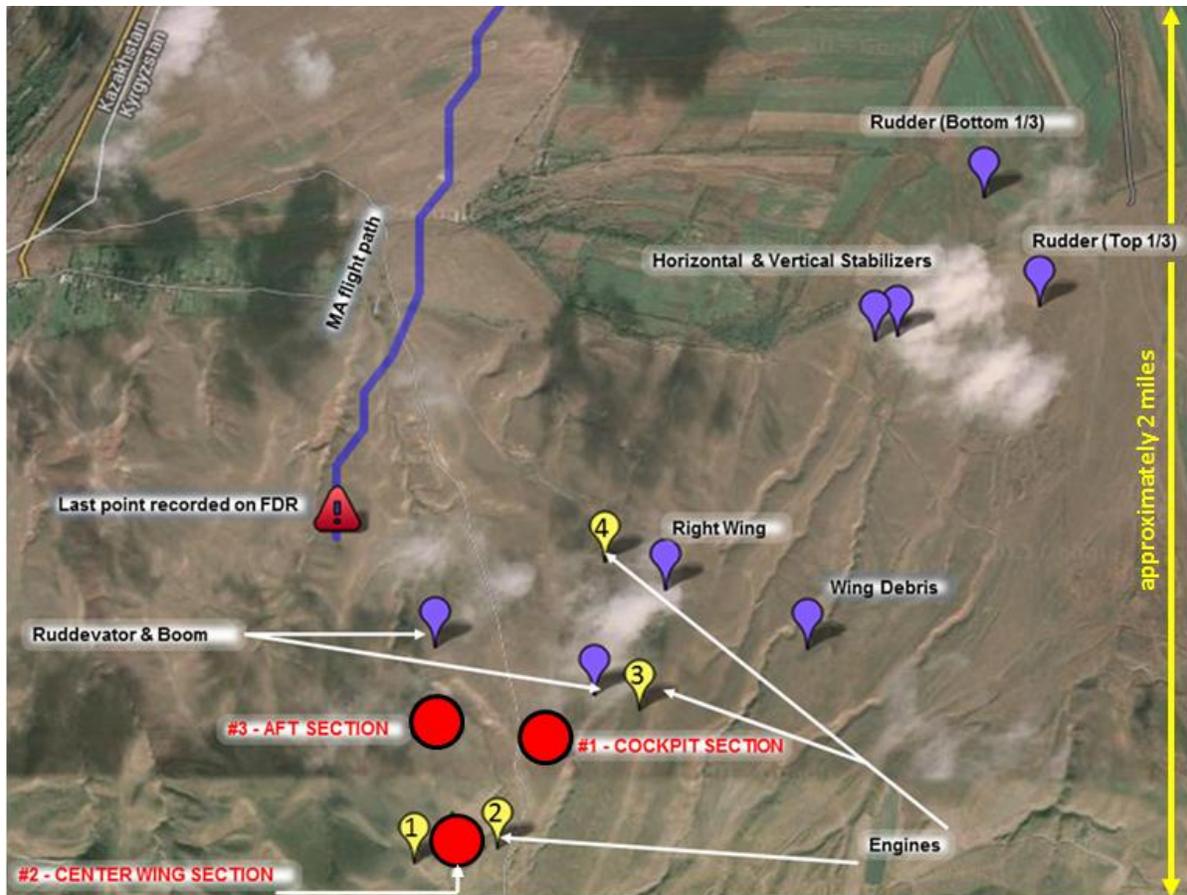
Figure 5. Plot of MA Wreckage (Tab Z-4)

The last point captured on the flight data recorder (FDR) was a nose down attitude of 82 degrees at 21,760 feet (Tab EE-12, EE-18). Around 10,000 feet, the MA exploded into three main sections and fell to the earth, impacting the terrain approximately 1.5 miles southwest of where the tail section of the MA was found (Tabs V-24.2, W-4, Z-8). The three main sections included the cockpit section, the center fuselage section, and the aft section (Tab Z-4).

The MA impacted the terrain at 1448L (0848Z) about 6 miles south of Chaldovar, Kyrgyz Republic (Tabs Q-5, GG-3). In addition to the three main sections mentioned above, the right wing and all four engines fell separately. The rudder, vertical stabilizer, and horizontal stabilizer separated from the MA prior to the explosion (Tab J-28). These relatively lighter aircraft parts were carried by the wind about 1.5 miles northeast of the main crash site (See Figure 5) (Tabs F-19, Z-4 to Z-5). The MA’s configuration before breakup was flaps and landing gear up (Tab N-8 to N-9).

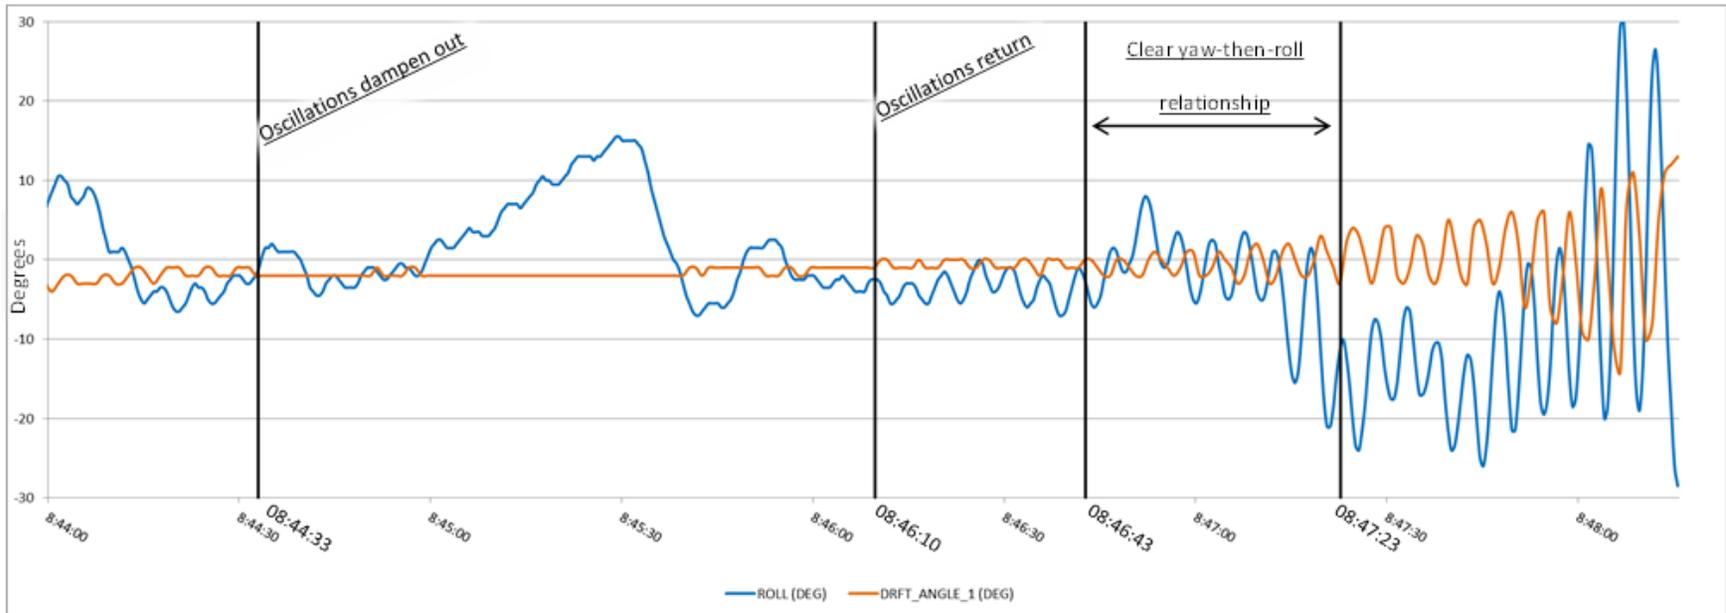
Figure 6. Onset of Dutch Roll of the MA (Tab EE-8)

In Figure 6 below, the blue plot is the MA’s roll and the orange plot is the MA’s drift angle, or yaw. Positive values indicate rolling/yawing to the right and negative values indicate rolling/yawing to the left (Tab EE-4, EE-8). Beginning with takeoff at 08:37:23Z, the MA experienced a series of uncommanded yaw movements that caused the nose of the MA to oscillate left and right (Tab EE-5, EE-8, EE-10). At around 08:44:33Z, the oscillations dampened out almost entirely, characterized by the flat segment of the orange line in Figure 6 (Tab EE-8). At approximately 08:46:10Z, the MA resumed the oscillations (Tab EE-5, EE-8). The period between 08:46:43Z and 08:47:23Z depicts a clear yawing-then-rolling relationship that is symptomatic of dutch roll (Tabs AA-27, EE-8). Each “peak” of roll occurs about two seconds after each peak of yaw. In this 40-second time frame, eight peaks equate to a period of about five seconds (Tab EE-8).

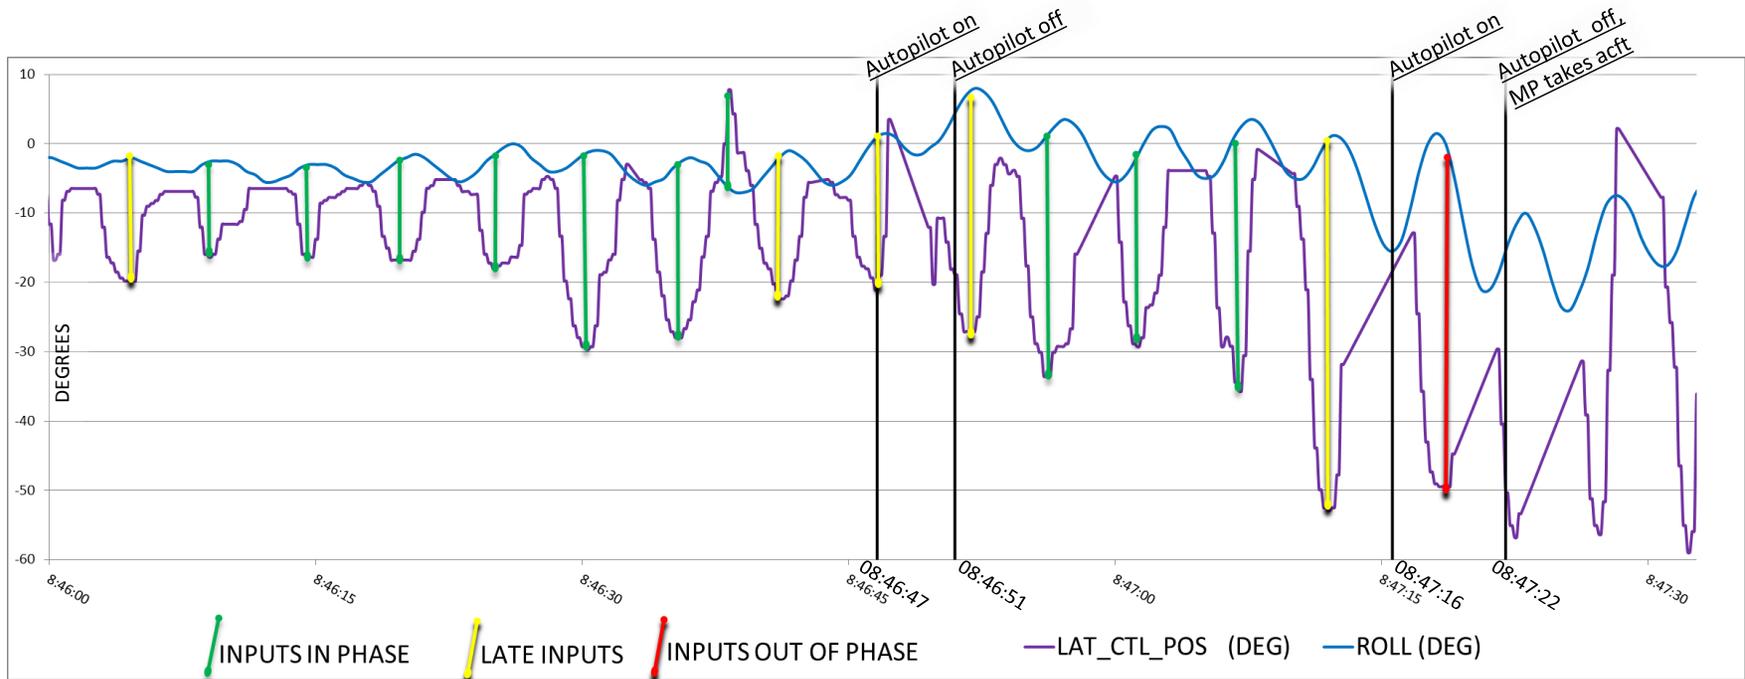
Figure 9. Lateral Inputs Made by MCP & Autopilot (Tab EE-9)

The FDR plot of the MCP's inputs is shown below in Figure 9. The yoke inputs of lateral, control, and position (LAT\_CTL\_POS) are mostly in-phase between 08:46:00Z and 08:47:22Z, except when the autopilot is engaged. Negative values are left yoke movements, and positive values are right yoke movements (Tab EE-4). When the MCP initially engages the autopilot, it makes two late lateral control inputs. The second time the autopilot is engaged it makes one large out-of-phase input before being disengaged by the MP (Tab EE-9).

Most of the lateral control inputs accomplished by the MCP resemble the example in Figure 8 regarding the in-phase properly timed inputs. As a trend, the roll oscillations of the MA did not get larger with in-phase inputs. The amplitudes of the inputs appear to be greater than that of the roll. When engaged, the autopilot applied late corrections and in turn generated a larger, steeper roll in the opposite direction (Tab EE-9). Once the MP takes control of the MA, the lateral control inputs can no longer be reliably measured due to the FDR constraints and rudder input (Tab EE-4 to EE-5, EE-9).

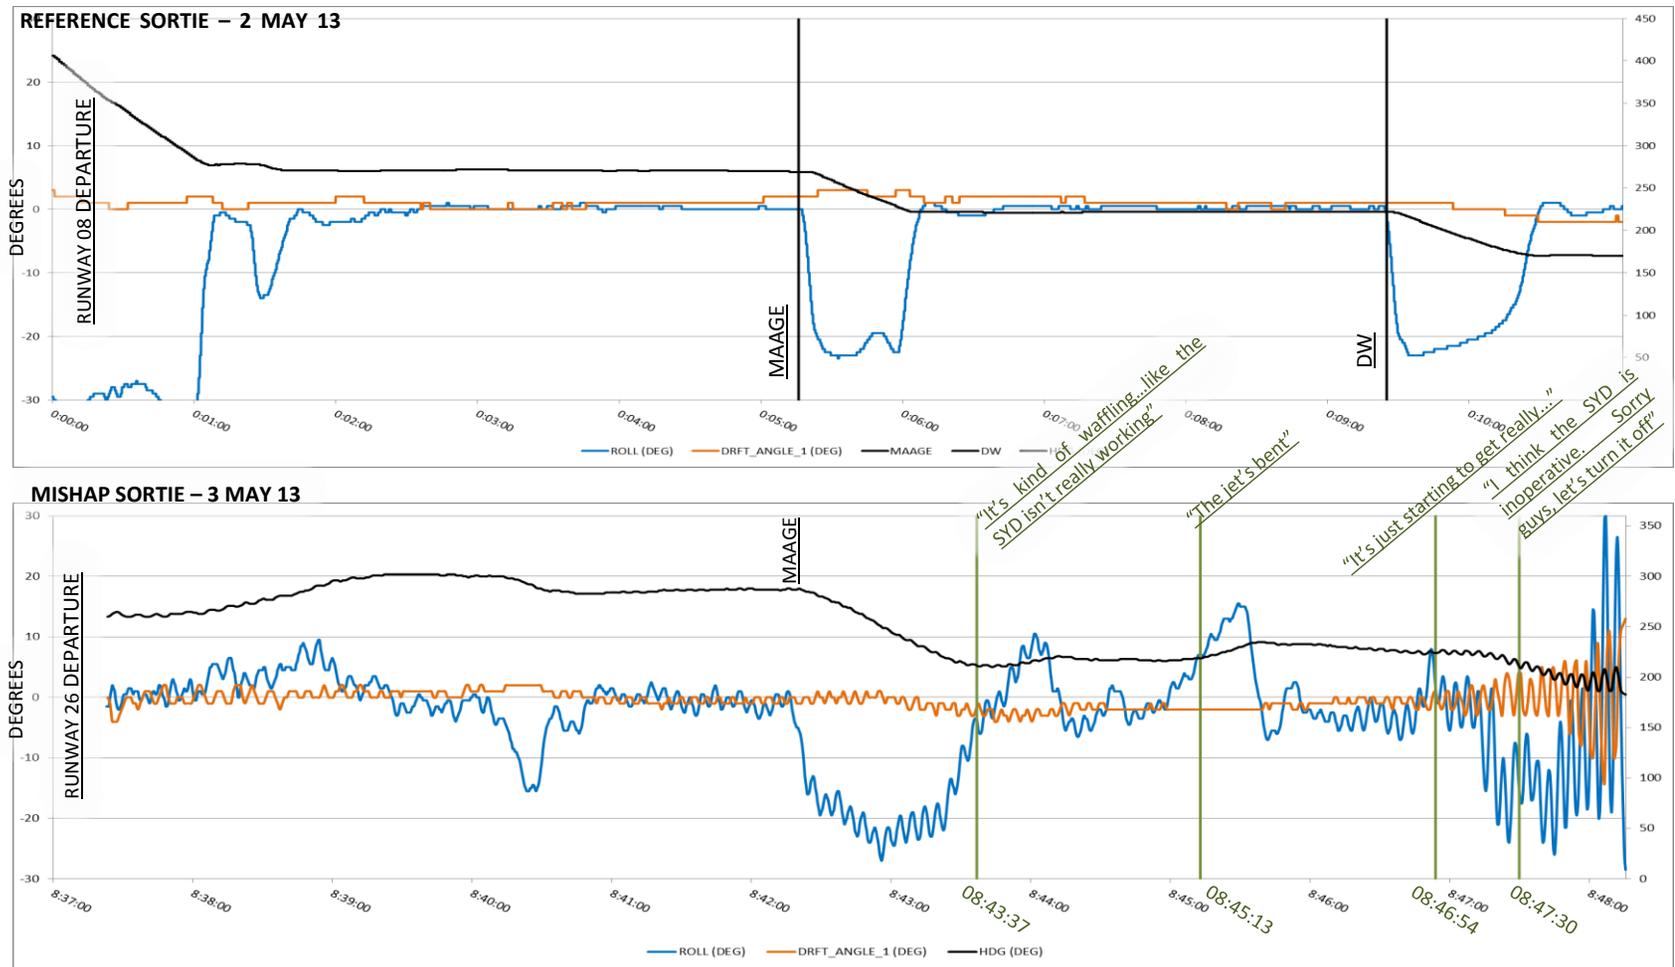
Figure 10. Comparison of Reference Sortie vs. Mishap Sortie on MAAGE Departure (Tab EE-10)

Figure 10 below depicts the yaw oscillations of the MA compared to another KC-135R flying a similar route of flight with all systems operating normally (Tab EE-5 to EE-6, EE-10).

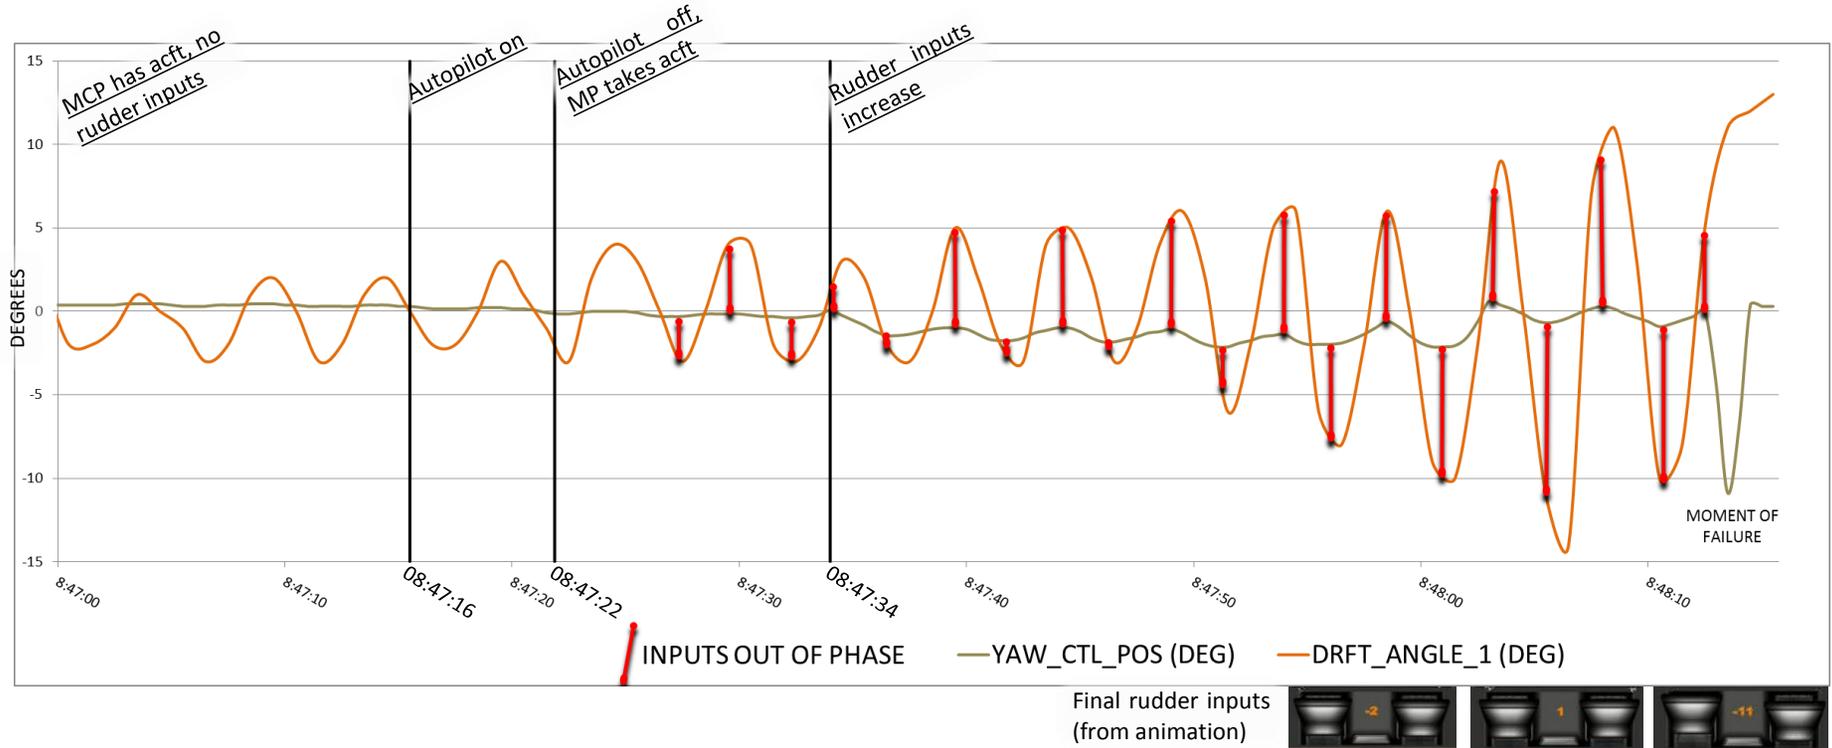
Figure 11. FDR Plot of MP's Rudder Input vs. Sideslip (Tabs Z-7, EE-11)

The sideslip oscillations of the MA represent rudder inputs (some abrupt) and a progressively increasing sideslip. Due to the timing of the input, each peak rudder input (depicted as red bars in Figure 11) occurs in the same direction as the sideslip as depicted in Figure 11. Instead of decreasing the sideslip, the MP's inputs compounded it. At 08:48:14Z, the final rudder input of 11 degrees coincides with the final FDR and cockpit voice recorder (CVR) data indicating failure of the MA's tail section. One second later the MA pitches over at 08:48:15Z (Tab EE-3, EE-11, EE-18).

The MP's rudder response in Figure 11 is analogous to the expected response shown in red in Figure 12. The rudder input is nearly zero between 08:47:00Z and 08:47:34Z, and the sideslip oscillates steadily around plus or minus three degrees. From 08:47:34Z until the end of the flight, rudder inputs correspond with increasing sideslip on each cycle. Figure 12 below depicts the same divergent sideslip tendency when rudder input is applied two seconds late (Tabs AA-28, EE-11). The amplitudes of the building sideslip are indicative of undesirable rudder inputs, as shown below in Figure 12 (Tab AA-28).

If the pilot reacts to an abrupt roll onset with a large rudder input in the opposite direction, the pilot can induce large amplitude oscillations. These large amplitude oscillations can generate loads that exceed the limit loads and possibly the ultimate loads, which could result in structural damage (Tab AA-14). Boeing airplanes are capable of sustaining a single control input, but do not account for input reversal or oscillatory inputs (Tab AA-8). The Inflight Manual contains a warning that states, "The sudden reversal of rudder direction at high rudder deflections, due to improper rudder application or abrupt release, can result in overstressing the vertical fin. This condition could be brought about during recovery attempts from a flight condition induced by a lateral control malfunction" (Tab BB-172). Figure 11 depicts an abrupt application and release of the rudder, as well as a rudder reversal in the final 10 seconds (Tab EE-11).

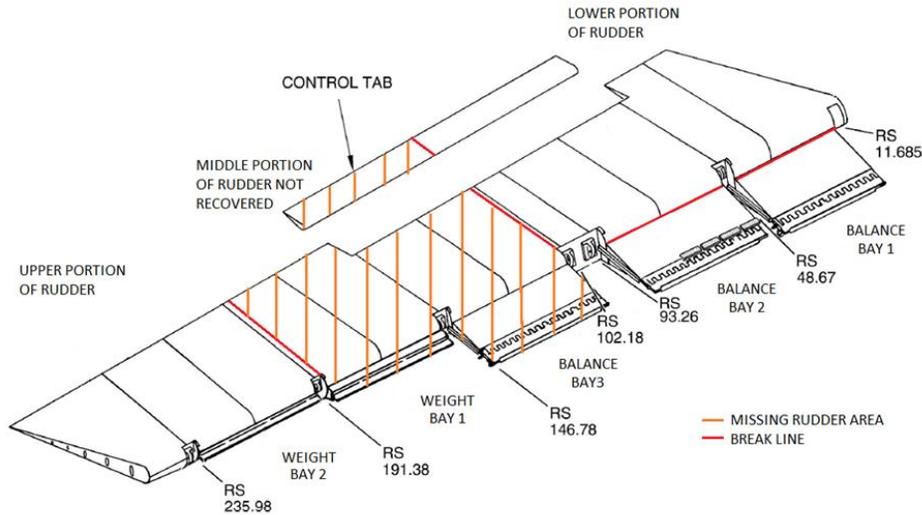
Figure 13. Rudder Shown Laying Flat with Balance Panels and Control Tab (Tab Z-9)

The rudder separated from the MA and landed separately from the vertical and horizontal stabilizers (Tab J-15). It was broken into multiple pieces. The bottom, middle, and top pieces of the rudder failed at the riveted splice joints shown by the red the break lines in Figure 13 (Tab J-88). The middle section of the rudder was not recovered (Tab J-15).

All seven of the vertical stabilizer-rudder hinge assemblies (fittings, bolts and nut plates), located at the Rudder Stations (RS) shown in Figure 13, failed at either the vertical stabilizer or the rudder side of the assembly (Tab J-87).

Examination of the failed rudder hinge parts and hardware revealed only evidence of overload, indicating failure above the design ultimate loads (Tab J-17, J-29). No evidence of preexisting failures such as fatigue or stress-corrosion was found (Tab J-88). Analysis was unable to provide a specific load case based on FDR data at which the observed failures would be expected to occur (Tab DD-12).

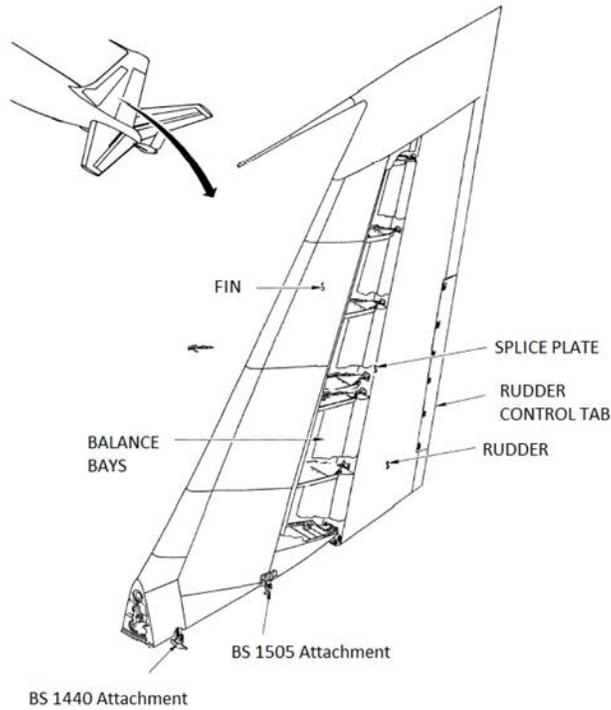
Figure 14. Vertical Stabilizer and Rudder Balance Bays (Tab BB-127, BB-131)

The vertical stabilizer has a steel splice plate on the left hand side at Fin Station 156 to splice the chord at the aft end of the balance bays (See Figure 14) (Tab J-18). A splice is a joint made in assembly of aircraft components in which all individual parts have to be attached (Tab HH-3). The Fin Station 156 splice plate was deformed to the left and down due to the rudder PCU being torn from the vertical stabilizer as the rudder hinge assemblies and rudder failed (Tab J-86 to J-87). In addition, there was a large rip on the left hand side of the vertical stabilizer where the rudder PCU tore through the skin (Tab J-18). The left and right sides of the vertical stabilizer contained forward to aft skin buckling from the bottom up (Tab J-87). Buckling is an out of plane bending, followed by crushing of material under compressive loads (Tab HH-3).

Contact marks within the vertical stabilizer show that the rudder was fully deflected and driven to its extreme limits in both directions (Tab J-29). The deflections occurred with sufficient force to deform the structures (Tab J-36). These marks along with the Fin Station 156 splice plate indicate that the rudder and rudder trim tab assembly departed the MA as one unit at, or in excess of, maximum left rudder travel. All skin fractures of the vertical stabilizer were typical of overload with no evidence of preexisting failures such as fatigue or stress-corrosion (Tab J-87). FDR data shows the MA entered a condition where the applied load to the vertical stabilizer exceeded the design ultimate load. The vertical fin spar chords were identified as possible critical areas when overloaded by the condition experienced by the MA. However, examination of the wreckage reveals the vertical fin spar chords did not fail (Tab DD-12).

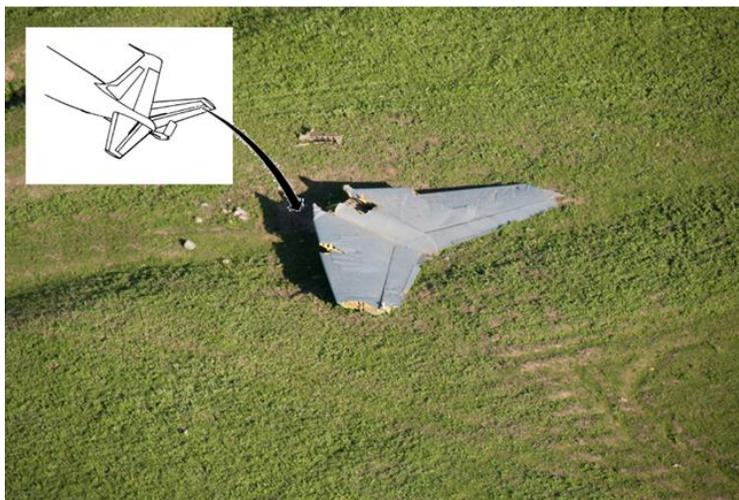
Figure 15. Horizontal Stabilizer Sections and Portion of Aft Fuselage (Tab Z-8)

The horizontal stabilizers (left hand, right hand and center sections) departed the MA intact along with their respective elevators (Tab J-20). There was no apparent damage to the stabilizer attachment points (Tab J-20). Symmetric outboard “V” shaped skin buckling and tears were present in the left and right horizontal stabilizers upper skins due to ground impact (See Figure 15) (Tab J-20, J-86).

All spar, rib, and skin fractures of the horizontal stabilizers and elevators were typical of overload with no evidence of pre-existing failures such as fatigue or stress-corrosion (Tab J-86).

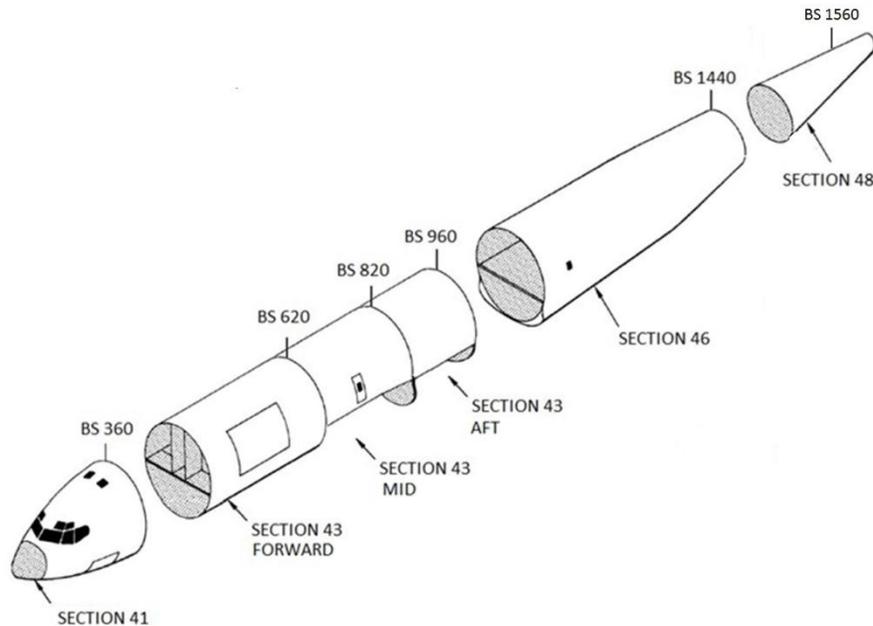
Figure 16. Fuselage Section Breakdown (Tab Z-11)

The fuselage is divided into four sections (Section 41, Section 43, Section 46 and Section 48) (See Figure 16). The wing-to-fuselage attachment structure consists of terminal fittings on bulkheads at BS 620 and BS 820. The horizontal stabilizer surfaces loads are transferred to the fuselage by the stabilizer trim actuator through the lower bulkhead at BS 1505 and the stabilizer hinge fitting through the bulkhead at BS 1592 (Tab BB-95).

The MA separated at the Section 46 to Section 48 joint just aft of the BS 1440 bulkhead (Tab J-23). The top of Section 48 remained attached to the vertical stabilizer (Tab J-24). It extended from approximately BS 1440 aft to BS 1560 and spanned multiple stringer bays (Tab J-24, J-85).

Based on wreckage distribution, analysts concentrated on the fracture surfaces associated with stabilizer separation (Tab J-34). The vertical stabilizer, front spar, and attachment fittings at BS 1440 failed due to overload just below the BS 1440 frame chord (Tab J-23, J-25). The vertical stabilizer, rear spar, and attachment fittings at BS 1505 fittings did not fail (Tab J-25). The BS 1505 bulkhead chord failed between S-10 and S-11 on the right hand side due to overload at the

10th fastener below the cutout for the stabilizer center section (Tab J-24, J-25). This is the strongest part of the BS 1505 bulkhead to fail on the right hand side of the MA (Tab J-25).

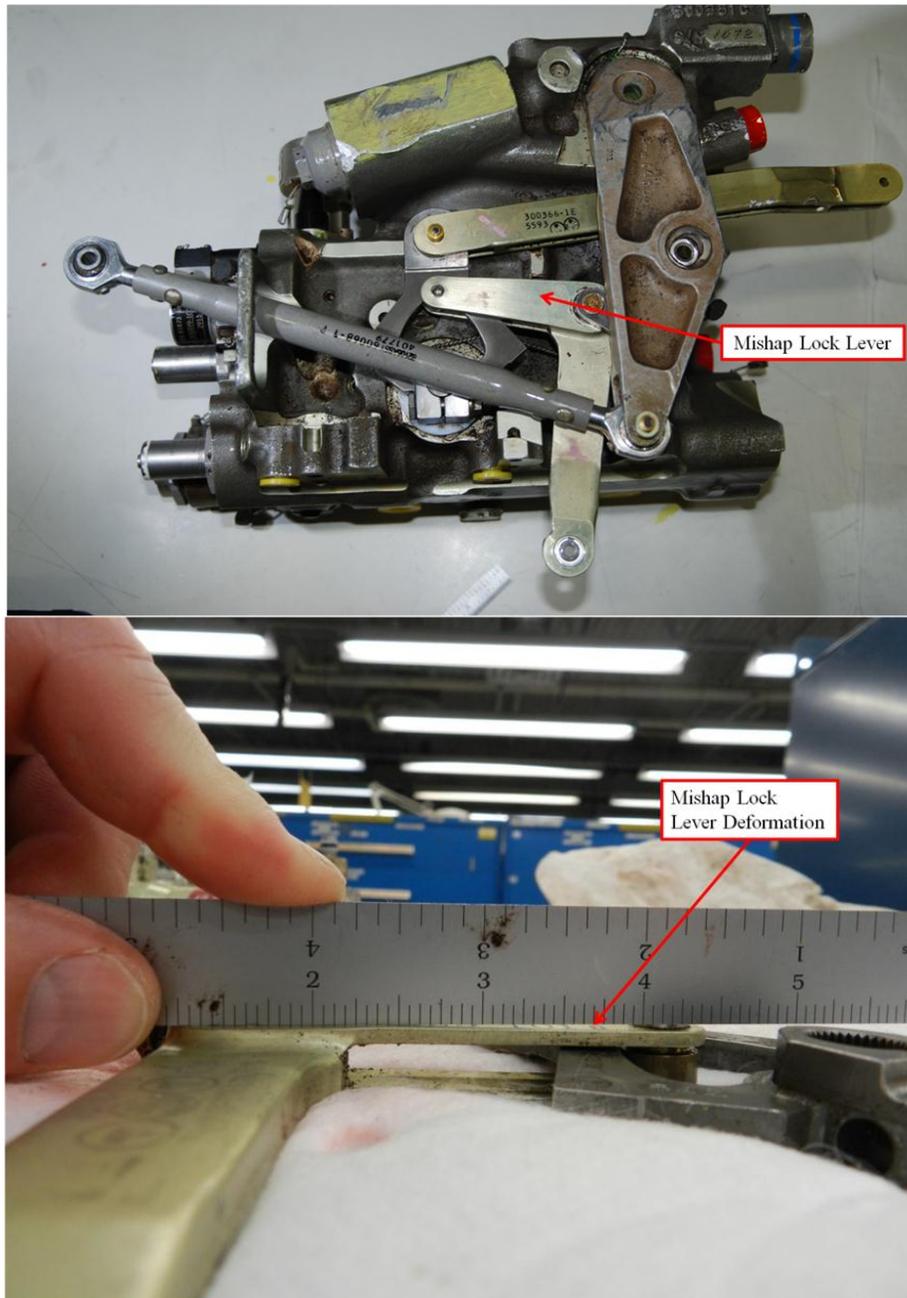
Figure 19. Mishap PCU with Bent Lock Lever (Tab Z-12)

The PCU main actuator shaft was broken in the vertical plane after the rudder hinges overloaded and subsequently failed (Tab J-35 to J-36). Failure of PCU linkages also occurred including a broken tablock H-assembly (Tab J-125). The outer fork of the main clevis of the lock lever was bent toward the actuator at the bearing rivet (See Figure 19) (Tab DD-12).

PCU testing showed the operating force at the Pilot Input Arm to cause main actuator movement was five pounds in one direction and six pounds in the other. The limit is five pounds but newly overhauled actuators normally require around one pound of input to operate. Hysteresis is the lag in response exhibited by a body reacting to changes in the forces affecting it (Tab HH-4). The PCU failed the electrical accuracy and hysteresis test (Tab J-128).
