**Loss of control in icing conditions, in-flight breakup,
collision with the ground**

Aircraft	Aircraft Pilatus PC-12/47 registered HB-FPZ
Date and time	24 August 2012 at around 16 h 00 ⁽¹⁾
Operator	Air Sarina
Place	Solemont (France)
Type of flight	General aviation, Business
Persons on board	Pilot and three passengers
Consequences and damage	Pilot and passengers fatally injured, aeroplane destroyed

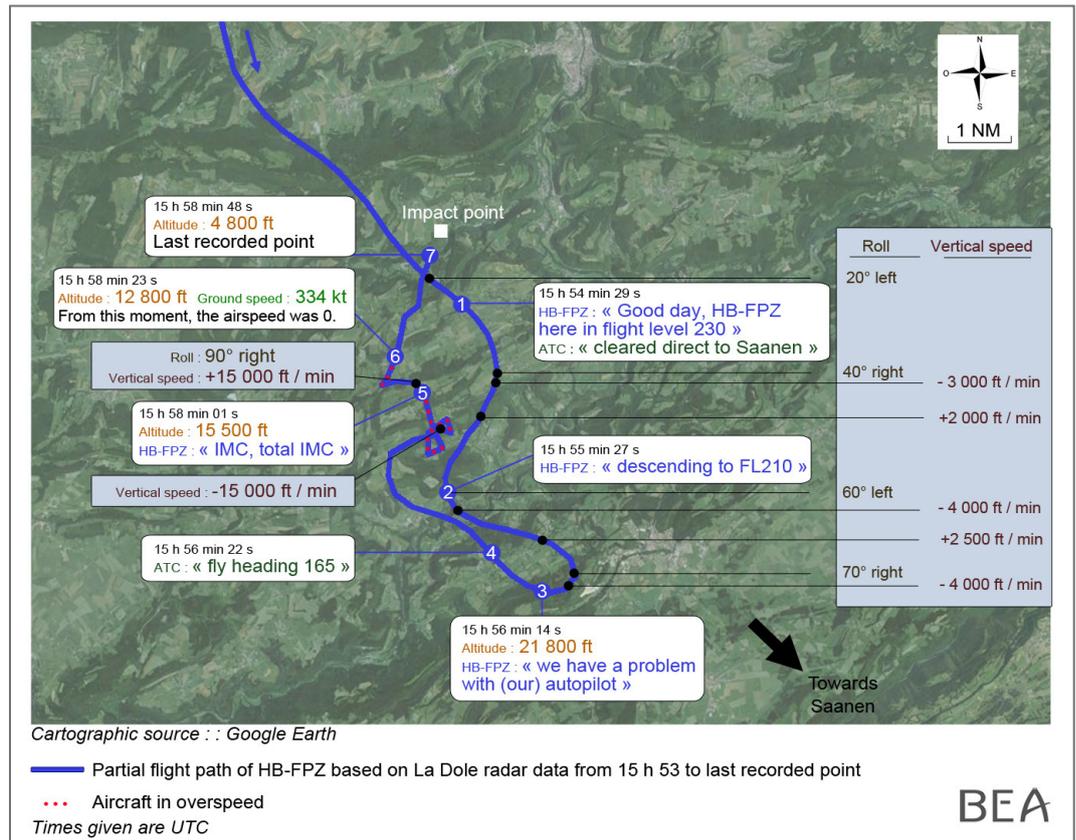
The wreckage was found in woods in the commune of Solemont (25). A piece of the right wing was found about 2.5 km from the main wreckage. Some debris, all from the right wing, was found on a south-west/north-east axis. The aeroplane part that was furthest away was found 10 km from the main site.

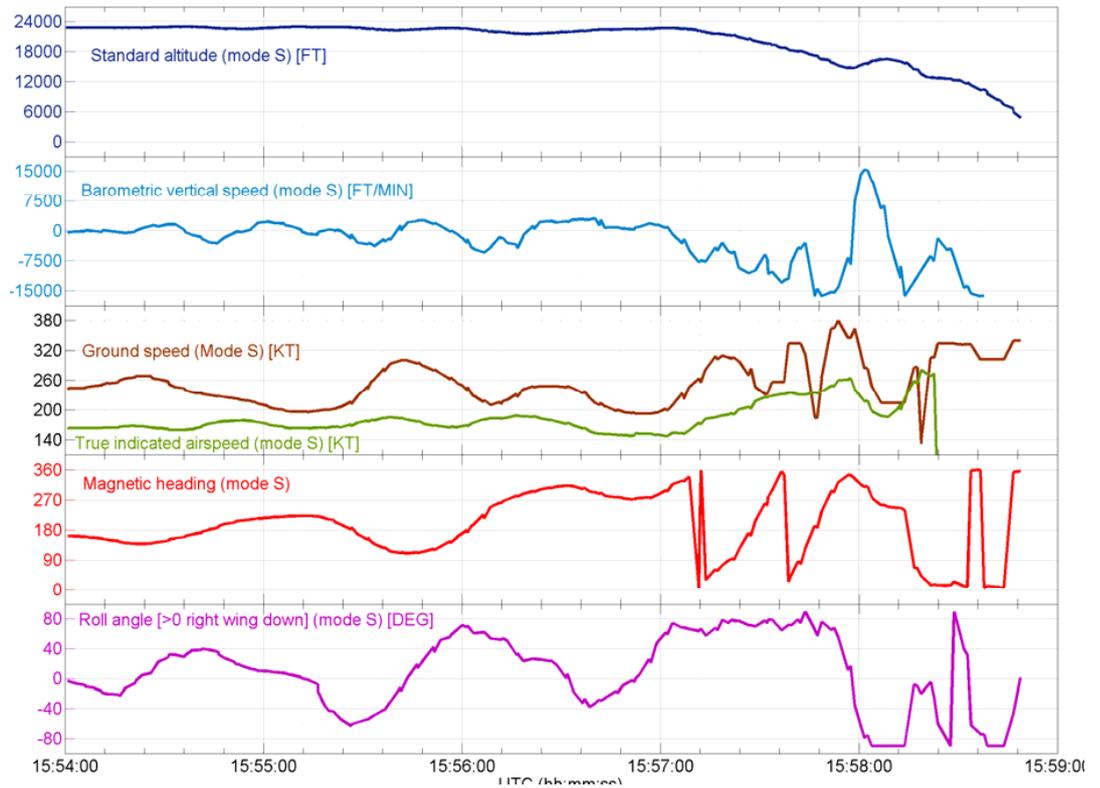
HB-FPZ's flight mode S extended parameters

Swiss radar recorded the extended data from the aeroplane during its last thirty minutes of flight. These showed slow oscillations (periods between 45 and 80 seconds) and increasing amplitude in roll and the vertical speed. These oscillations seem to begin before the recording in mode S and before the pilot warned the Geneva controller of his difficulties. The periods and the amplitude of these variations suggest that they were not linked to turbulence and that the autopilot was not connected.

Available meteorological information indicated that some icing phenomena were likely in the area of the accident. It was not possible to determine the severity of the phenomenon, but it could have led to airframe icing. The initial attitude and speed oscillations shown by the enhanced mode S data is consistent with the contamination of the airframe and/or wing by icing. The incident that happened in Canada had similarities with those of this accident (meteorological conditions, and roll and altitude oscillations at altitude) but it cannot be established with certainty that the same situation occurred.
