National Transportation Safety Board Aviation Accident Final Report

Location:	Philadelphia, Pennsylvania	Accident Number:	DCA14MA081
Date & Time:	March 13, 2014, 18:22 Local	Registration:	N113UW
Aircraft:	Airbus A320 - 214	Aircraft Damage:	Substantial
Defining Event:	Abnormal runway contact	Injuries:	154 None
Flight Conducted Under:	Part 121: Air carrier - Scheduled

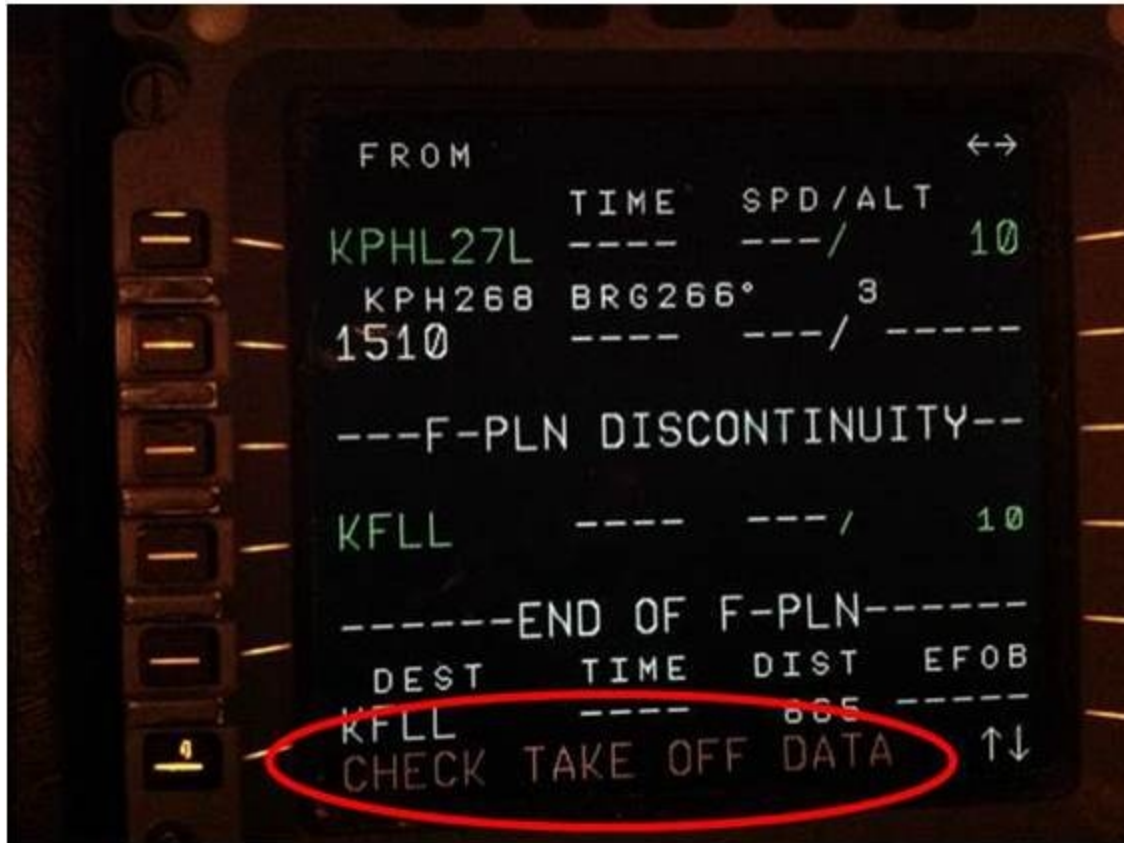
Figure 3. MCDU flight plan page after runway change (27R to 27L), with MCDU message (indicated).

During the March 26, 2014, testing in an A320 simulator at the US Airways training facility in Charlotte, North Carolina, NTSB investigators conducted a runway change in the MCDU from runway 27R to 27L without entering the new takeoff V-speeds or a FLEX temperature and documented the MCDU screen, the PFD, and the ECAM. Following the runway change in the MCDU, the "CHECK TAKE OFF DATA" message was visible in the MCDU scratchpad and the upper ECAM indicated a TO/GA target power setting since no FLEX temperature was entered (see figures 3 and 4).

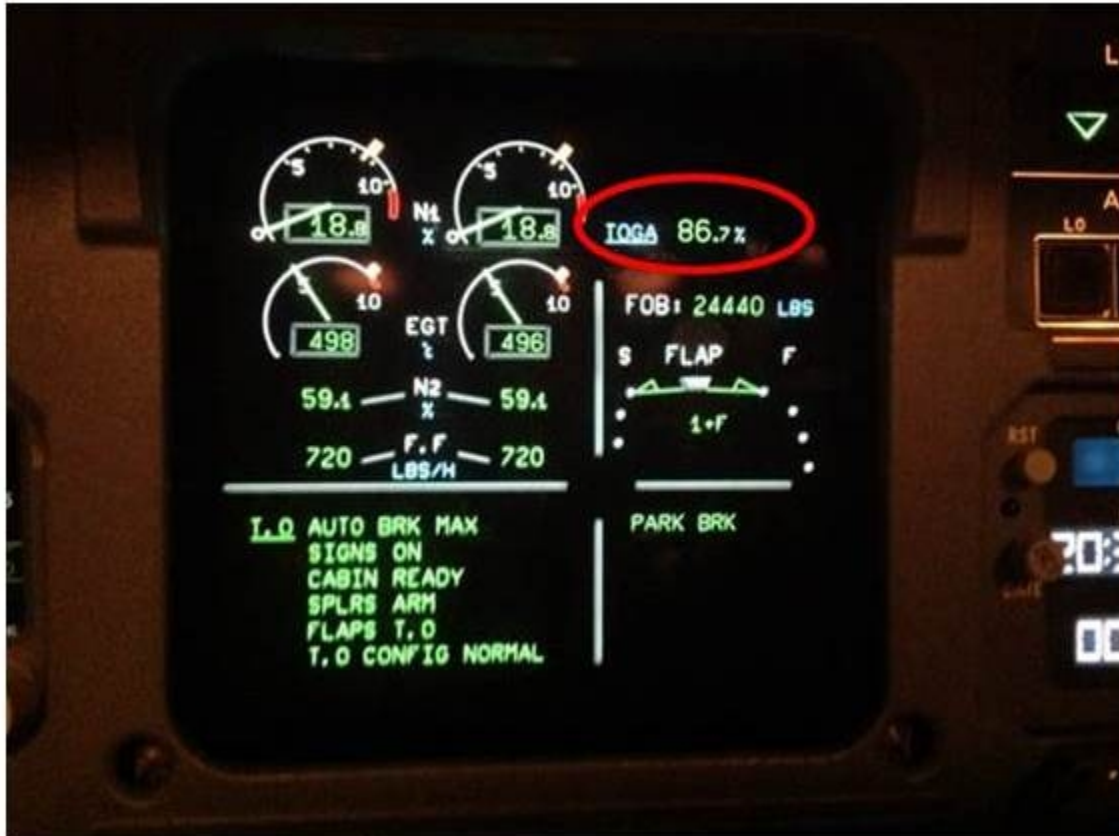
Figure 4. Upper ECAM without FLEX temperature inserted in MCDU (TO/GA indicated).

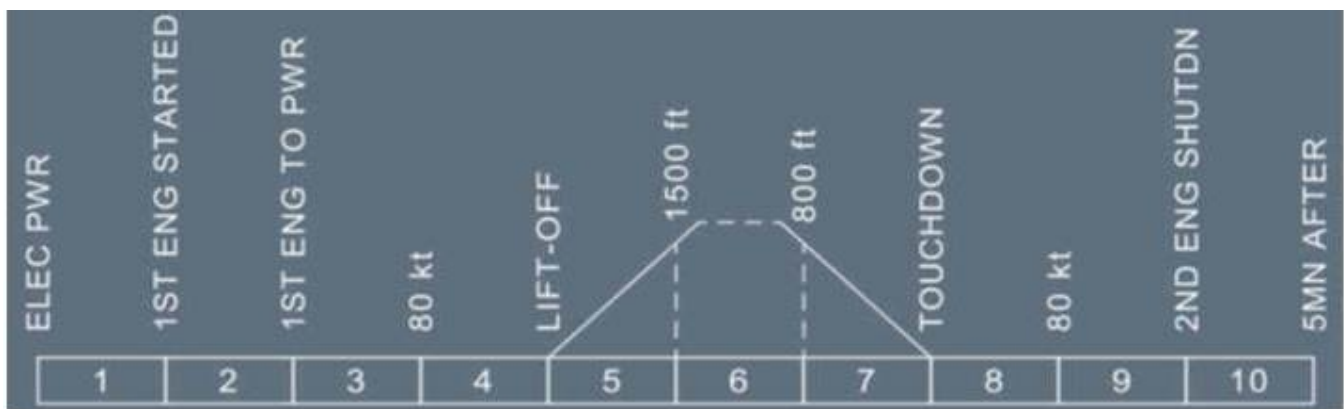
Figure 6. Chart of flight phase segments.

If the takeoff is initiated with an abnormal thrust setting, during the acceleration phase FWC remains in flight phase 2 and does not enter into flight phase 3 because of low TLA. When over 80 KIAS, the FWC leaves the flight phase 2 for speed above the defined threshold and computes the flight phase 8 corresponding to a landing roll (see figure 6).

The RETARD callout is therefore triggered at around 80 KIAS. Airbus stated that, in this scenario, the RETARD callout is not associated with Master Caution or Master Warning lights, and the RETARD callout experienced during the takeoff roll is linked to a divergence between the FWC computation and the aircraft's flight phase, due to the throttles position not being set in the TO POWER condition (TO/GA or FLX/MCT TLA positions). Airbus stated that this FWC behavior is due to the TLA configuration combined with the flex temperature not being entered in the FMS.
