# Investigation Report

Type of Occurrence:	Accident
Date:	9 August 2013
Location:	Leipzig/Halle Airport
Aircraft:	Cargo Airplane
Manufacturer / Model:	Antonov / An-12 BK
Injuries to Persons:	None
Damage:	Aircraft destroyed
Other Damage:	Cargo, apron surface
State File Number:	BFU AX002-13

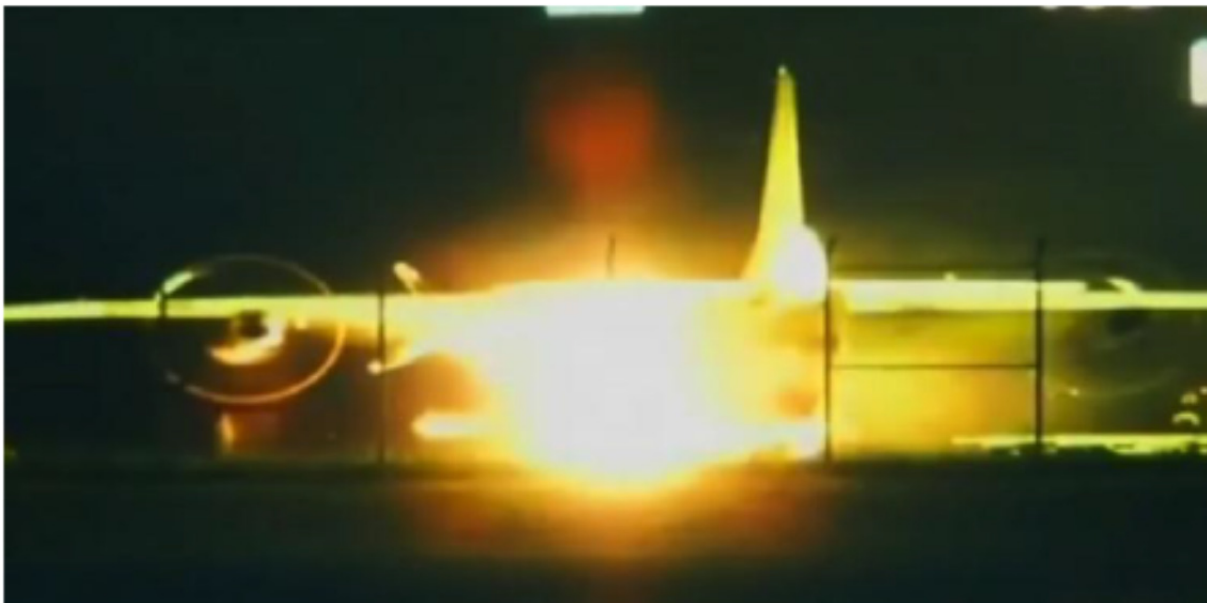
One photo (see Appendix) shows a glaring light on the left fuselage side. At this time propellers 1 and 4 were turning; propellers 2 and 3 stood still. Video recordings show fire in the area of the left main landing gear.

The fire developed very rapidly. Image 1 in the Appendix shows a glaring light which is probably the effect of deflagration due to the burning through of the combustion chamber described above.

Image 1: Eruption of the fire

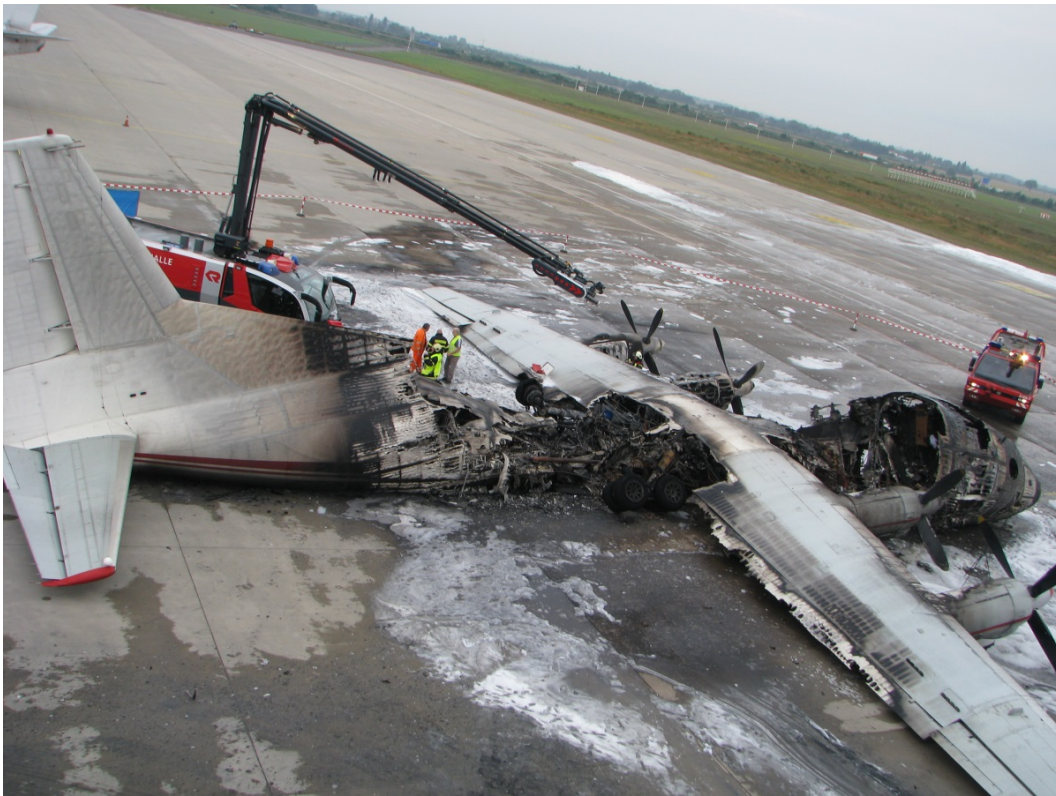
The airplane had burned out (Image 2). The wings and the tail section had fallen down. The cockpit area had been severed from the fuselage and was lying on its right side. The cargo compartment had burnt and melted, respectively, to the ground. Several light metal alloy components, such as aluminium and magnesium, had either completely melted or burnt, except for a few debris pieces.

Image 2: Burnt-out wreckage AN-12 BK

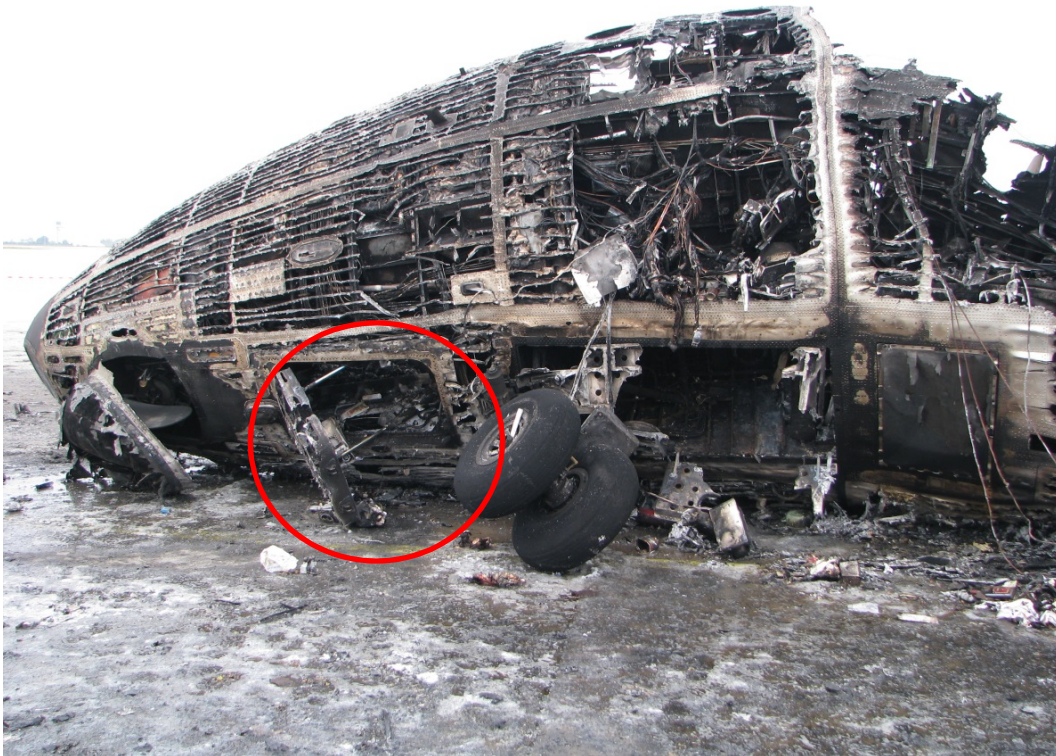
The emergency exit in the floor of the cockpit was open (Image 3).

Image 3: Emergency exit

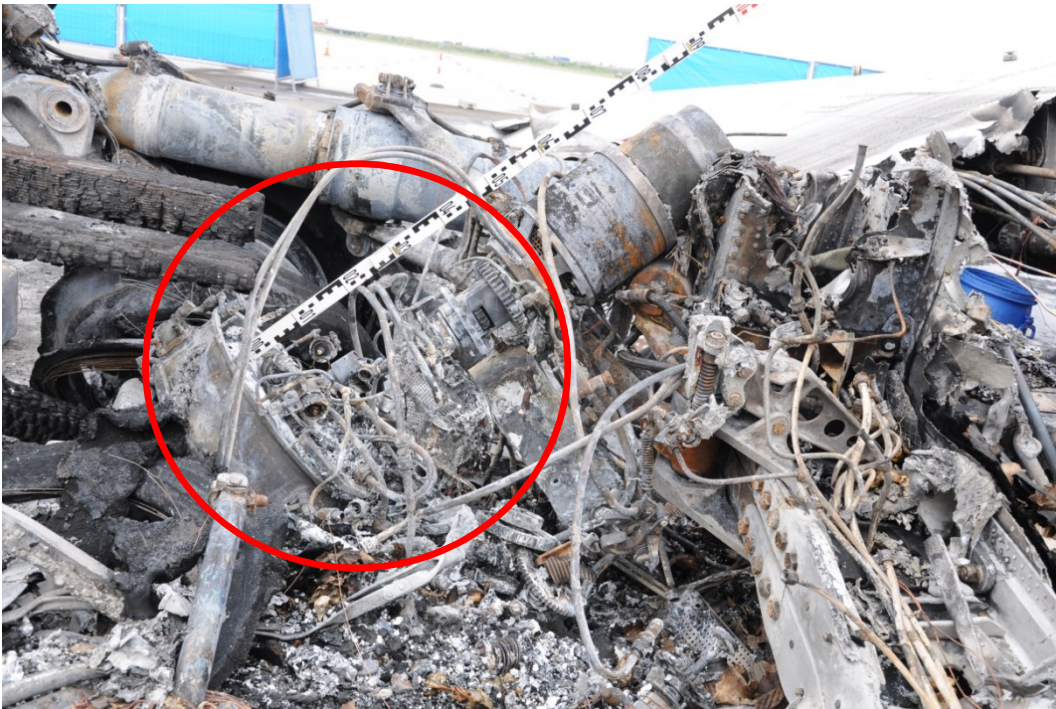
The gas turbine of the APU and gear wheels of the APU gearbox were salvaged from the wreckage and transported to the BFU for further examination (Image 4).

The Magnesium gearbox housing had burnt and melted, respectively, as had the light metal alloy compressor unit consisting of centrifugal compressor wheel and guide wheel.

Image 4: APU

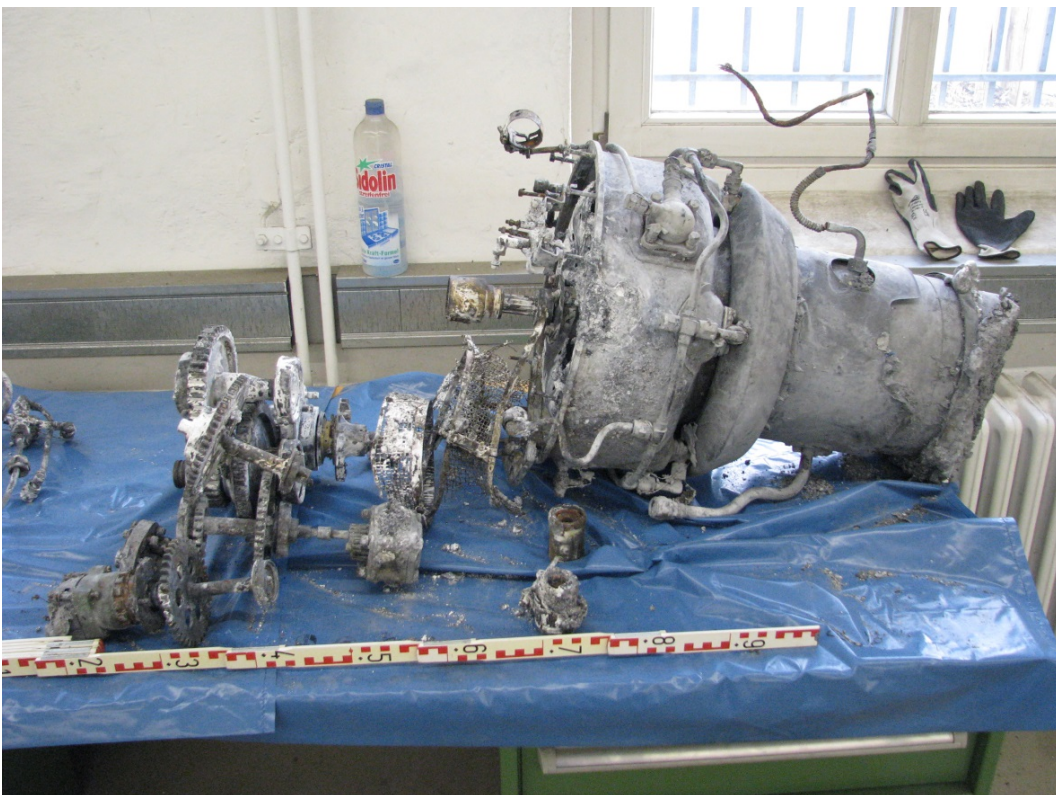
Using construction plans the APU gearbox was reconstructed with the gear wheels salvaged from the wreckage (Images 5 and 6).

Image 5: Gas turbine including APU gearbox gear wheels

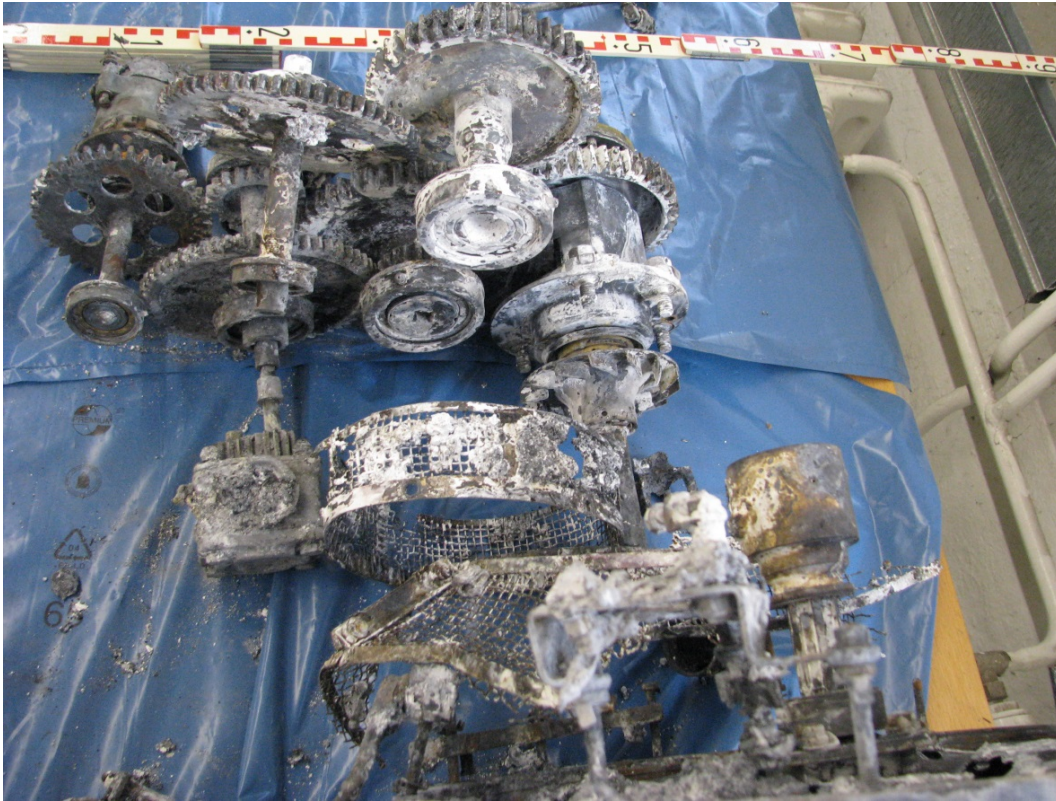
Image 6: Reconstructed APU gearbox; air intake grid (front)

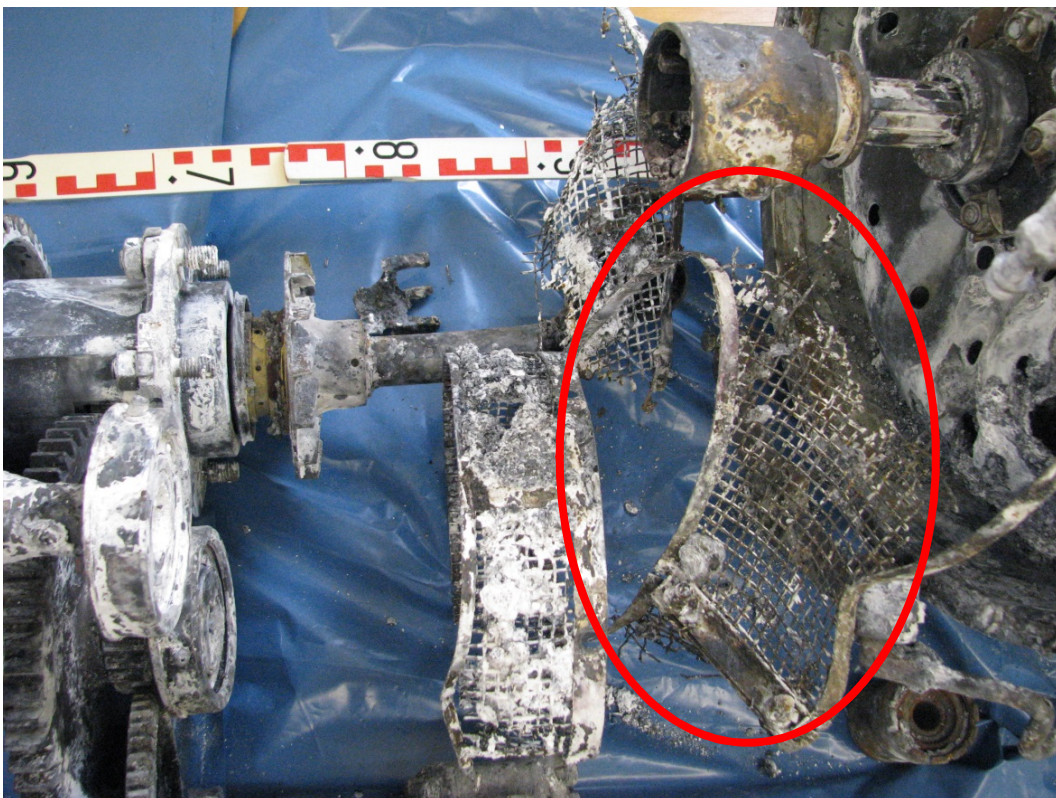
Image 7 depicts the two air intake grids. The cylindrical air intake grid faced the generator. In spite of the exposure it showed little damage and had mostly retained its original form. The conical air intake grid faced the centrifugal compressor. It was torn and bent. The compressor wheel and the guide wheel were missing. The bolts, which had connected the compressor with the combustion chamber, were almost completely preserved. On two bolts the bolt heads were missing (Image 8). Some areas of the combustion chamber of the gas turbine had burnt through. The turbine drive shaft and its bearing positions showed traces of fire. The turbine wheel was in the turbine housing and showed traces of fire. After dross and ash had been cleared from the exhaust, the turbine wheel could be moved somewhat but not turned.

Image 7: Air intake grid

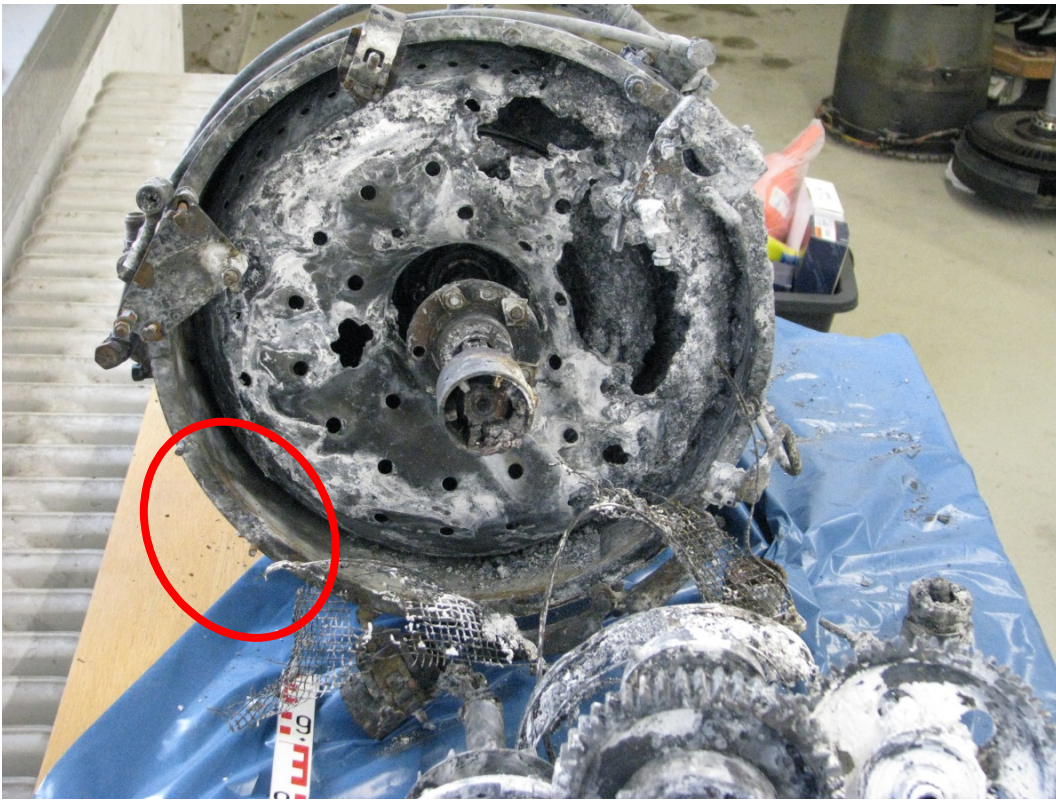
Image 8: Bolts without heads
