AIRCRAFT ACCIDENT REPORT AND EXECUTIVE SUMMARY

Reference:	CA18/2/3/9109	
Aircraft Registration	ZS-JHN	Date of Accident	25 November 2012		Time of Accident	0927Z
Type of Aircraft	Piper PA31		Type of Operation		Private	
Pilot-in-command Licence Type		Commercial Pilot	Age	30	Licence Valid	Yes
Pilot-in-command Flying Experience		Total Flying Hours	1699.5		Hours on Type	1.6
Last point of departure		Grand Central Aerodrome (FAGC) - Gauteng				
Next point of intended landing		Tzaneen Aerodrome (FATZ) - Limpopo				
Location of the accident site with reference to easily defined geographical points (GPS readings if possible)						
Corner Donovan and Austin Rd approximately 0.5nm north of Grand Central Aerodrome. S25°58' 41" E 028°08' 61"						
Meteorological Information		Wind: VAR/05 Temperature/Dewpoint : 19/08°C Cloud: SCT025 Visibility: >10km				
Number of people on board	1+0	No. of people injured	0	No. of people killed	0	
Synopsis						
<p>The pilot who was the sole occupant on board the aircraft departed on an IFR flight from FAGC to FATZ. After take-off he was cleared by Johannesburg Approach Control (Approach) to climb to F110 whilst climbing through F090, the left engine suddenly fai

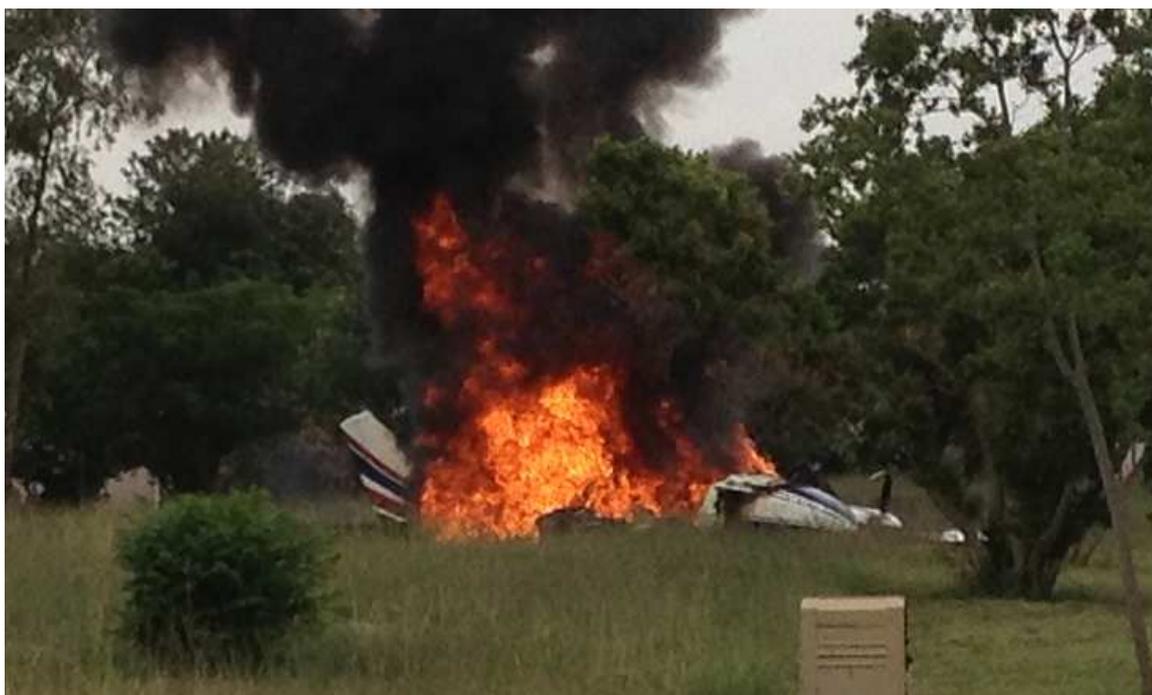
1.3.1 The fuselage and the right wing were completely destroyed in the fire. The right propeller broke off the engine while the aircraft was skidding across the field. The left wing and propeller suffered minor damages. There was no visible puncture on the left main and outboard fuel tanks

Picture 1 - Minutes after the crash

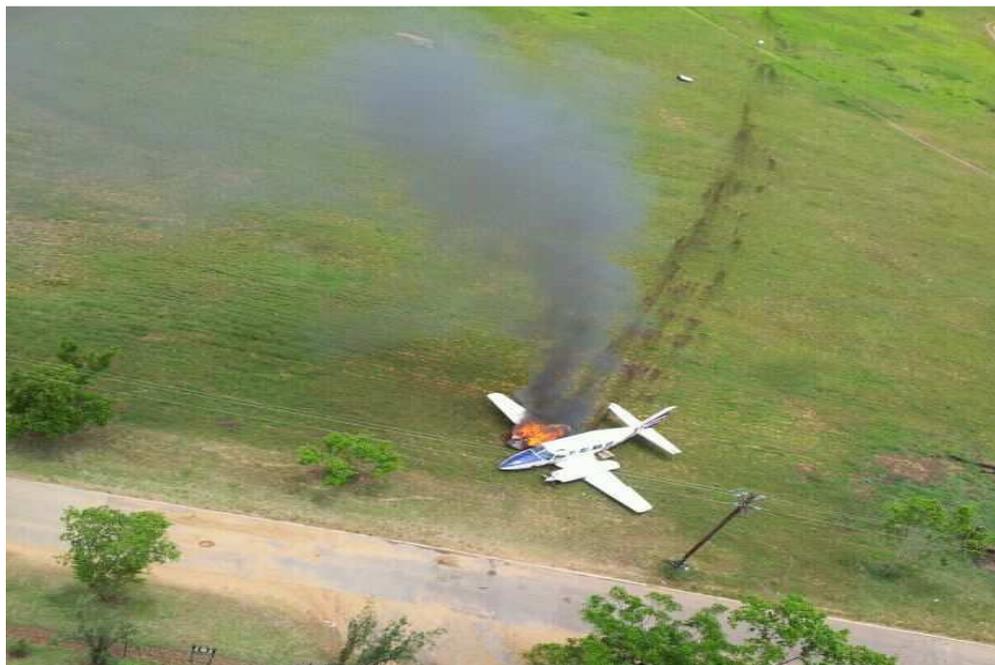
- 1.12.3 The fire which started in flight and continued until the aircraft came to a stop, completely destroyed the aircraft seconds after the pilot safely disembarked the aircraft.

Picture 2 - final stop and fire intensifying as taken from ZS-RMJ R22 flying in the vicinity

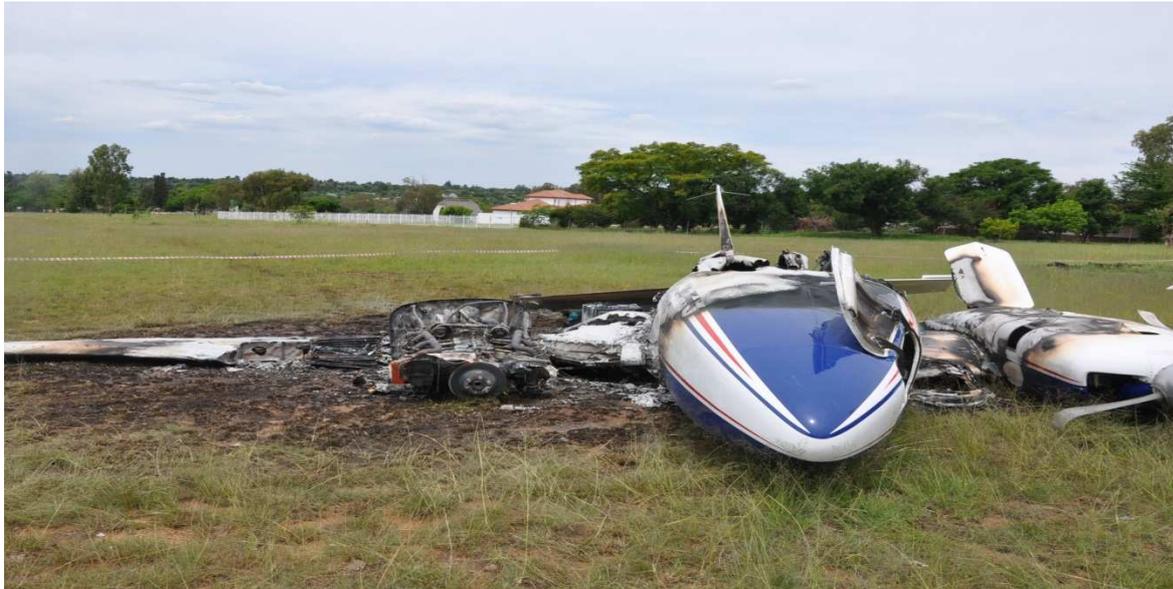
- 1.14.1 The pilot first noticed the fire in flight through the cooling vents of the right engine cowling. The origin of the fire in the engine is still not determined.
- 1.14.2 After the aircraft came to stop the pilot was unable to put out the fire because of its intensity and the size of the fire extinguisher, 1kg. Within minutes the fire spread through the whole right wing and the fuselage.
- 1.14.3 The FAGC fire department took some time to find the entry to the enclosure which was not far from the airport, two vehicles arrived 5 to 10 minutes after the accident occurred and completely extinguished the fire in 3 to 4 minutes.

Picture 3 – Aircraft was almost completely destroyed by fire
