ACCIDENT

Aircraft Type and Registration:	Raytheon 390, Premier I, G-OOMC	
No & Type of Engines:	2 Williams International FJ44-2A turbofan engines	
Year of Manufacture:	2005 (Serial no: RB-146)	
Date & Time (UTC):	12 March 2015 at 1148 hrs	
Location:	Blackpool Airport, Lancashire	
Type of Flight:	Commercial Air Transport (Passenger)	
Persons on Board:	Crew - 2	Passengers - 2
Injuries:	Crew - None	Passengers - None
Nature of Damage:	Damaged beyond economic repair	
Commander's Licence:	Airline Transport Pilot's Licence	
Commander's Age:	34 years	
Commander's Flying Experience:	3,455 hours (of which 408 were on type) Last 90 days - 85 hours Last 28 days - 29 hours	
Information Source:	AAIB Field Investigation

Synopsis

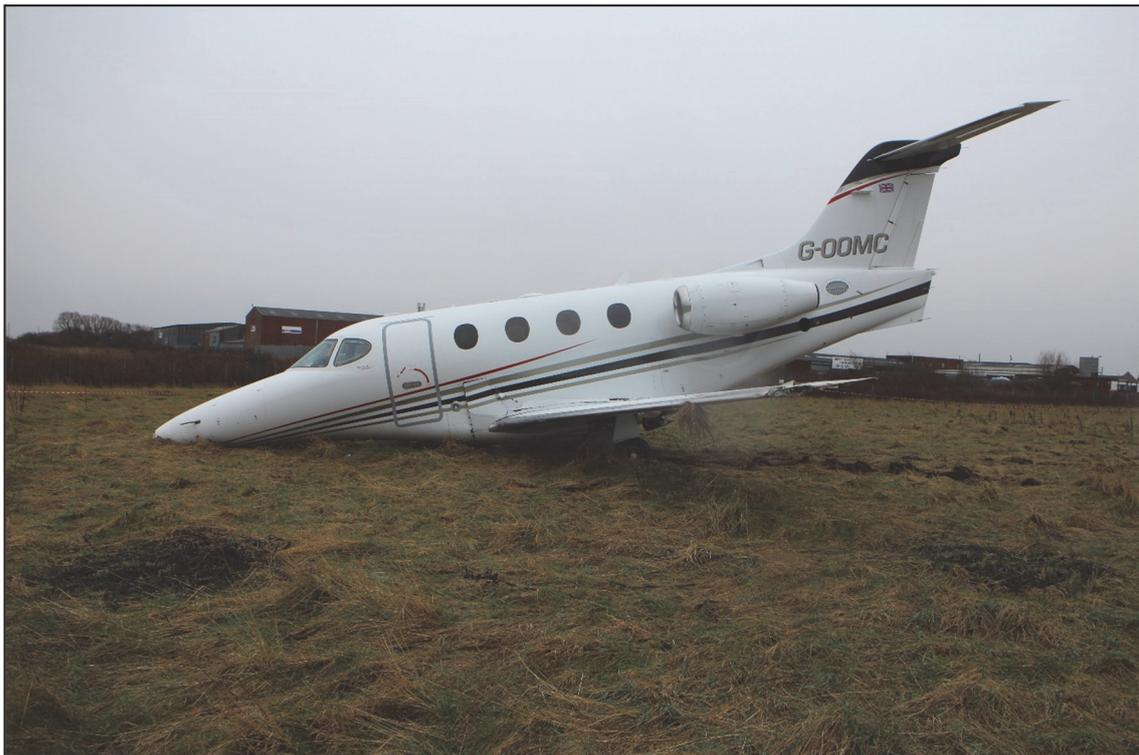
Figure 1
G-OOMC post-accident

The emergency brakes, although available, were not applied during the landing and the aircraft overran the runway at about 80 kt and was extensively damaged. The occupants, who were uninjured, evacuated without assistance.

Marks on the runway showed that the main landing gear (MLG) inboard doors remained extended throughout the landing, suffering edge abrasion damage as a result. The aircraft travelled approximately 123 m beyond the runway paved surface, during which the nose landing gear collapsed and the nosewheel detached.

Prior to coming to a halt, the left wingtip was driven into the ground, deflecting the aircraft from its path. The four wing-to-fuselage mounting forgings were damaged and, in three cases, had fractured. The wing was displaced to the right, indicated by extensive root fairing and inboard flap track damage.

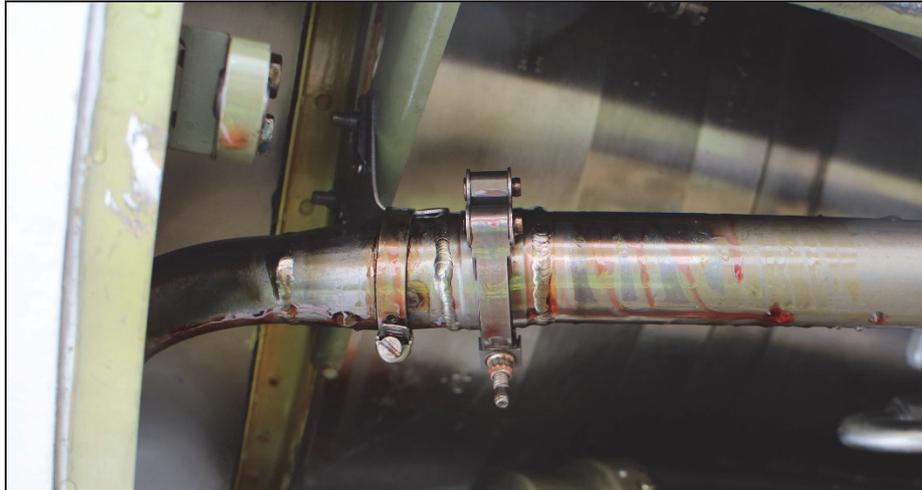
Figure 3

Subsequent examination found evidence of a hydraulic fluid leak within the left engine nacelle, in the vicinity of the hydraulic pump. Hydraulic fluid had congealed and accumulated on the engine bleed air pipe, on surrounding pipes and surfaces, and at the bottom of the lower panel. The engine casing and components attached to the lower portion of the engine were covered in a thin film of hydraulic fluid (Figure 3). The hydraulic reservoir was empty, but a small amount of residual fluid was present in the filter housings and the bottom of the assembly. The filter blockage indicators had not 'popped' and the fluid and filters were found in a clean and uncontaminated condition.

Hydraulic system leak spray dispersion within the left engine nacelle

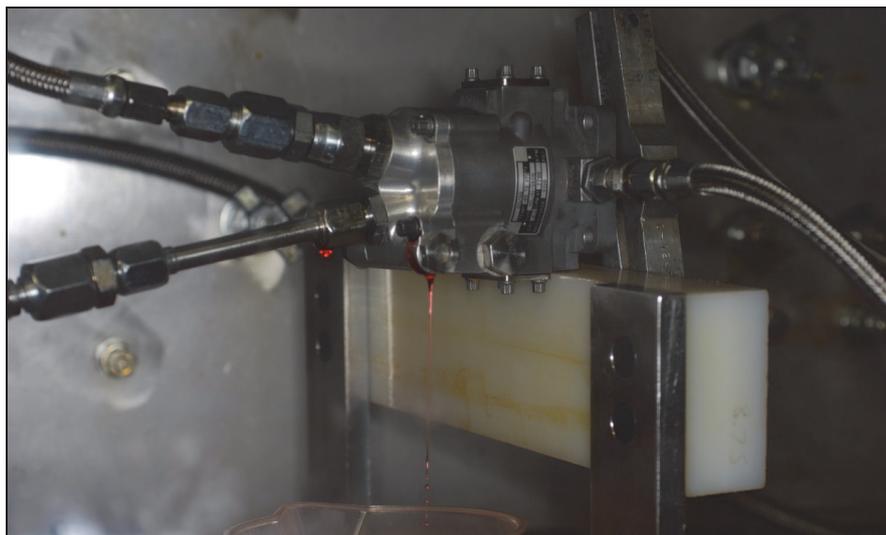
The left hydraulic pump and associated pipework were tested at the system working pressure. During the test a constant leak was visible in the vicinity of the pressure compensator⁷ assembly chamber plug on the port cap of the pump.

Further testing was performed by the manufacturer in the US, under the supervision of the NTSB Accredited Representative. Figure 4 shows the pump under test leaking hydraulic fluid.

Hydraulic pump leaking under high pressure (3,000 psi) test
(Photo courtesy of the NTSB)

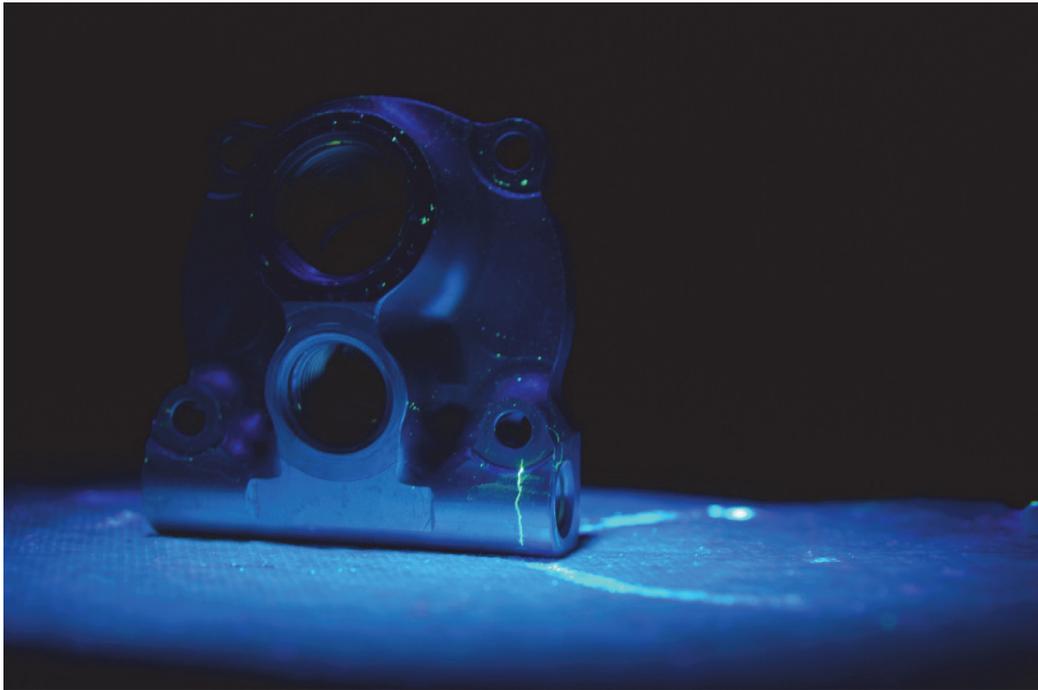
Figure 5

The leak was emanating from a crack surrounding a threaded hole for the compensator plug fitting in the port cap. A steady stream of hydraulic fluid leaked from the crack and 50 ml was collected over a two-minute period. The crack was enhanced by dye penetrant and is shown in Figure 5.

Crack in the port cap shown with dye penetrant under UV light
(Photo courtesy of the NTSB)

Detailed laboratory testing was carried out on the port cap structure and fracture. This showed that the port cap was of the correct material specification. Examination of the fracture area revealed multiple-origin fatigue cracking from a thread root inside the bore which had propagated to the outer surface of the port cap. The thread root, from which the crack originated, was mid-way down the bore and its trough radius was found to be 0.003 inch. There was also evidence of pitting on the thread root and adjacent surfaces.

The multiple-origin cracking found in the port cap by the laboratory testing had propagated from a thread root in the bore to the outer surface of the cap. It is not known how long the crack had been propagating for, but it is likely that the crack broke the surface of the cap relatively recently, allowing the leakage of fluid outwards under pressure from within the pump. The excessive pitting at the root of the thread is likely to have initiated the fatigue crack, with the thread root radius as a contributory factor. The load imparted into the thread by the compensator plug fitting places the thread under a constant tensile stress when the pump is operating, leading to the eventual fatigue failure.

The pump manufacturer is taking action to replace the port caps from the batch of port caps processed by the outside non-destructive testing (NDT) vendor which have excessive pitting. Service Bulletin 66179-29-486 is being issued to replace port caps with serial numbers 0057 to 0099 with port caps manufactured under the current process which do not have excessive pitting.
