# Runway overrun involving an Aero Commander 500, VH-WZV

Badu Island (ALA), Queensland, 8 March 2015

**ATSB Transport Safety Report**  
Aviation Occurrence Investigation  
AO-2015-028  
Final – 10 June 2015

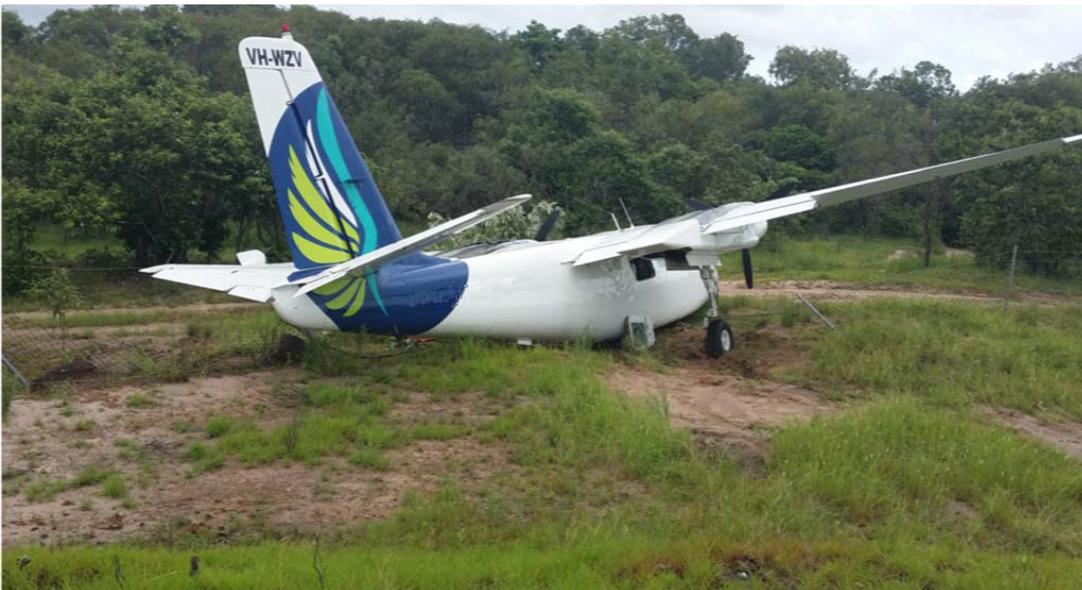
**Figure 1: Damage to VH-WZV**

The pilot initially assessed that there was sufficient runway remaining to stop on but, due to the wet runway surface, the aircraft did not decelerate as quickly as expected and he anticipated that the aircraft would overrun the runway. As there was a steep slope and trees beyond the end of the runway, he steered the aircraft to the right towards more open and level ground. The aircraft departed the runway to the right, collided with a fence and a bush resulting in substantial damage (Figure 1). The pilot and passengers were not injured.
