National Transportation Safety Board Aviation Accident Final Report

Location: San Bernardino, California Accident Number: WPR16LA101

Date & Time: May 6, 2016, 12:00 Local Registration: N2AN

Aircraft: Antonov AN2 Aircraft Damage: Substantial

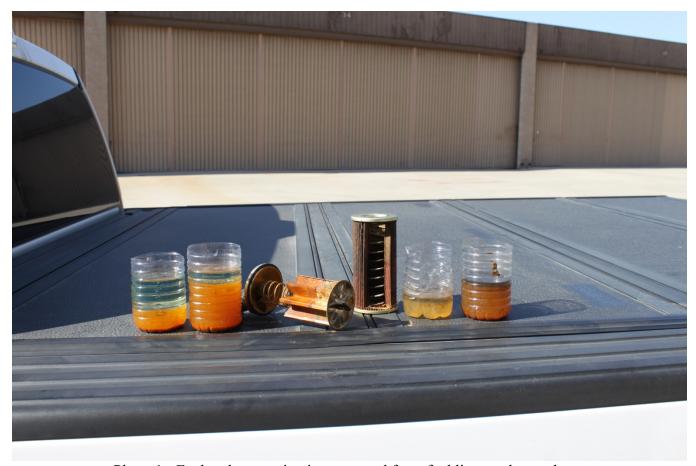
During the postaccident examination of the airplane, about 16 ounces of water were removed from the fuel system. Water was present in the lower gascolator, the fine fuel filter (upper gascolator), and subsequent fuel line to the carburetor inlet. A brass screen at the carburetor inlet and 2 carburetor fuel bowl thumb screens also contained corrosion, water, and rust.

The mechanic's failure to inspect the fine fuel filter gascolator as required during the most recent inspection, which resulted in a total loss of engine power due to fuel contamination.

During the NTSB examination of the airplane, about 16 ounces of water was removed from the fuel system. Water was present in the lower gascolator, the fine fuel filter (upper gascolator), and subsequent fuel line to the carburetor inlet. A brass screen at the carburetor inlet and 2 carburetor fuel bowl thumb screens also contained corrosion, water and rust. (See Photo 1.)

Photo 1 - Fuel and contamination removed from fuel lines and gascolator
