# National Transportation Safety Board Aviation Accident Final Report

<b>Location:</b>	Chariton, Iowa	<b>Accident Number:</b>	CEN16FA361
<b>Date &amp; Time:</b>	September 7, 2016, 12:19 Local	<b>Registration:</b>	N465JM
<b>Aircraft:</b>	Piper PA 46-310P	<b>Aircraft Damage:</b>	Substantial
<b>Defining Event:</b>	Loss of control in flight	<b>Injuries:</b>	1 Fatal
<b>Flight Conducted Under:</b>	Part 91: General aviation - Personal

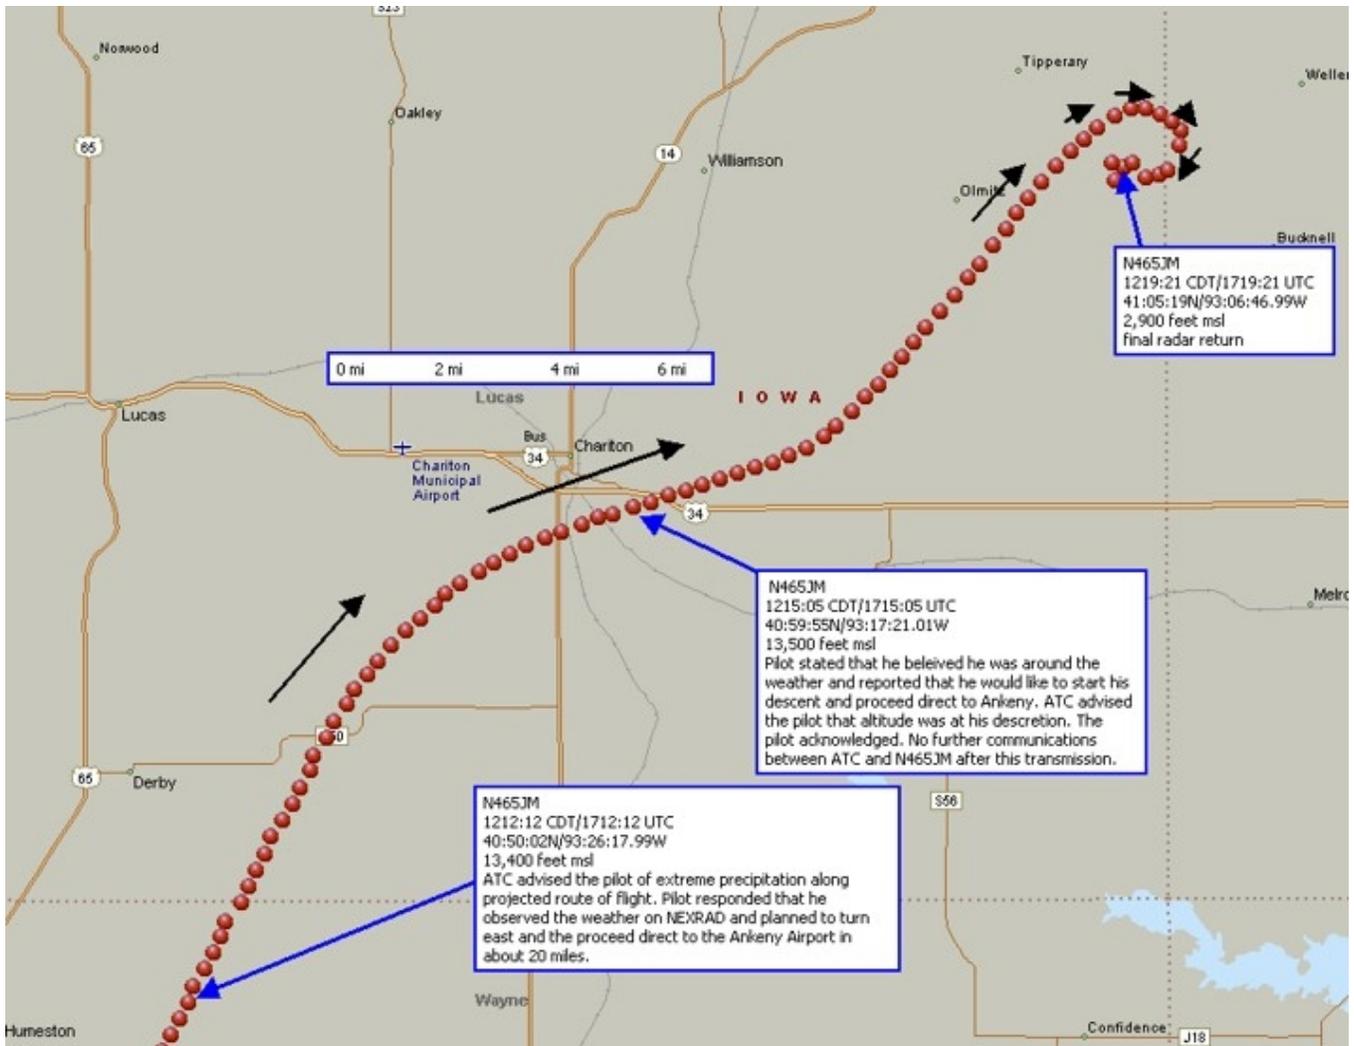
According to radar data and air traffic control communications information from the Federal Aviation Administration (FAA), the pilot was receiving visual flight rules (VFR) flight following from the Chicago Air Route Traffic Control Center (ARTCC) at a cruise altitude of 13,500 ft mean sea level (msl). The pilot had deviated around convective weather earlier in the flight and was proceeding direct to IKV. The controller issued a weather advisory to the pilot about areas of moderate to extreme precipitation along his route, and the pilot responded that he had weather information on the airplane's NEXRAD system. About 3 minutes later, the pilot reported to the controller that he was around the weather and requested to start a descent direct to IKV. The controller responded that the descent altitude was at the pilot's discretion, then instructed the pilot to contact Des Moines Air Traffic Control Tower. The controller received no response from the pilot, and subsequent attempts to contact him were unsuccessful. Radar data showed the airplane making a descending right turn before radar contact was lost (Figure 1). The last radar return showed the airplane about 2,900 ft msl.

Figure 1. The radar flight track of N465JM is indicated by red dots. The direction of flight is indicated by black arrows.

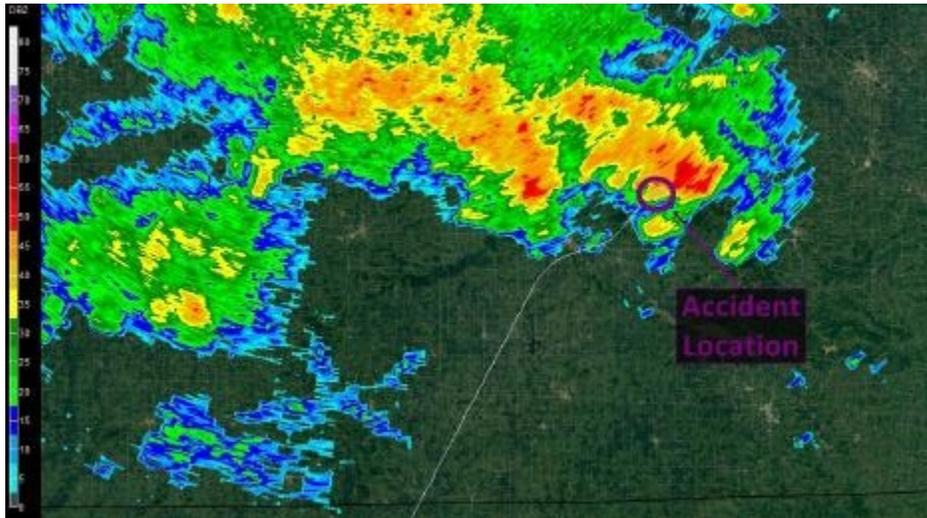
Given the pilot's discussions with ATC during the flight, the pilot was aware of and was trying to avoid convective weather along his route of flight. The airplane most likely would have encountered instrument meteorological conditions (IMC) during the last several minutes of flight. Figure 2 shows the airplane's flight path into storms. Additional details can be found in the weather study in the docket.

Figure 2. Level-II reflectivity product from a sweep initiated at 1223:06 CDT. Accident flight path through the accident time denoted by white line with accident location marked.

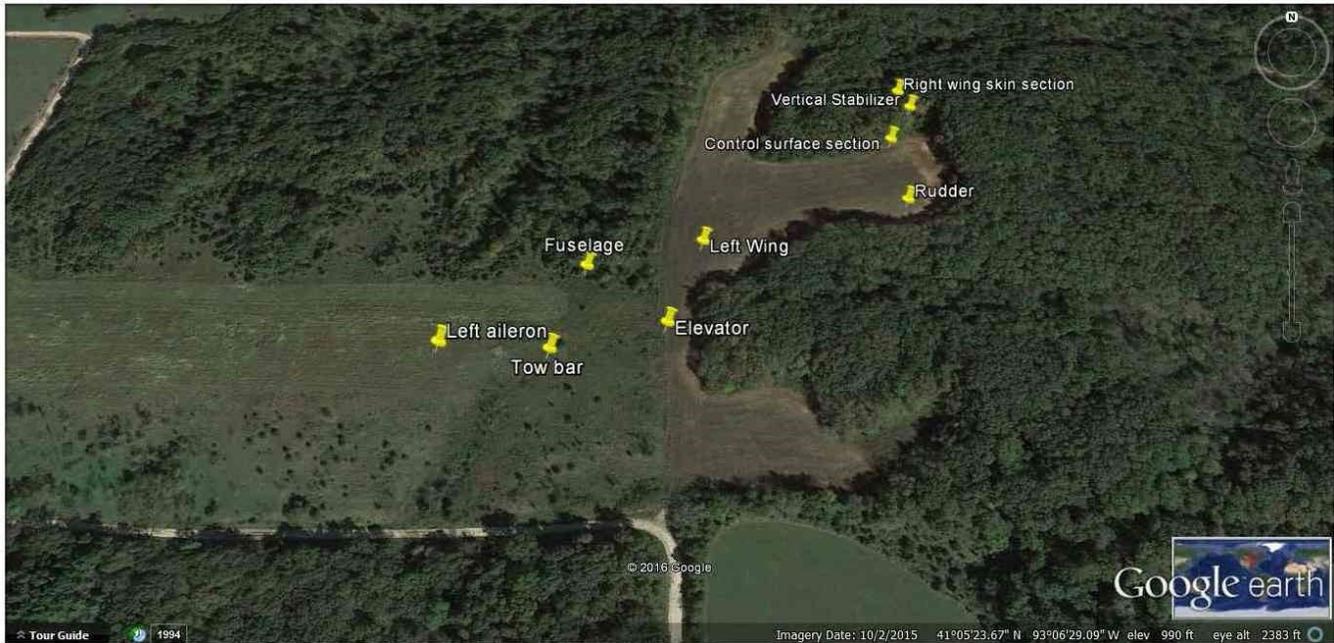
Figure 3. Wreckage Distribution

The airplane impacted a mature corn field, and components of the wings and empennage were scattered along a path about 1/4-mile long (see figure 3). The main wreckage (cabin and fuselage) came to rest along a stand of trees adjacent to the corn field. The distribution of the wreckage was consistent with an in-flight breakup.
