# National Transportation Safety Board Aviation Accident Final Report

<b>Location:</b>	Tampa, Florida	<b>Accident Number:</b>	ERA16FA133
<b>Date &amp; Time:</b>	March 18, 2016, 11:30 Local	<b>Registration:</b>	N6239X
<b>Aircraft:</b>	Cessna 340	<b>Aircraft Damage:</b>	Destroyed
<b>Defining Event:</b>	Abrupt maneuver	<b>Injuries:</b>	2 Fatal
<b>Flight Conducted Under:</b>	Part 91: General aviation - Personal

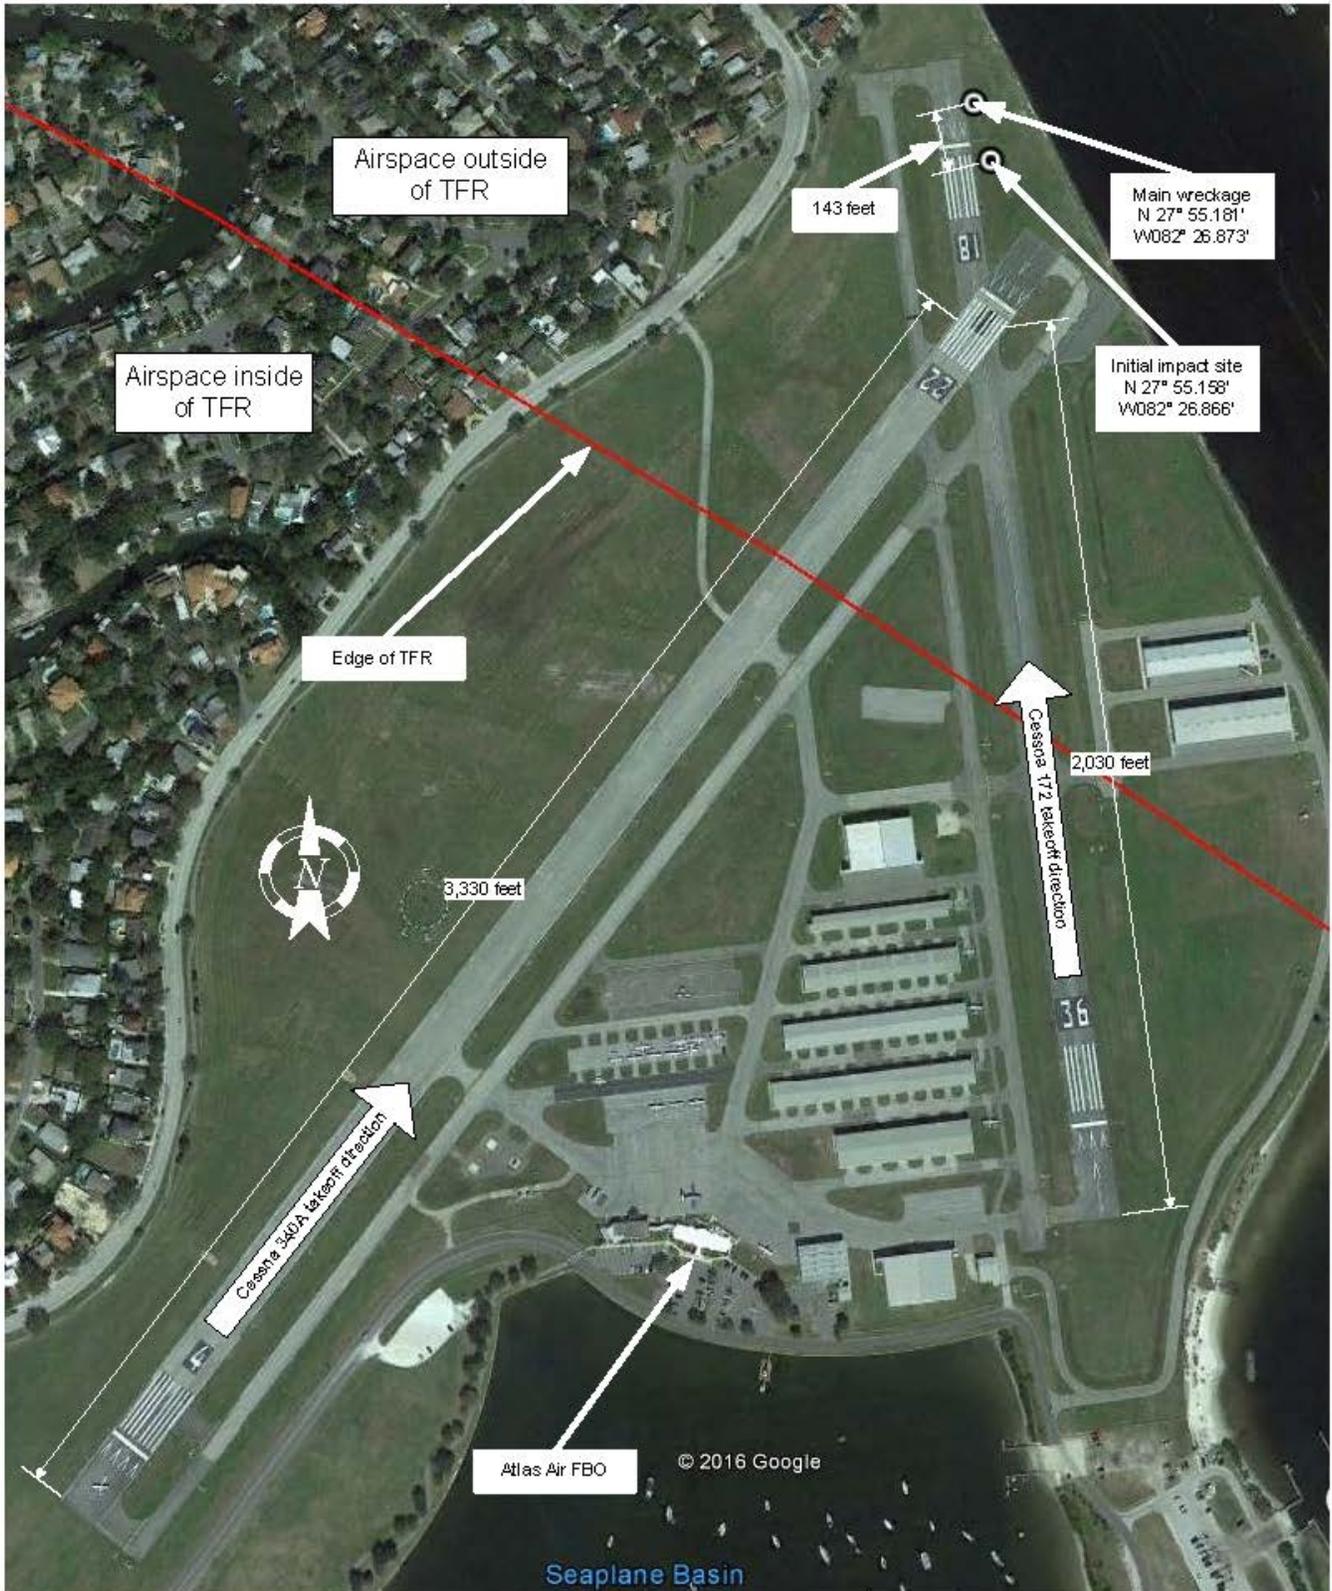
Figure - Airport and Accident Site Diagram

"screaming engine noise," which caused him to look toward the two airplanes. He saw that a "twin engine plane was behind and below the single engine plane." The twin engine airplane was in a left turn; it then caught a wing and slammed into the ground with an "instantaneous" explosion. He also indicated that the airplanes were so close that he thought they would collide (The figure below shows the airport diagram and accident site location).

Examination of the accident site revealed that the Cessna 340A impacted flat terrain about 40 ft to the right of and 250 ft from the departure end of runway 36. The initial ground scars indicated a magnetic heading of about 10°. The wreckage came to rest upright, and both engines were separated from the wings. The right engine was located between the beginning of the wreckage path and the main wreckage, and the left engine was laying on the right wing.
