Kodiak-100 N642RM Draft Report Courtesy Translation

INTERSTATE AVIATION COMMITTEE

FINAL REPORT

Type of occurrence	Accident
Type of aircraft	Airplane, Kodiak-100
Registration	N642RM
Owner	Apelsin-T, LLC
Aviation Administration of place of occurrence	Rosaviatsia ITO AT for North-West Regions
Aviation Administration of the aircraft registration	FAA (USA)
Place of occurrence	1400 m southward of Pskov aerodrome ARP Coordinates: N 57°46,263', E 28°23,578'
Date and Time	06.07.2015, 13:18 UTC, 16:18 local time, day

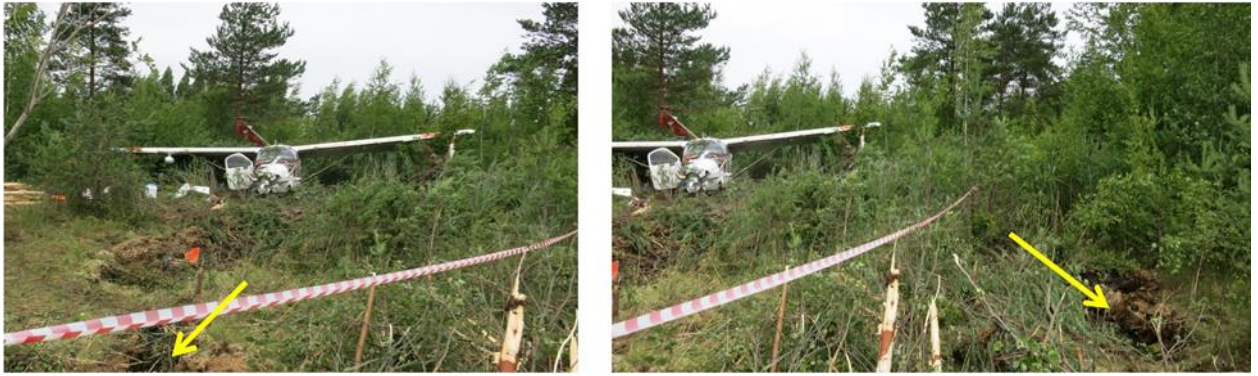
Initially, the aircraft hit a tree (birch) occurred at a height of 6 m; moving further it hit three more individual trees (pine trees). At a distance of 37 m from the initial impact place, the aircraft hit the ground with RH MLG and with RH wingtip having MH $\approx 330^\circ$, right bank not less than 30° , nose-up angle $\approx 5^\circ$, and a small forward speed of $\approx 80\div 100$ km/h (see Figure 5).

Figure 5. Initial impact by RH MLG (left) and by RH wingtip (right)

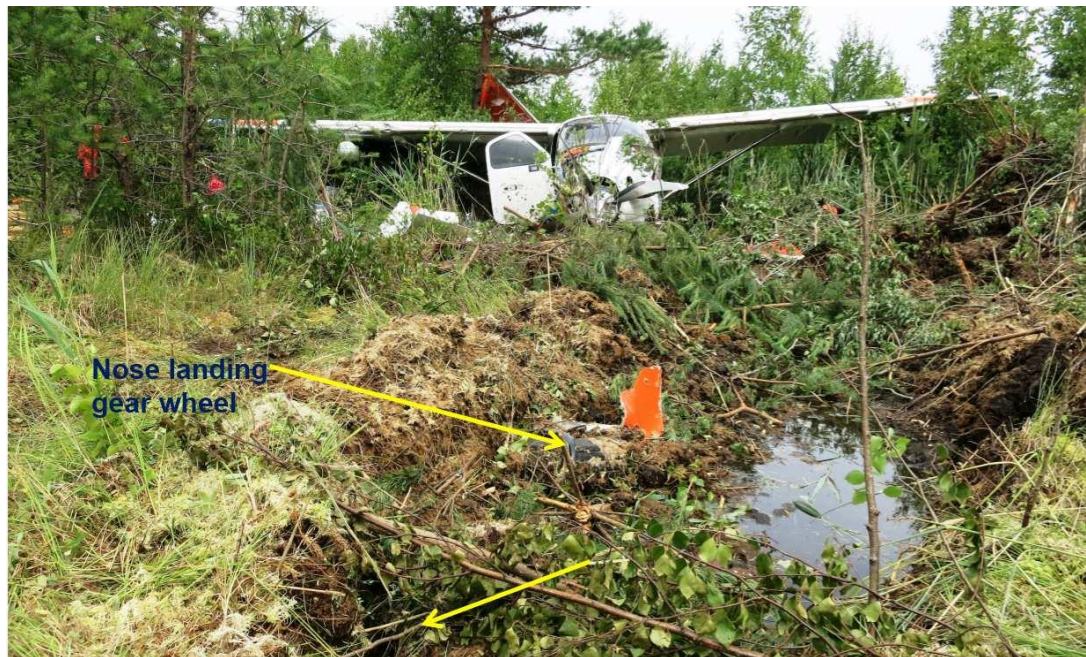
During its further movement the aircraft hit the ground with its NLG, which was destroyed by that (see Figure 6).

Figure 6. Footprint of hitting ground with NLG (see arrows)

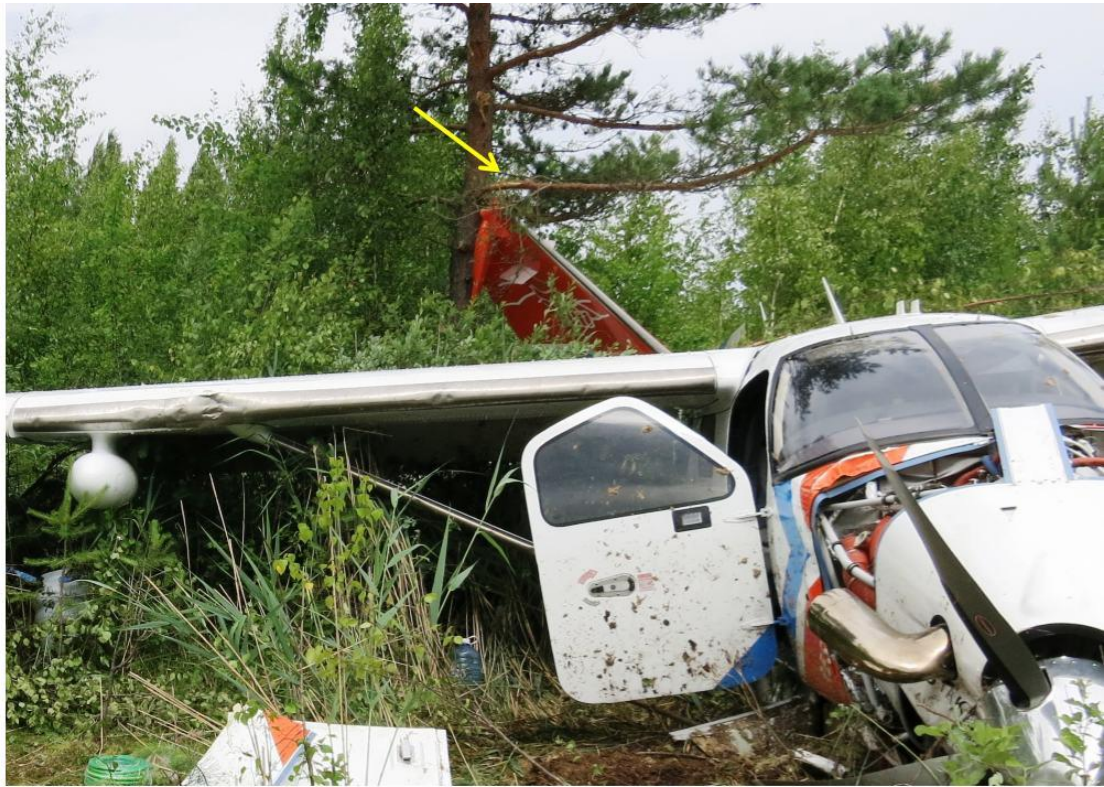
After the aircraft with ground collision, it started its right (clockwise) rotation. The rotation stopped after the fuselage tail section hit the pine tree (see Figure 7); at that, the aircraft was turned around, almost opposite to its flight direction.

Figure 7. With pine tree collision

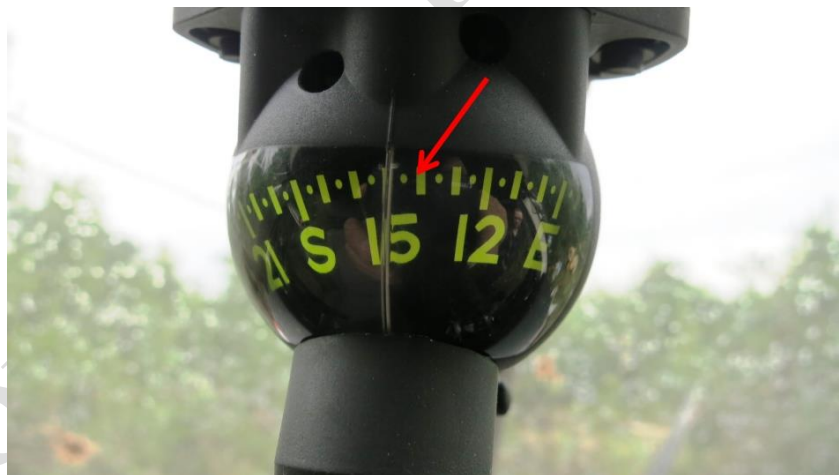
At the accident site the aircraft was disposed at the fuselage with $MH=150^\circ$ and with right bank (see Figure 8).

Figure 8. Magnet compass indication in the cockpit after the accident

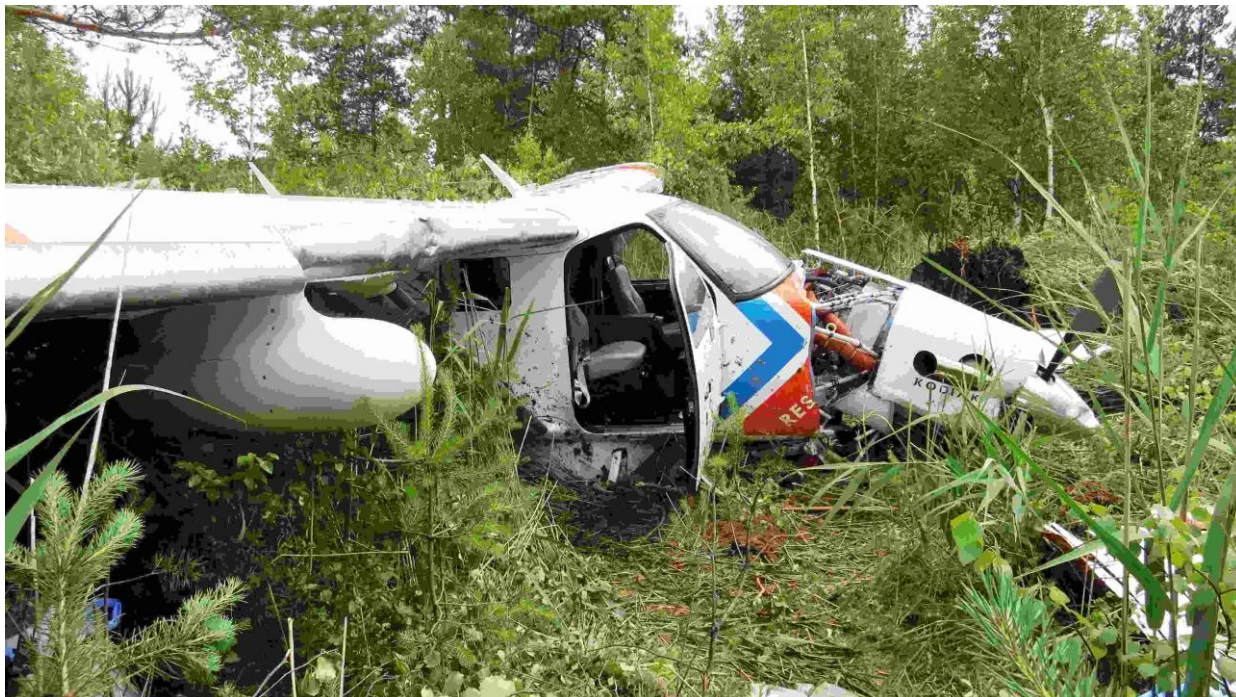
When collided with trees and with ground, off-design impact forces affected the aircraft. With that, the underbelly (baggage compartment) and fuselage tail part were destroyed; the tailfin, stabilizer and elevators were warped and destroyed; the engine bed was malformed and the engine was displaced.

Figure 9. Accident site. View to the aircraft from its RH side

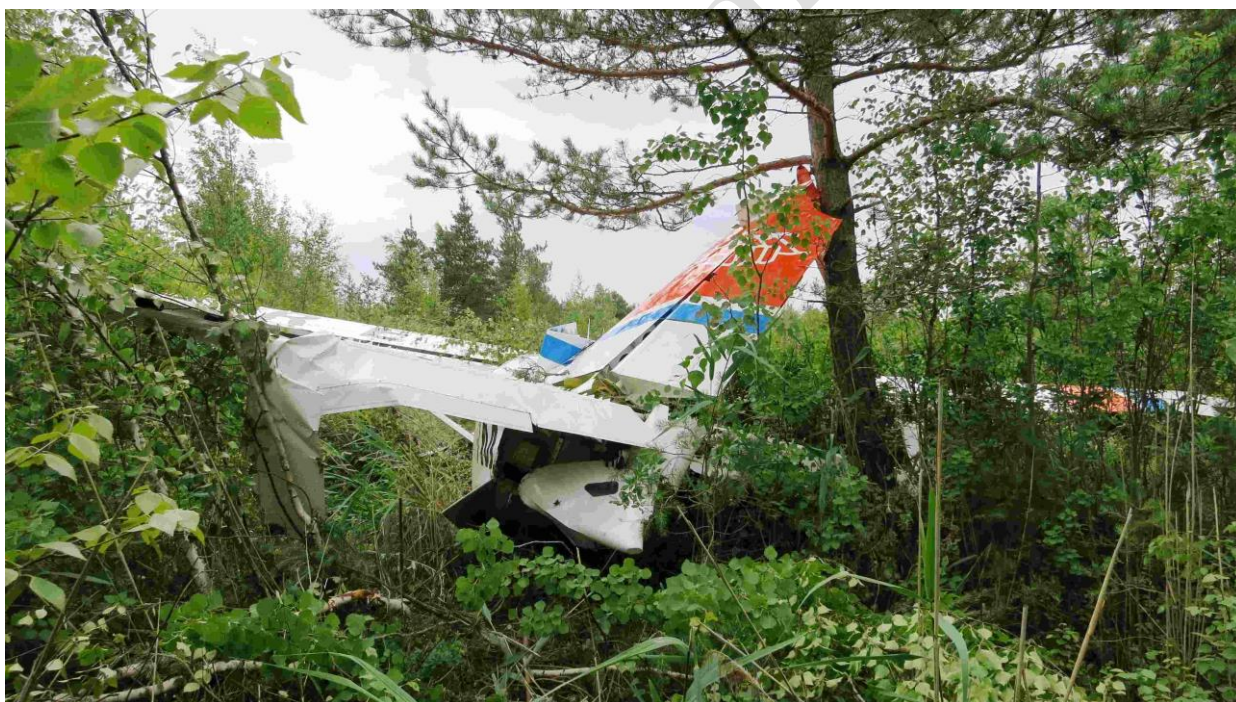
Figure 10. Accident site. View to the aircraft from its back

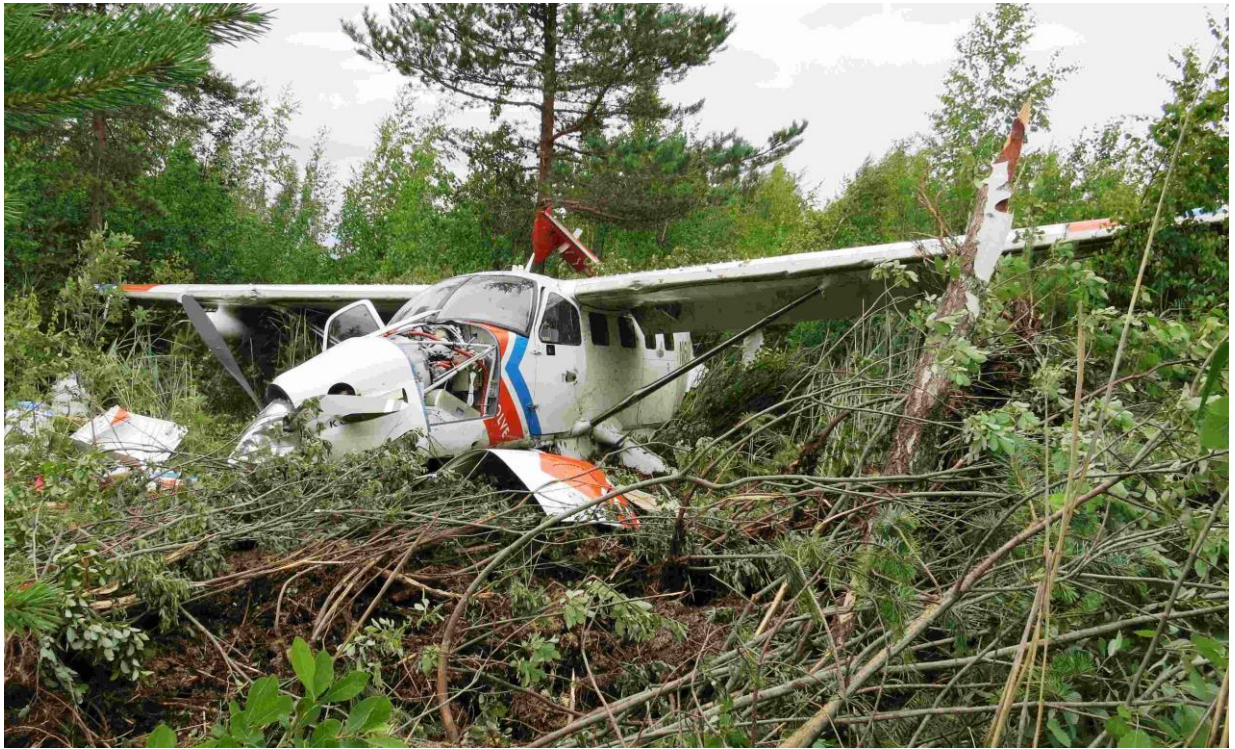
Figure 11. Accident site. View to the aircraft from its LH side

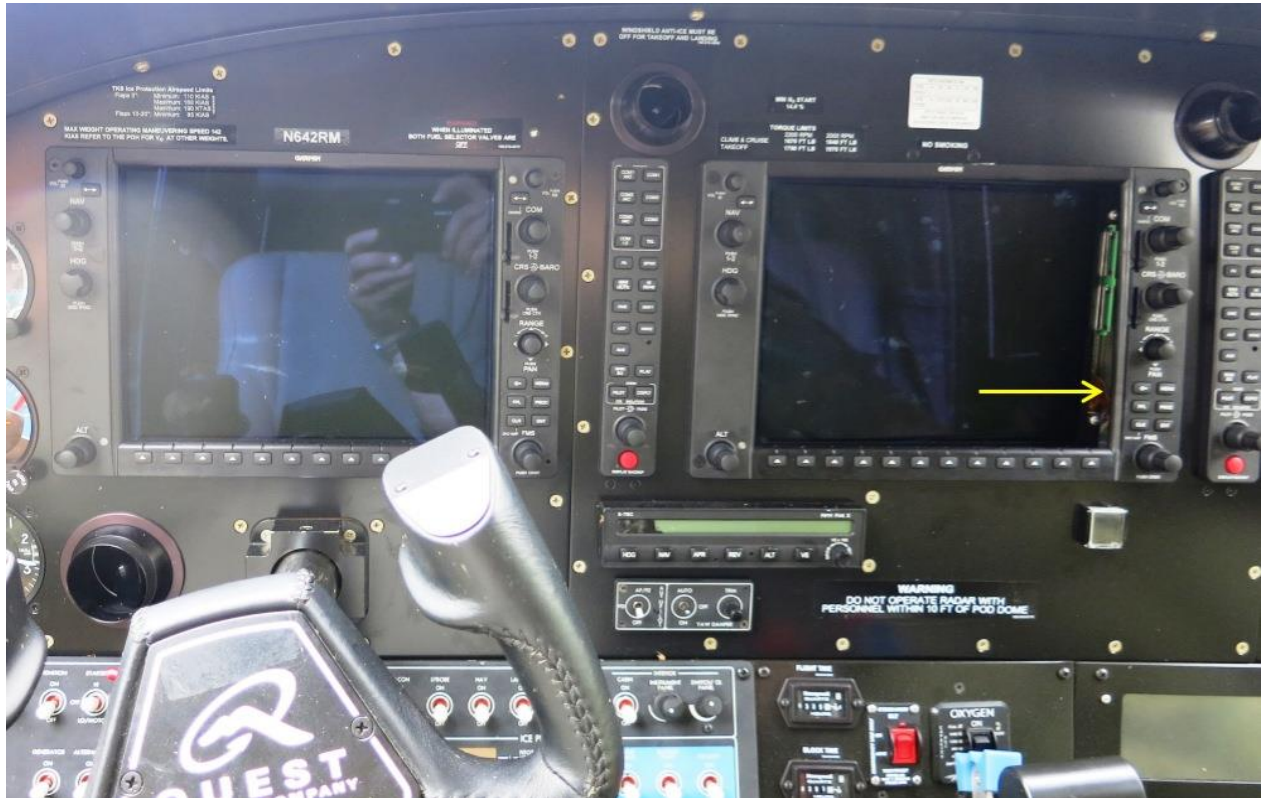
During the aircraft cockpit inspection it was determined that the central FDIS Garmin G-1000 display had received its damage in course of the accident; the display right side was shifted towards the power plant at approximately 15 mm (see Figure 14).

Figure 14. FDIS Garmin G-1000 display – after the accident. The amber arrow shows the shift

It doesn't contain any SD data card. The Investigation team failed to find out the missing data cards inside the cockpit and inside the aircraft cabin. They might have been thrown out of the aircraft cockpit in course of the aircraft with trees collision.

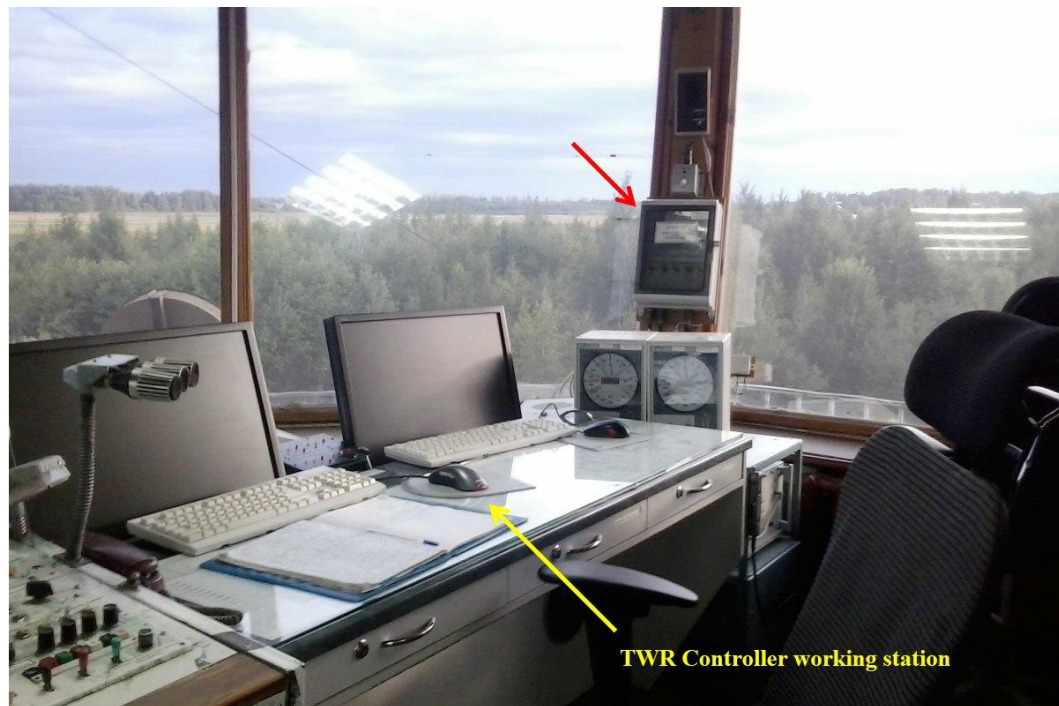
The Investigation team underlines that there was no possibility for TWR controller to see the entire RWY from his working station because there are trees and bushes located between TWR and RWY (see Figures 16 and 17).

Figure 16. View to the north threshold of RWY 19 (red arrow) from TWR controller working station. Threshold is partly covered with trees and bushes

5.3. To Pskov unit "Pskov-Aerocontrol" of North-West office of FSUE State ATM Corporation: to provide TWR controller with visual observation conditions at his working station.

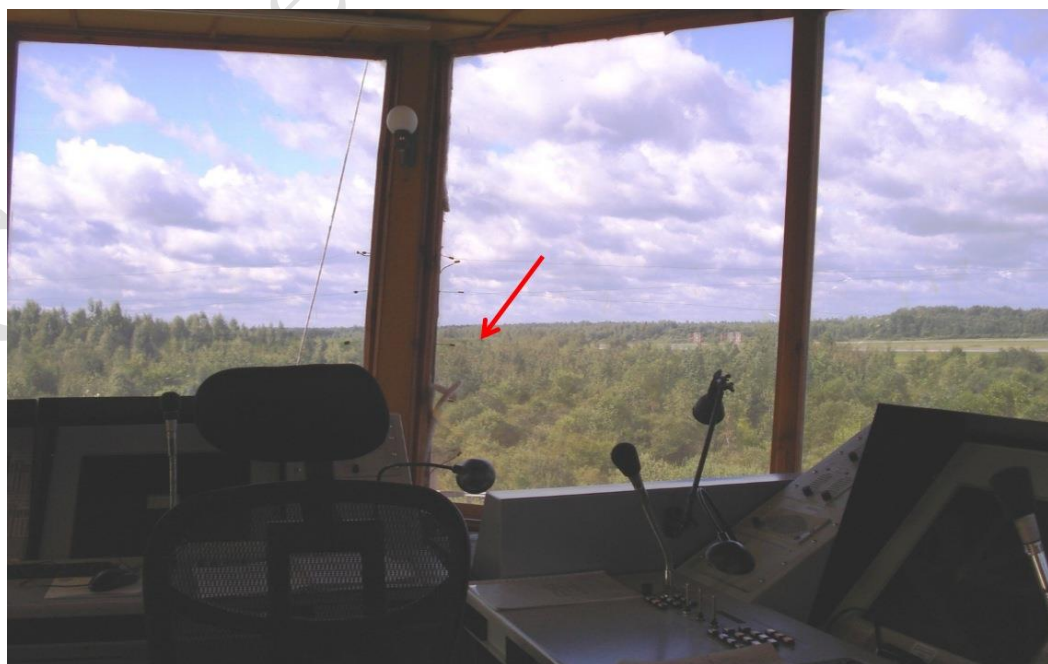
Figure 17. View to the north threshold of RWY 01 (red arrow) from TWR controller working station. Threshold is covered with trees and bushes

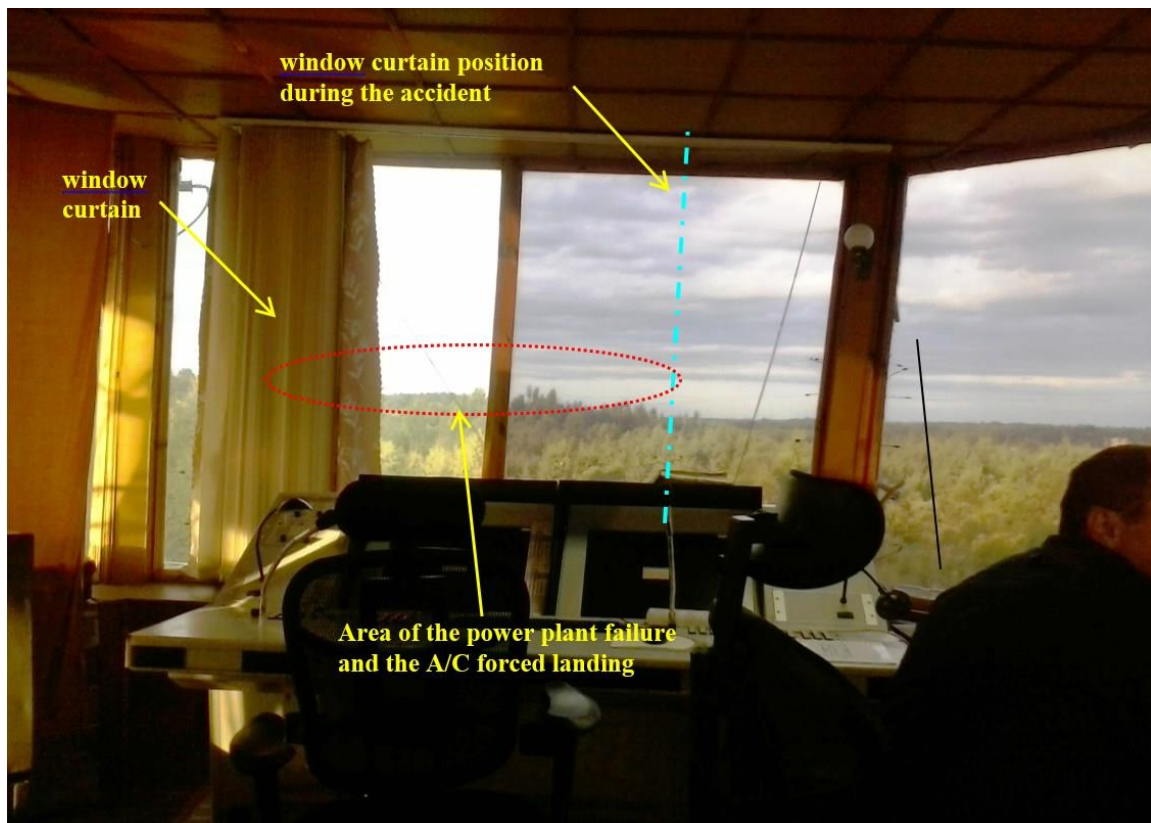
However, in this case, when the engine failed and the flight crew performed a forced landing, TWR controller had no ability to see the aircraft because it was shielded by the curtain, which was covering an angle of view of the accident site (see Figure 19).

Figure 19. TWR controller angle of view of the accident site restricted by a curtain
