National Transportation Safety Board Aviation Accident Final Report

Location:	SAVANNAH, Georgia	Accident Number:	ERA16LA082
Date & Time:	January 6, 2016, 08:35 Local	Registration:	N978AF
Aircraft:	PILATUS AIRCRAFT LTD PC-12	Aircraft Damage:	Substantial
Defining Event:	Flight instrument malf/fail	Injuries:	2 Minor
Flight Conducted Under:	Part 91: General aviation - Positioning

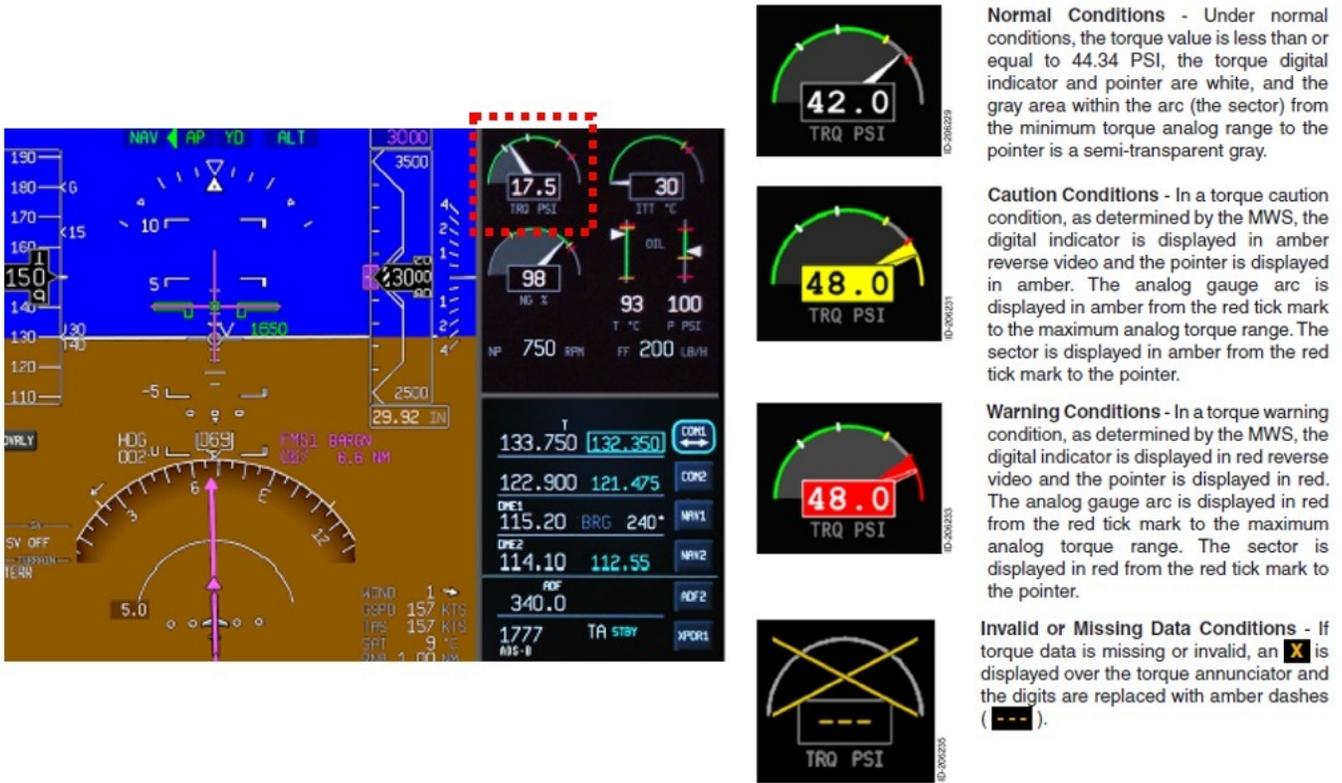
The torque and engine temperature indications in the cockpit were depicted with pointer-type display gauges and digital values (see figure 1). During normal operations, all digital values were displayed in white against a black background. The torque analog scale range was from 0 to 55 psi and the digital scale range was from 0 to 70 psi. Two white torque tick marks were on the analog scale at 15 psi and 25 psi. An amber tick mark at 36.95 psi indicated maximum climb/cruise torque, and a red tick mark at 44.34 psi indicated maximum continuous torque. A green arc on the torque gauge from 0 psi to the

amber tick mark indicated normal operating torque range and beyond the amber tick mark, the gray arc is the maximum torque range. When the excessive torque warning occurred, the digital indicator and pointer were displayed in red with the associated CAS message. There were no associated CAS messages for low torque values, only high torque exceedances activated a CAS caution or warning.

Figure 1. Primary Flight Display (PFD) and engine instruments window showing torque conditions examples.
