**KOMITE NASIONAL KESELAMATAN TRANSPORTASI
REPUBLIC OF INDONESIA**

KNKT.16.09.27.04

Aircraft Accident Investigation Report

**PT. Trigana Air Services
Boeing 737-300F; PK-YSY
Wamena Airport, Papua
Republic of Indonesia
13 September 2016**

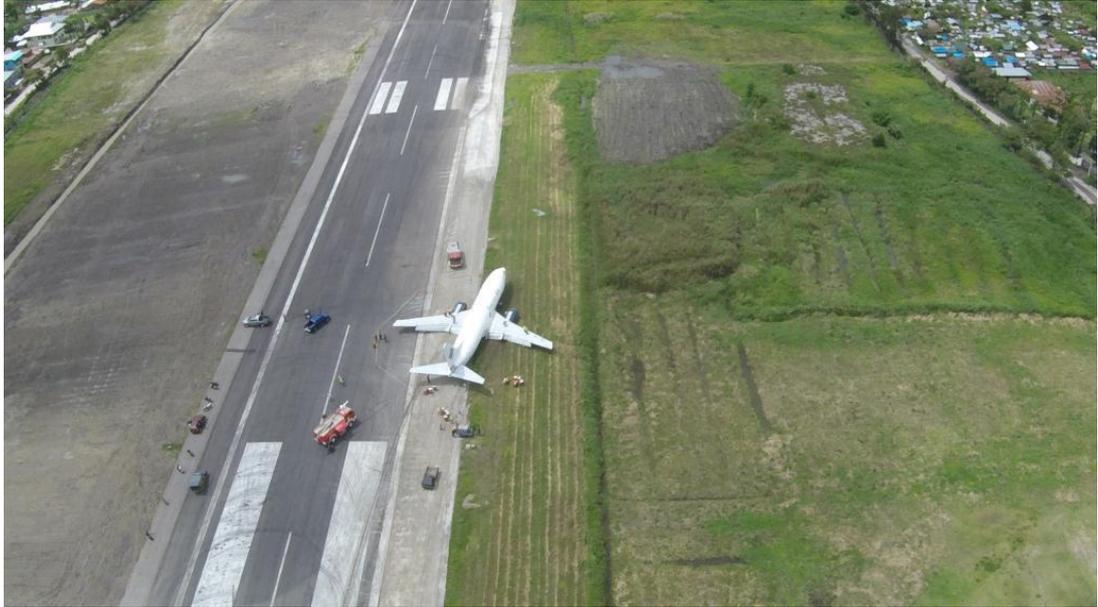
Figure 1: The aircraft final position

Both of main landings gear collapsed. The left main landing gear detached and found on runway. The engine and lower fuselage contacted to the runway surface. The aircraft veer to the right and stopped approximately 1,890 meters from the beginning of the runway 15.

No one was injured on this occurrence and the aircraft had substantially damage. Both pilots and the load master evacuated the aircraft via the forward left main cargo door used a rope.

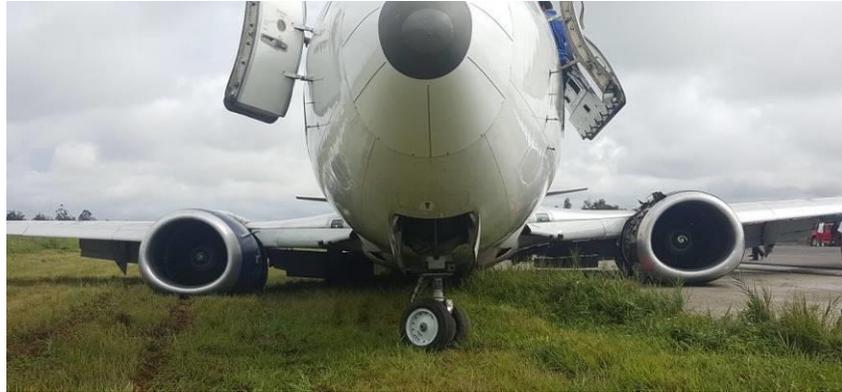
Figure 2: Damage on the nose wheel

- Both of main landing gears collapsed with the left main landing gear including the landing gear strut detached and the right main landing gear strut broken;
- Nose wheel broken;
- Tire number 2 blown out;

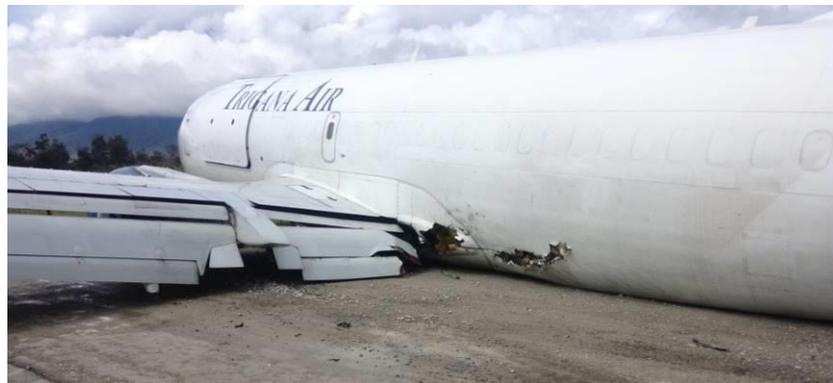
Figure 3: Damage on the lower fuselage

- Both inner flaps broken;
- Left engine cowling detached;
- Leading edge of right horizontal stabilizer dent and the lower skin of right horizontal stabilizer perforated;
- Aft lower fuselage scratched;
- Left wing to fuselage fairing torn.

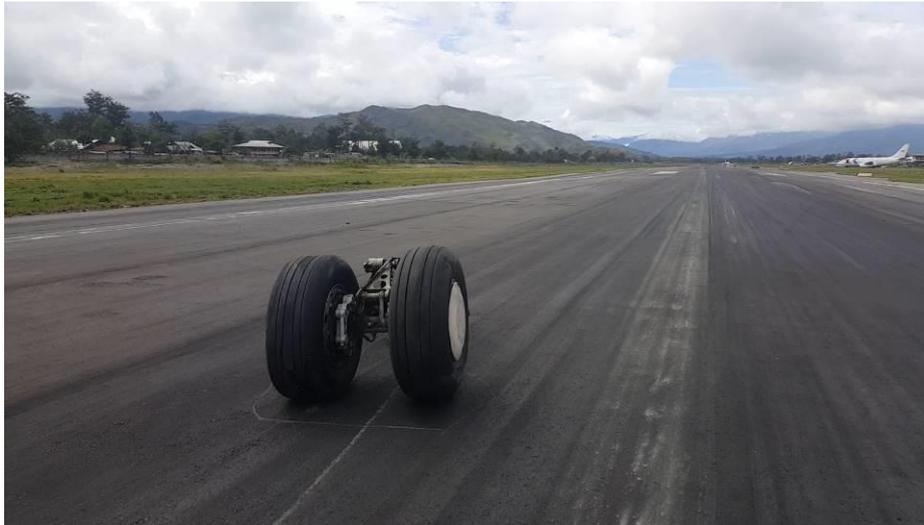
The investigation found the tire marks of left main landing gear on the runway at approximately 125 meters from the runway threshold, followed by the tire mark of the right main landing gear. Following these marks, a white paint between two purple paint scratch marks which afterward changed to metal scratch marks found along the aircraft trajectory.

Figure 10: The left main landing gear found on the left side of the white paint scratch mark

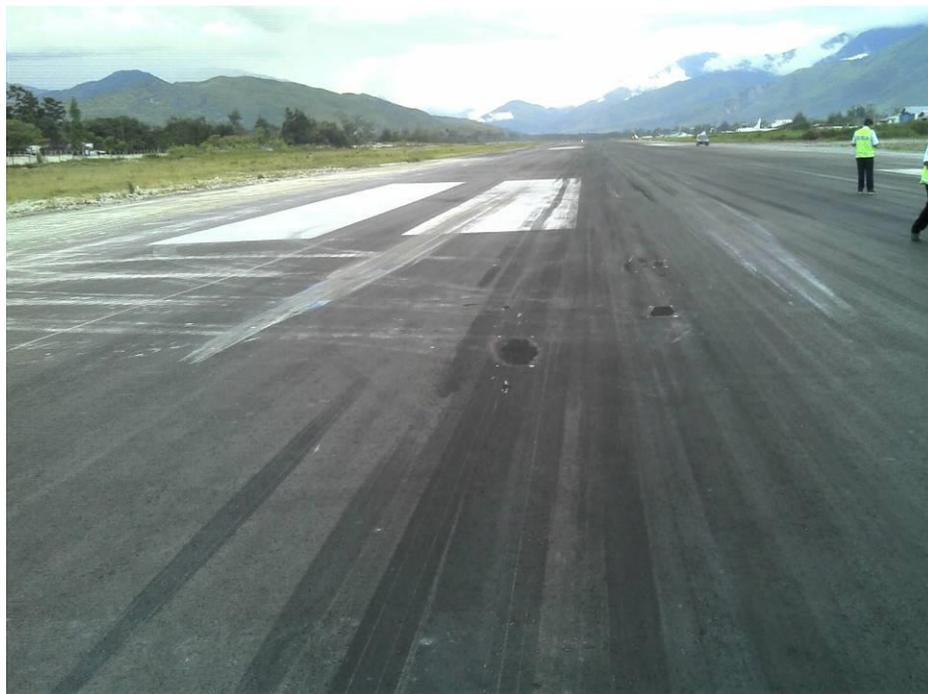
Observation on the runway found paint and metal scratches marks on the touch down zone area of runway 15 and continued to the last aircraft position. The aircraft stopped at approximately 1,890 meters from the beginning of the runway 15.

Figure 11: Marks of paint and metal scratches found on the runway

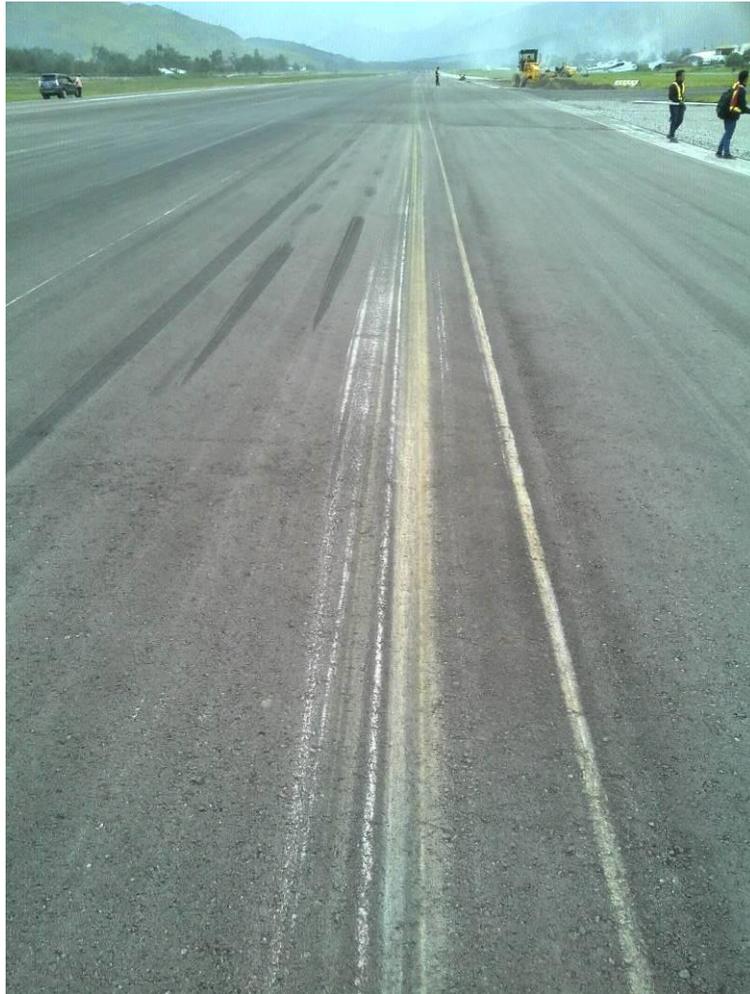
Figure 12: The metal scratch marks along the aircraft trajectory

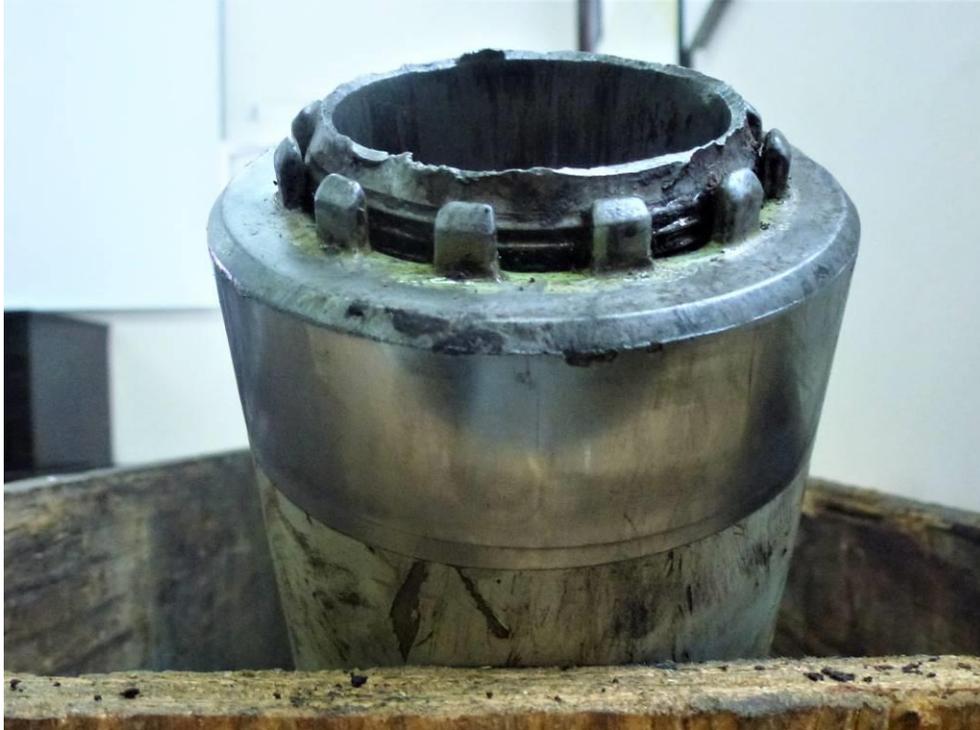
The broken left main landing gear strut was examined by KNKT metallurgist to determine the mode of failure. The examination did not find any sign of fatigue or any other condition that may degraded the strength of the landing gear strut.

The examination on the broken part found that the surface was at 45° cut, is a common characteristic of a ductile fracture under axial tensile loading.

Figure 13: the broken surface of the left main landing gear strut

of failure was due to torsional force.	<u>common characteristic of a ductile fracture under axial tensile loading.</u>	main landing gear strut, Boeing believes the failure was a ductile fracture resulting from tensile loading. Our experience has shown fractures on tubular parts due to high torsional loading tend to spiral around the circumference in a helical direction	
4	3.1 Findings (page 30, first item)	<i>The aircraft was airworthy prior to the occurrence and was operated within the weight and balance envelope. There was no report or record of the aircraft system abnormality during the flight from take-off until the time of the occurrence.</i>	<i><u>The aircraft was airworthy prior to the occurrence and was operated within the weight and balance envelope. Except for damage that resulted from the accident, there was no report or record of the aircraft system abnormality during the flight. from take-off until the time of the occurrence.</u></i>	To clarify there were no aircraft system anomalies noted, other than damage that resulted from the accident.	rejected

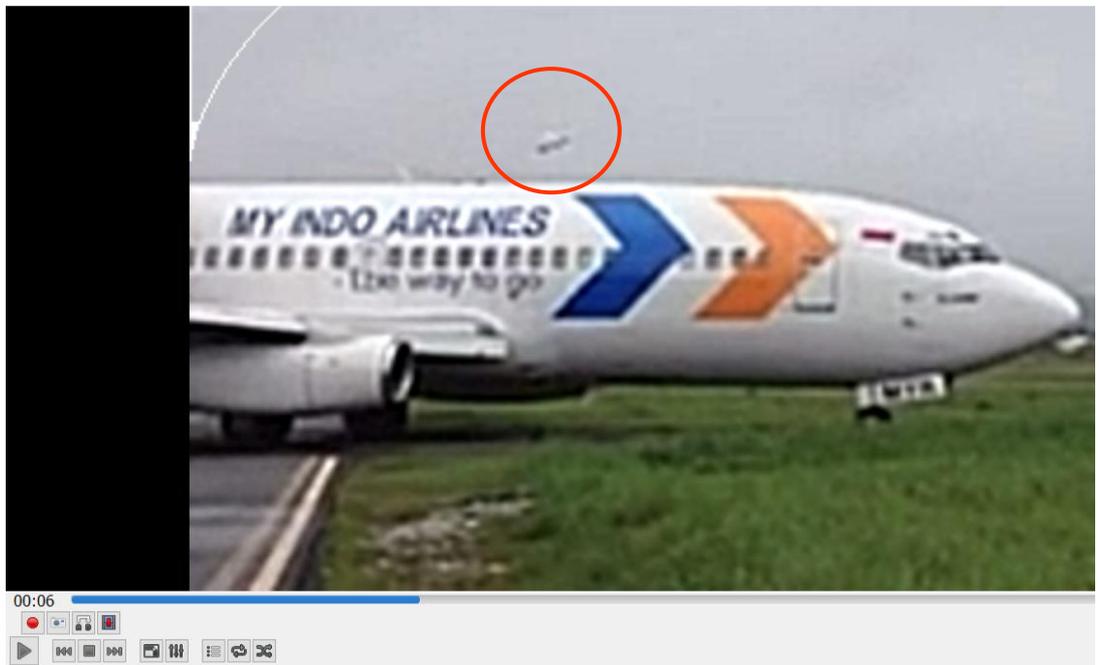
Figure 16: At video time 00:06, the aircraft was rolling to the right and pitching down

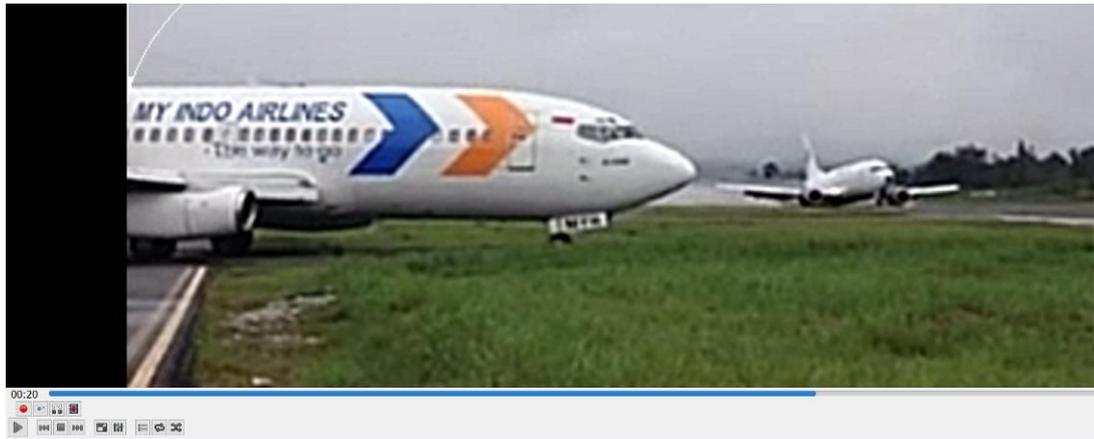
Figure 17: At video time 00:20, the aircraft was on landing roll and main landing gear had collapsed

Excessive sink rate resulted in touched down with high vertical acceleration and led to the failure of the main landing gears.
