FINAL REPORT

CLASSIFICATION	Accident
Operator	AEROWEST
Manufacturer	W.S.K – MIELEC
Aircraft	Antonov AN-2
Registration country	ROMANIA
Registration	YR-PEG
Location	Coordinates: Latitude: 44° 54' 1.31" N Longitude: 027° 51' 8.87" E
Date and time	01.08.2015/ 08:05 LT

No. : A 20 - 04
Date : 27.03.2020

FINAL REPORT**AIRCRAFT LOSS OF CONTROL DURING TAKE-OFF**

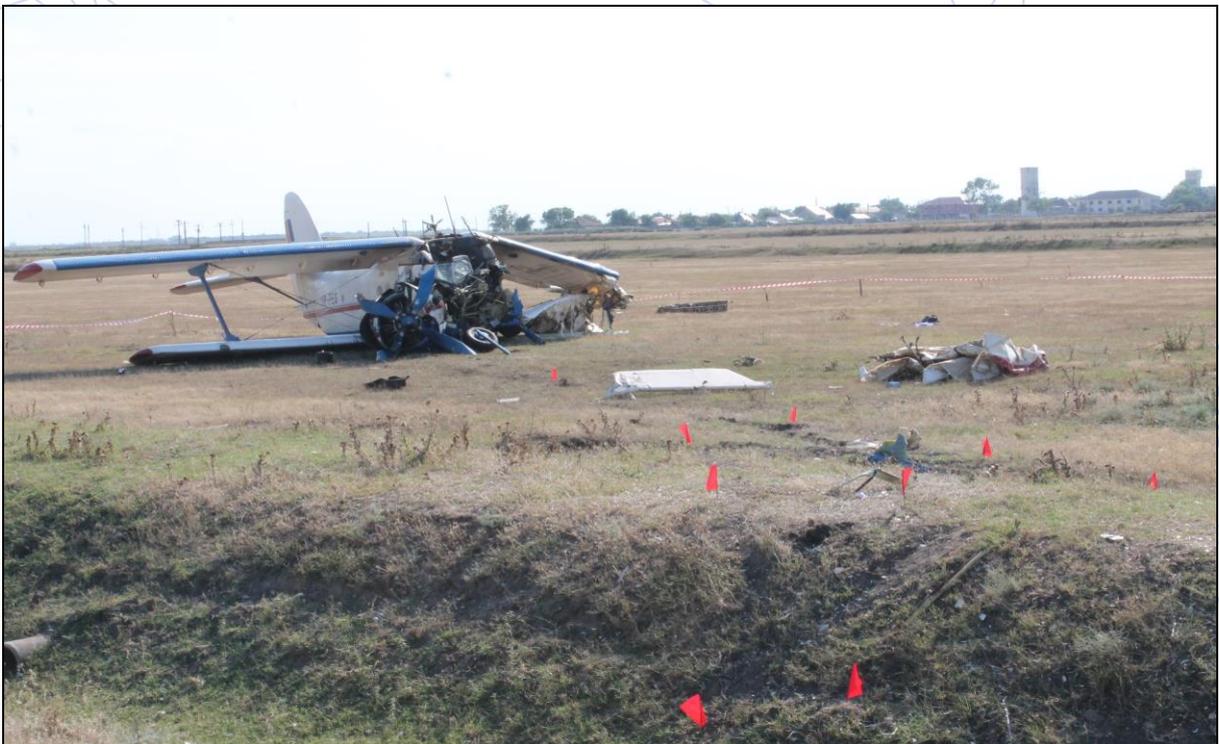
Fig. 1 Aircraft wreckage

The aircraft was totally destroyed.

The aircraft has stopped at the point of coordinates: N 44°54'1.31"; E 027°51'8.87".

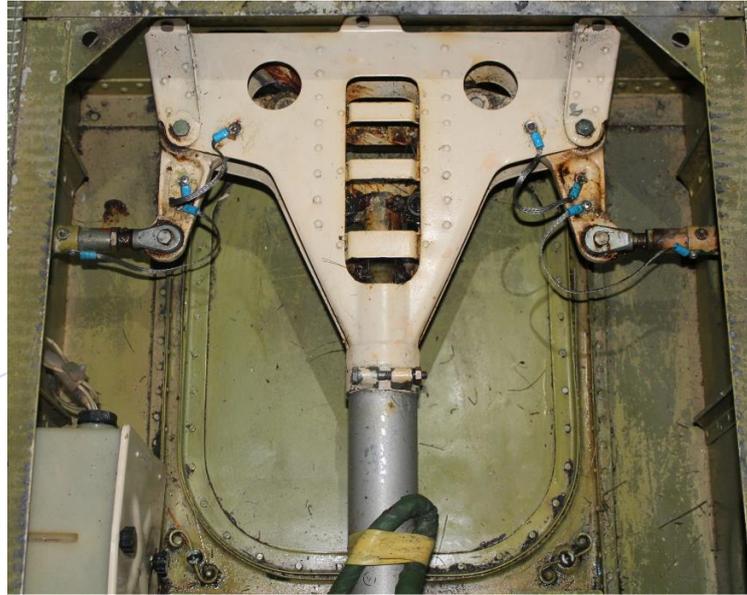
Fig. 9 Lower flaps position 15° at a mechanism on a functional AN2 aircraft

By comparing the figures 8, 9 and 10, it can be seen that the position of the lower flap was between 18°-20° (no marks for precise identification thereof).

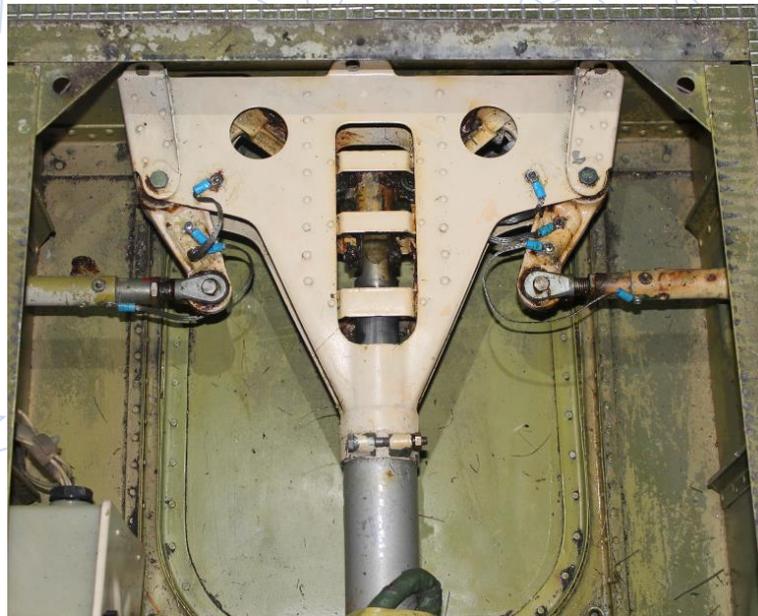
Fig. 10 Position 30° at the same functional electro-mechanism

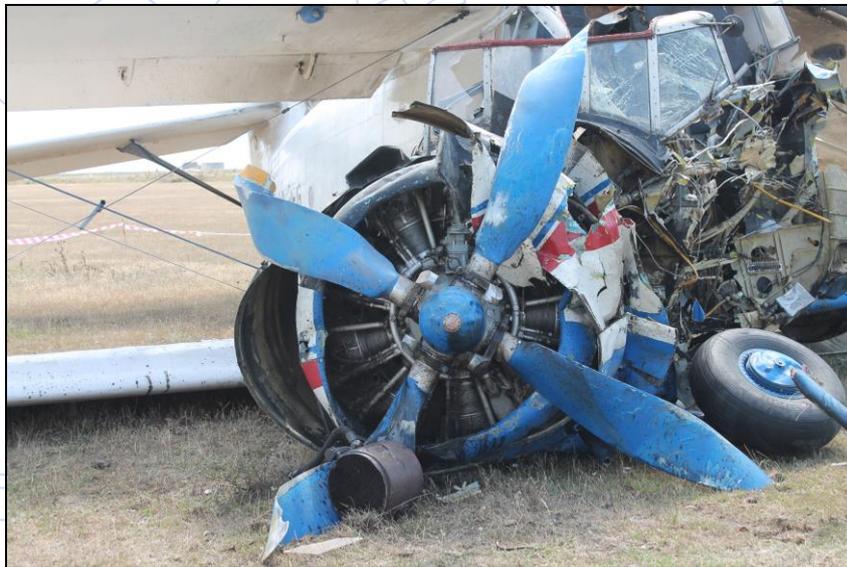
During this evolution the engine worked properly. This is also confirmed by the appearance of the propeller blades after the impact.

Fig. 15 Propeller blades after the impact
