National Transportation Safety Board Aviation Accident Final Report

Location:	Amagansett, New York	Accident Number:	ERA18LA157
Date & Time:	June 2, 2018, 14:33 Local	Registration:	N41173
Aircraft:	Piper PA 31	Aircraft Damage:	Destroyed
Defining Event:	Loss of control in flight	Injuries:	4 Fatal
Flight Conducted Under:	Part 91: General aviation - Personal

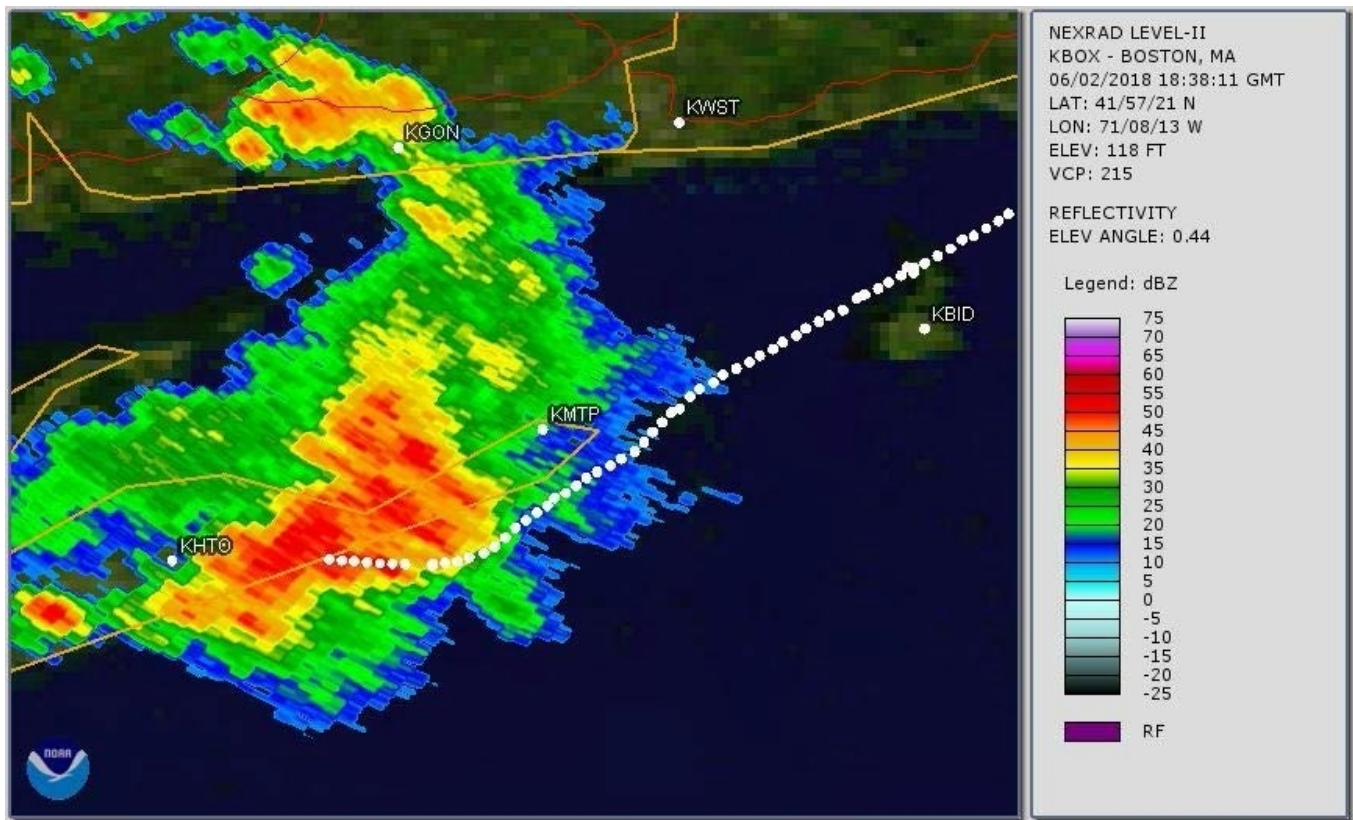
Figure 1: Boston WSR-88D Base Reflectivity Image at 1438 with flight track

Figure 1 depicts the accident airplane's flight track overlaid on the Boston WSR-88D base reflectivity image for 1438 (Echoes less than 10 dBZ have been removed from the image). The airplane's flight track entered the leading of the echoes with a maximum of 53 dBZ "extreme" intensity echoes with tops near 48,000 ft. Extreme intensity echoes over 50 dBZ extended between the accident site and HTO.
