National Transportation Safety Board Aviation Accident Final Report

Location:	Canadian, Texas	Accident Number:	CEN19FA082
Date & Time:	February 15, 2019, 10:00 Local	Registration:	N421NS
Aircraft:	Cessna 421	Aircraft Damage:	Destroyed
Defining Event:	Loss of control in flight	Injuries:	2 Fatal
Flight Conducted Under:	Part 91: General aviation - Personal

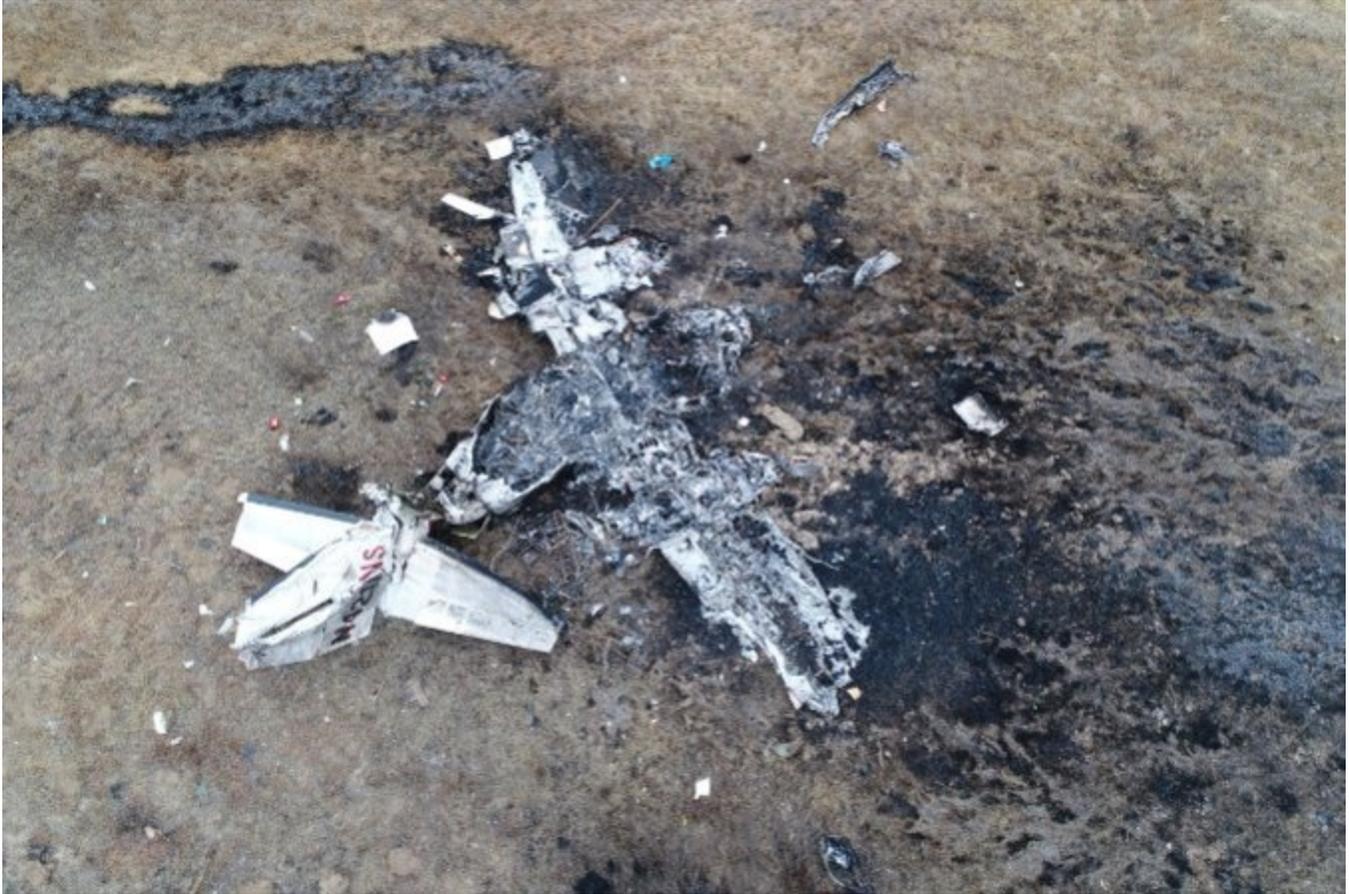
The airplane impacted terrain in a slightly nose-low and wings-level attitude with no evidence of forward movement, and a postimpact fire destroyed a majority of the wreckage. The damage to the airplane was consistent with a relatively flat spin to the left at the time of impact. A postaccident examination did not reveal any preimpact mechanical malfunctions or anomalies that would have precluded normal operation. A detailed examination of the cockpit instruments and other portions of the wreckage was not possible due to the fire damage.

The airplane impacted remote terrain and a post impact fire consumed a majority of the wreckage (see figure 1).

Figure 1 – Aerial image of the accident site. A majority of the airplane was consumed by fire.

A postaccident examination indicated the airplane impacted the ground in a slight nose-low and wings-level attitude and there was no evidence of forward momentum. All major airplane components were observed at the accident site. The empennage was displaced to the right. The flap setting was 15° extended. The cockpit and instrumentation were destroyed by fire and none of the components could be examined. The engines were found embedded in the mud and all propeller blades were accounted for. The engines and propellers exhibited signatures consistent with rotation at the time of impact. The examination did not reveal any preimpact mechanical malfunctions or anomalies that would have precluded normal operation.
