# National Transportation Safety Board Aviation Accident Final Report

<b>Location:</b>	Atqasuk, Alaska	<b>Accident Number:</b>	ANC18LA031
<b>Date &amp; Time:</b>	April 11, 2018, 08:18 Local	<b>Registration:</b>	N814GV
<b>Aircraft:</b>	Cessna 208B	<b>Aircraft Damage:</b>	Substantial
<b>Defining Event:</b>	VFR encounter with IMC	<b>Injuries:</b>	1 Minor
<b>Flight Conducted Under:</b>	Part 135: Air taxi & commuter - Non-scheduled

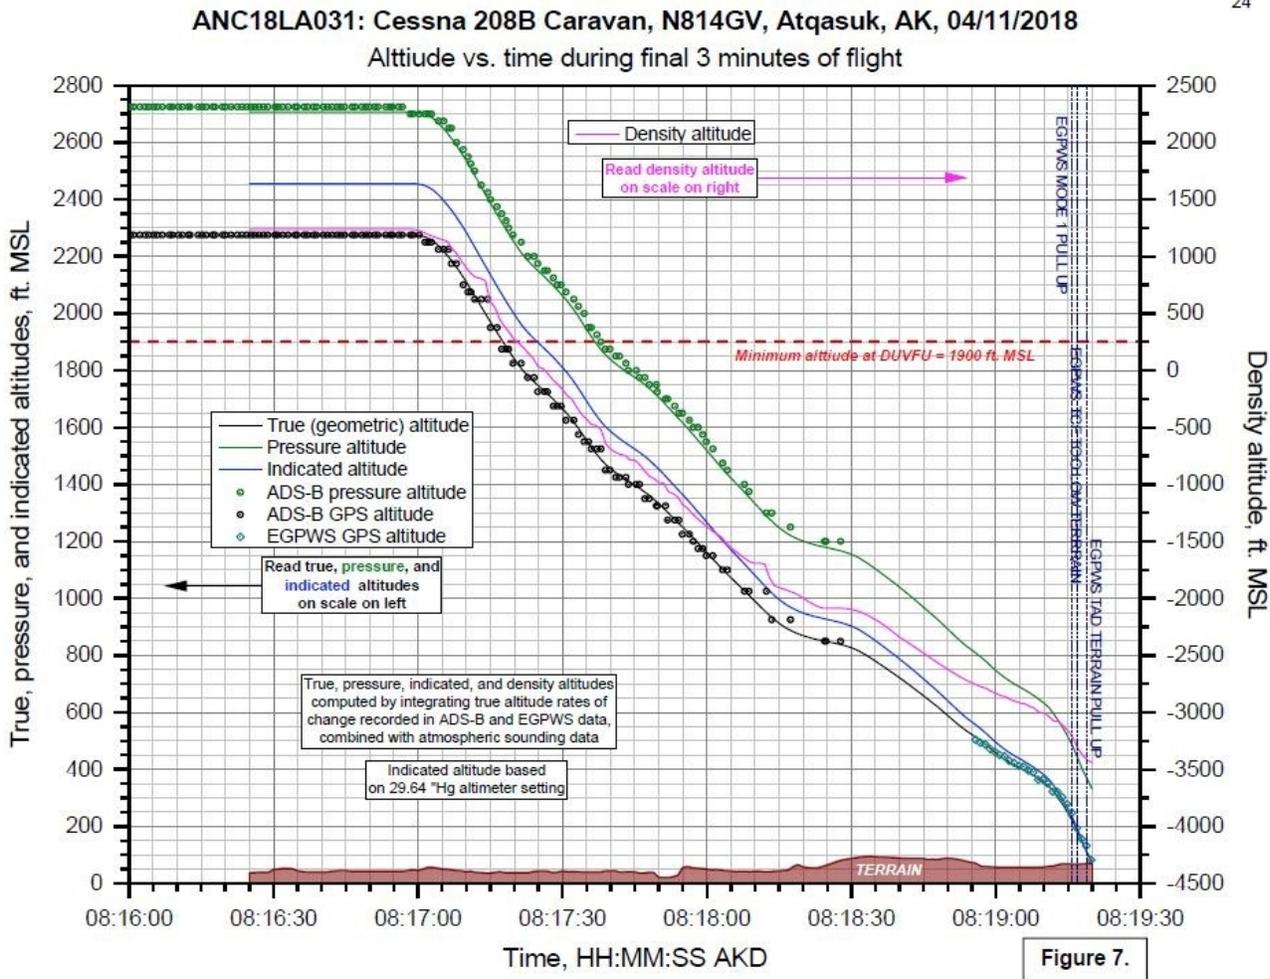
Figure 1. Airplane performance chart during last 3 minutes of flight.

An airplane performance study indicated that the airplane was in a continuous descent from 2,500 ft until the final data point about 12 ft above the surface; the airplane was not leveled off at any time during the descent. In the final 15 seconds of recorded data, the rate of descent increased from about 500 fpm to about 2,300 fpm before decreasing to 1,460 fpm at the last recorded data point.

The performance study indicated a continuous descent from about 2,500 ft msl to the last data point about 12ft above the surface. (See figure 1.)
