National Transportation Safety Board

Aviation Accident Final Report

Location:	Willow, Alaska	Accident Number:	ANC18FA055
Date & Time:	July 18, 2018, 19:00 Local	Registration:	N9878R
Aircraft:	De Havilland DHC-2	Aircraft Damage:	Destroyed
Defining Event:	Aerodynamic stall/spin	Injuries:	1 Fatal, 2 Serious
Flight Conducted Under:	Part 135: Air taxi & commuter - Non-scheduled

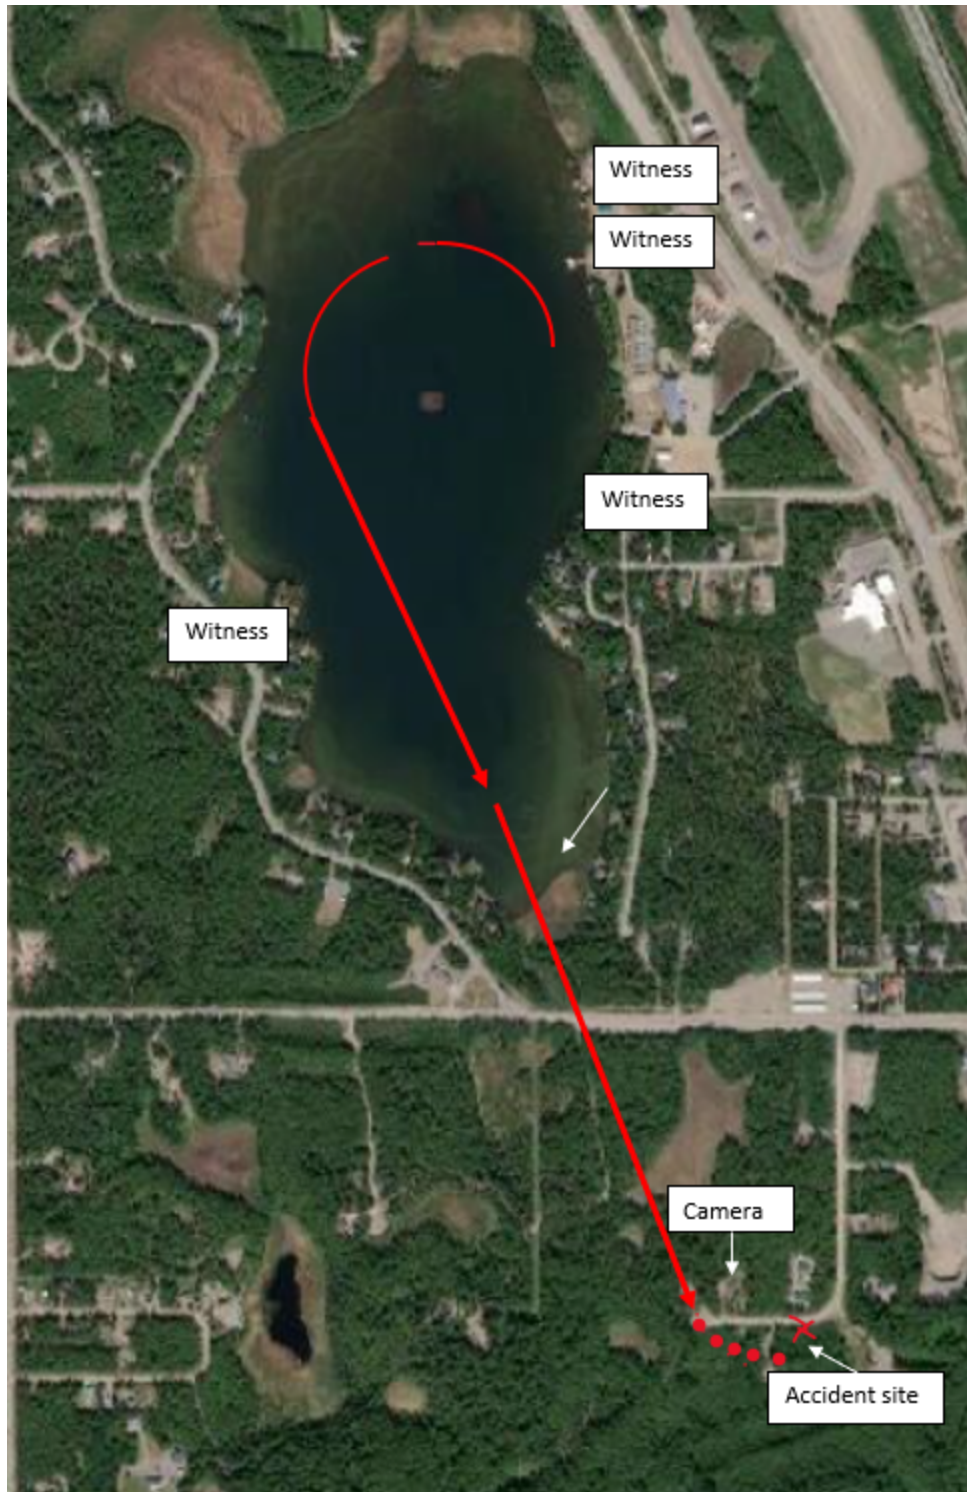
According to the witnesses, the airplane slowly lifted off and attained a nose high attitude as it barely climbed over trees at the southeast end of the lake (see figure 1). The passenger stated that after takeoff, as the airplane turned left in the direction of the destination, it rolled left and crashed. After the impact, she noted that the pilot was unresponsive as the airplane became engulfed in fire, and she immediately evacuated with her son.

Figure 1. Willow Lake with approximate water and flight tracks based on witness videos.

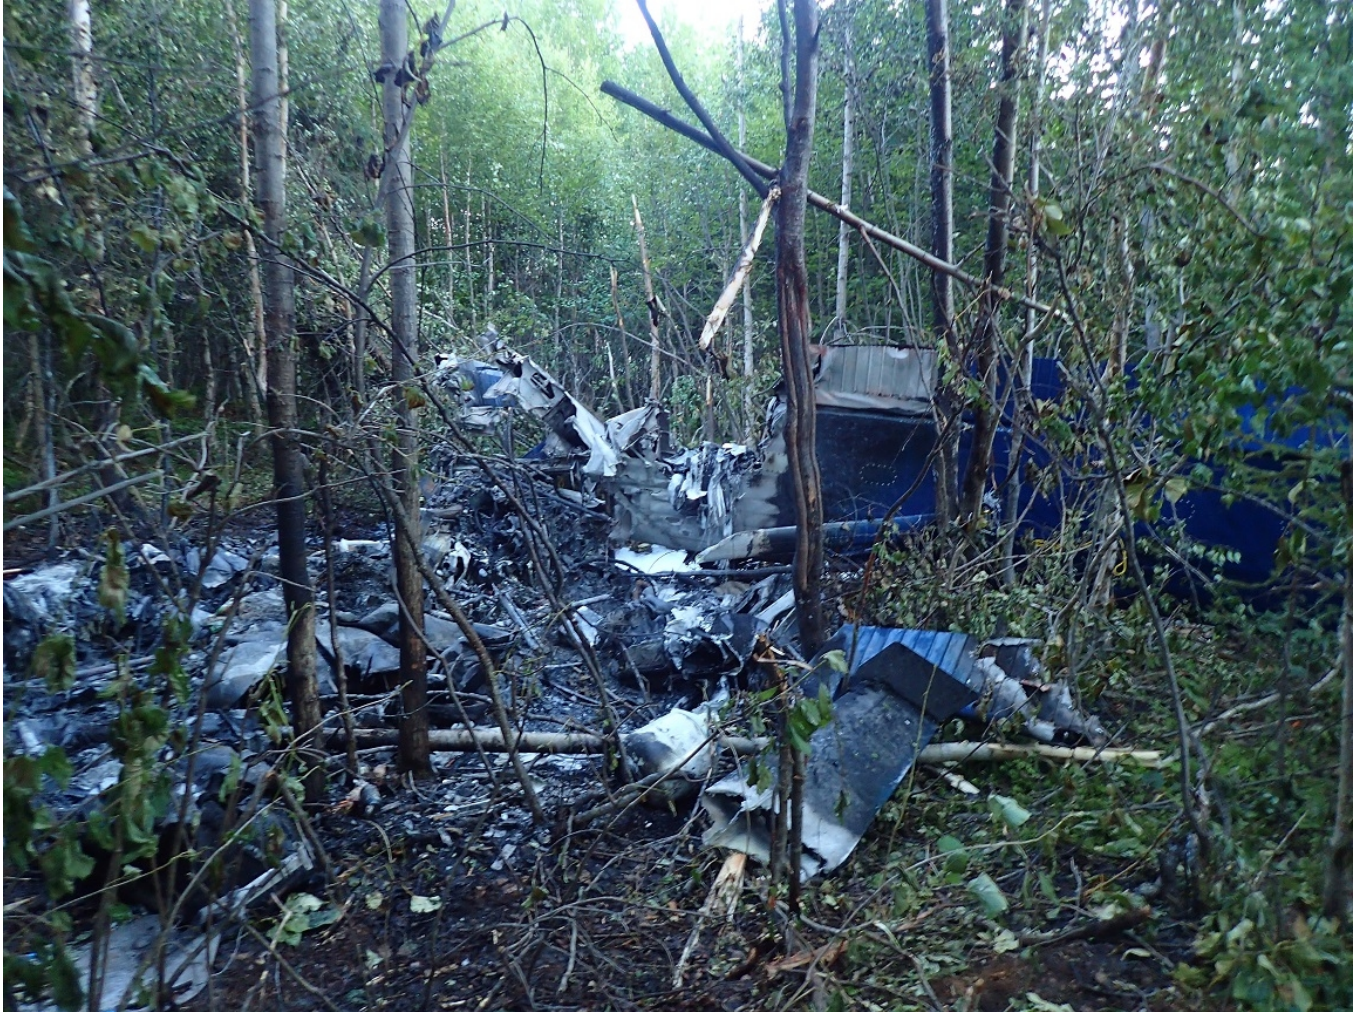
The airplane came to rest in a level, wooded, residential lot in a nose-down attitude, on a heading of about 300°. The postcrash fire incinerated the fuselage, cockpit instruments, empennage, floats, engine components, and cargo (see figure 2.)

Figure 2. Accident airplane at the accident scene.

The wreckage consisted primarily of the wings, forward fuselage frame, floor structure and engine with propeller attached. The wreckage exhibited either soot, charring, oxidized metal, or melted aluminum. Hardened masonry mortar was intermixed with the airframe and engine components. The right wing was mostly intact with some fore-to-aft buckling on the outboard leading edge and the flap and aileron were attached. The left wing had significant leading edge buckling near the outer edge. The left flap and aileron were attached, but the flap control rod was disconnected at the C clamp. The left aileron inboard edge had impact damage that matched the adjacent flap edge damage with the flaps extended about 30°, which indicated the flaps were likely at or near the takeoff position at the time of impact.
