This document is an English translation of the Final Report on the fatal accident involving the L-410UVP-E20 aircraft registered RA-67047 that occurred on November 15, 2017 at Nelkan landing site, Khabarovsk Krai, RF. The translation was done as accurate as a translation may be to facilitate the understanding of the Final Report for non-Russian speaking people. The use of this translation for any purpose other than for the prevention of future accidents could lead to erroneous interpretations. In case of any inconsistency or misunderstanding, the original text in Russian shall be used as the work of reference.

INTERSTATE AVIATION COMMITTEE

**FINAL REPORT
RESULTS OF INVESTIGATION
OF ACCIDENT**

Type of accident	Accident
Type of aircraft	L-410UVP-E20, airplane
Registration	RA-67047
Owner	State Transport Leasing Company, Public Company
Operator	Khabarovsk Airlines, RSUE
Aviation Administration	Rosaviatsia Far East ITO
Place of accident	Nelkan landing site, Khabarovsk Krai, RF Coordinates: N 57°37'25.5" E 136°09'11.4"
Date and time of accident	15.11.2017, 13:09 local time (03:09 UTC), daytime

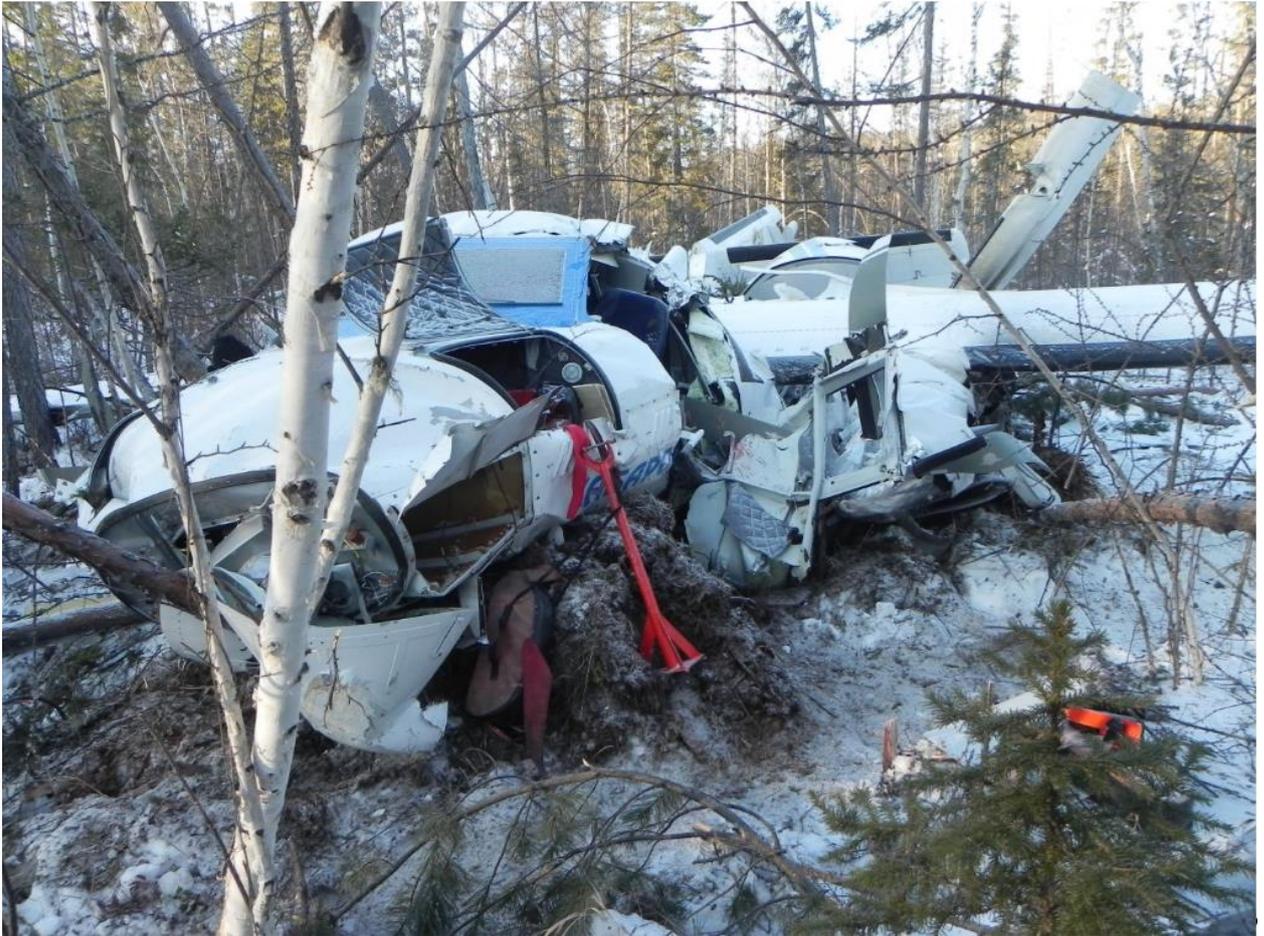
In course of the with-the-ground collision, the fuselage, the engines and the tail assembly were damaged significantly. The cockpit was almost destroyed; the wings show some damage and deformation (see Fig. 3).

Fig. 3. View of A/C after accident

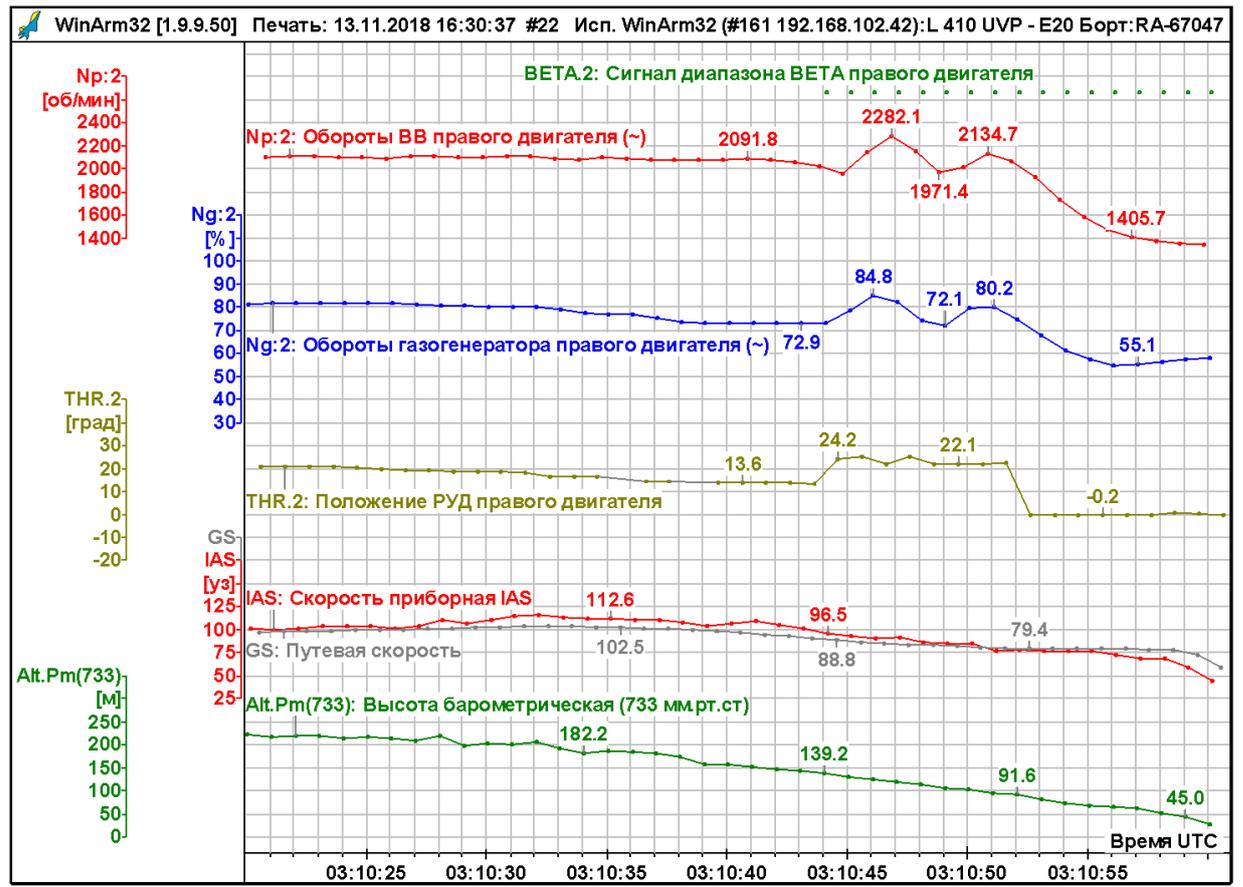
According to the FDR data, when BETA status annunciation got on (see Fig. 8) the propeller speed increased up to 2282 RPM that corresponds to the unloaded propeller condition when the propeller blades are moved close to the flat pitch. It is above the overspeed governor setting (2160 ± 10 RPN), which is abnormal, however, in this situation this observed dynamic behavior of the propeller system is expected. Starting from the blades setting angle of $\sim +1^\circ$ the overspeed propeller governor is partly disabled (it is fully disabled at minus 7°) that influence the provided governing.

Fig. 8. Record of final stage of flight

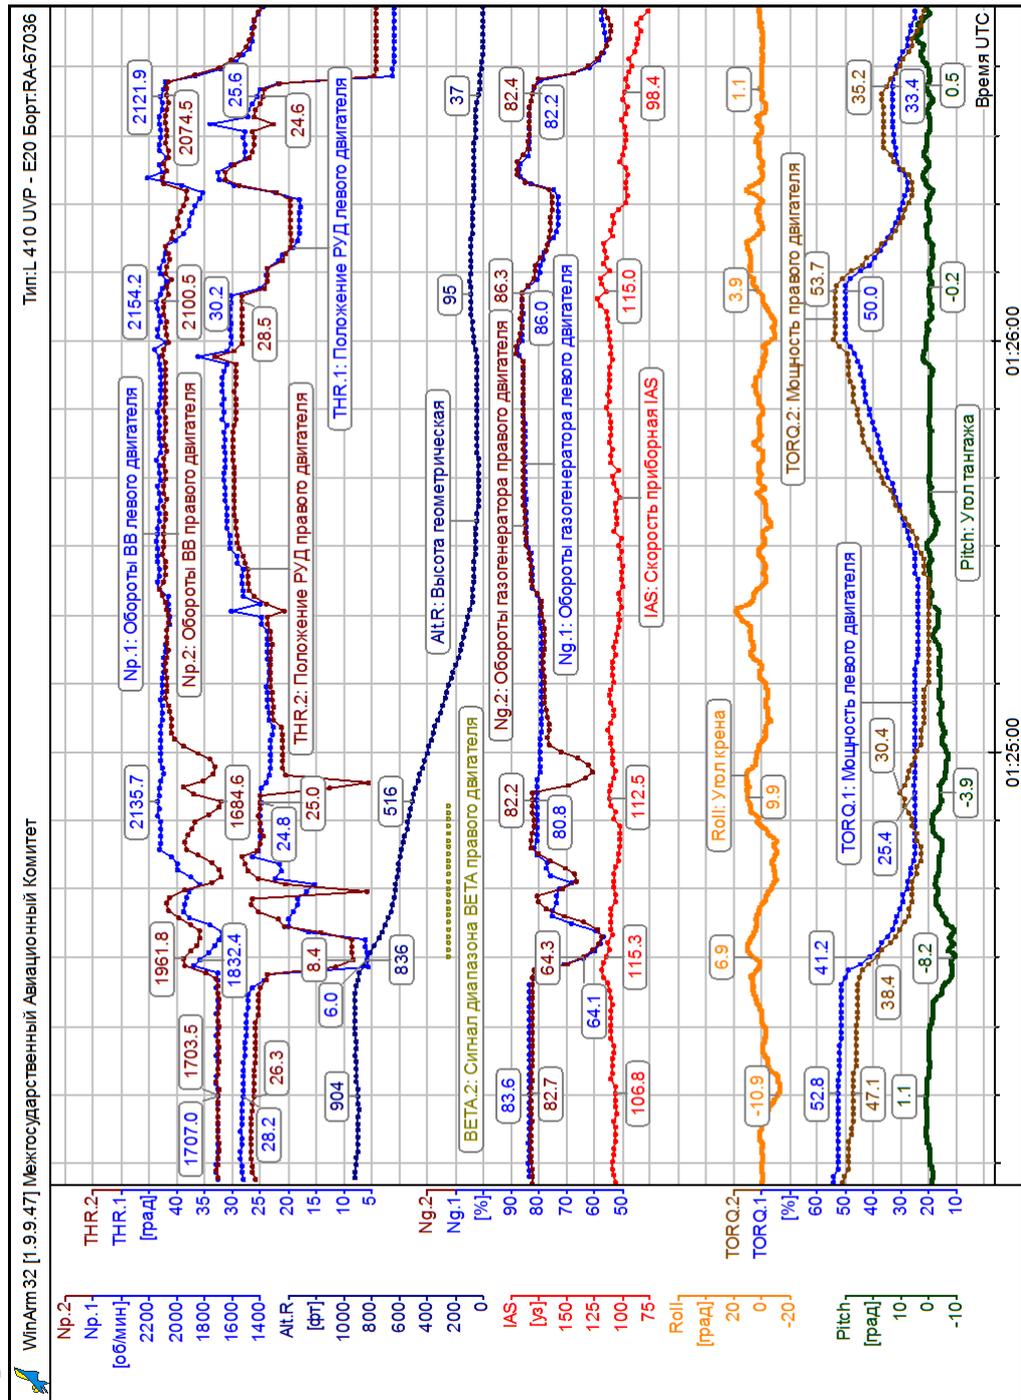
During the approach, at the height of 260 m and at the speed of 115 knots (see Fig. 9), when PCLs were set to the fine pitch mode, the BETA status annunciation got on at RH engine.

Fig. 9. Record of L410UVP-E20 RA-67036 aircraft landing stage on 03.04.2015 at Ayan airport

After the BETA status annunciation was generated, RH engine continued to operate, the gas-generators' RPMs corresponded to the TCLs positions, the propellers' RPMs corresponded to the PCLs' fine pitch mode. The above case evidences that the Pitch Lock was activated and the propeller blades' inflight uncommanded moving below 9° did not occur.

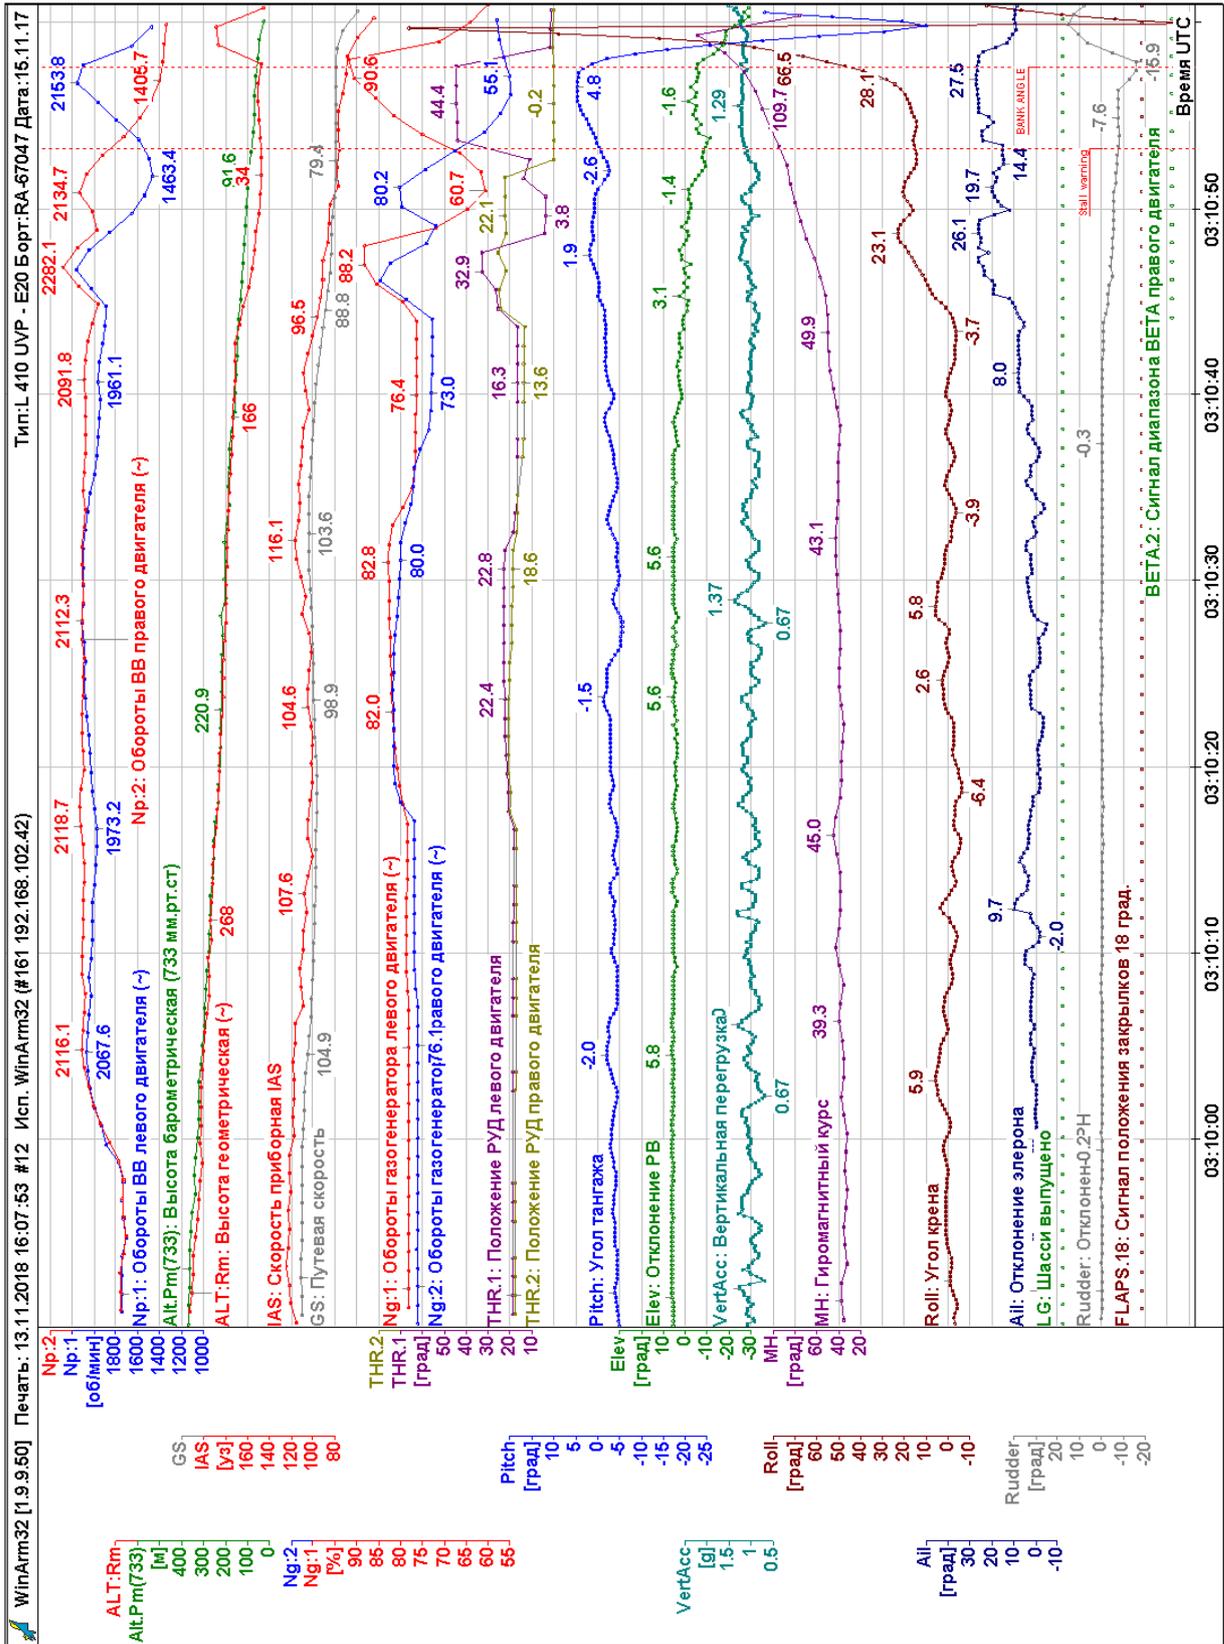
Fig. 11. Record of the final stage of the flight

When the crew had set the PCLs to the fine pitch mode (while the TCLs' positions remained unchanged), the RH propeller rotation speed increased up to 2118 RPM, while the LH propeller rotation speed was within the range of 1970 to 1960 RPM. When the propeller speed is above

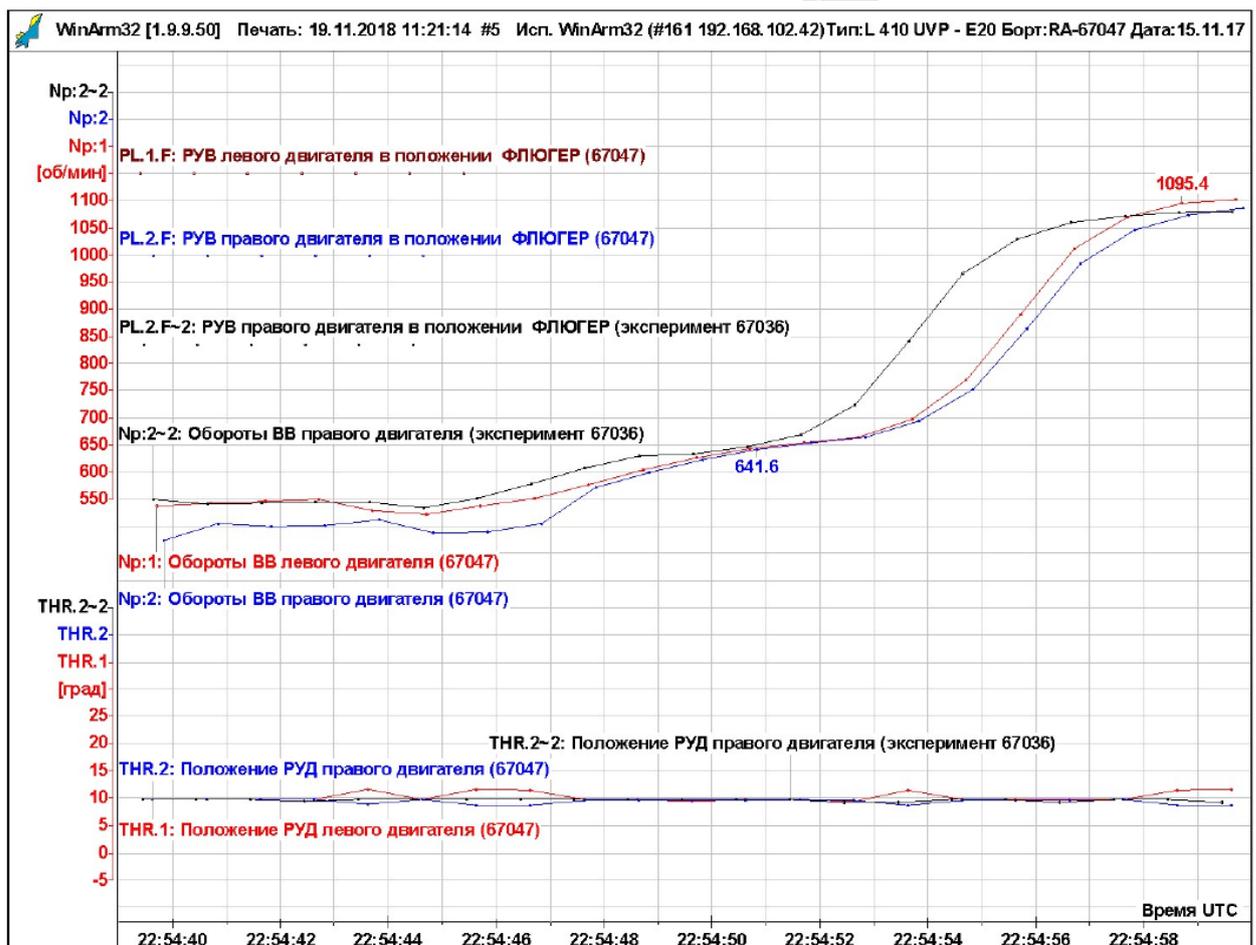
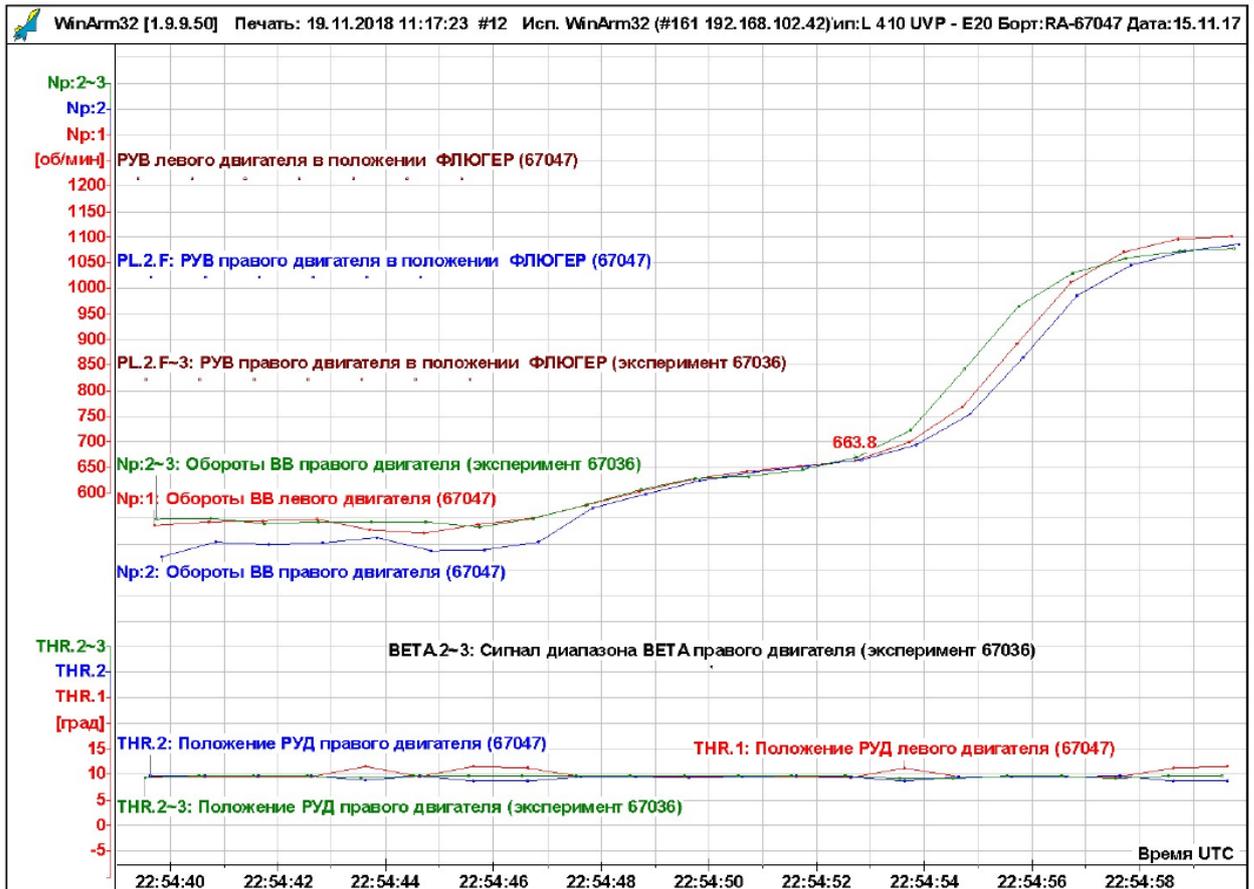
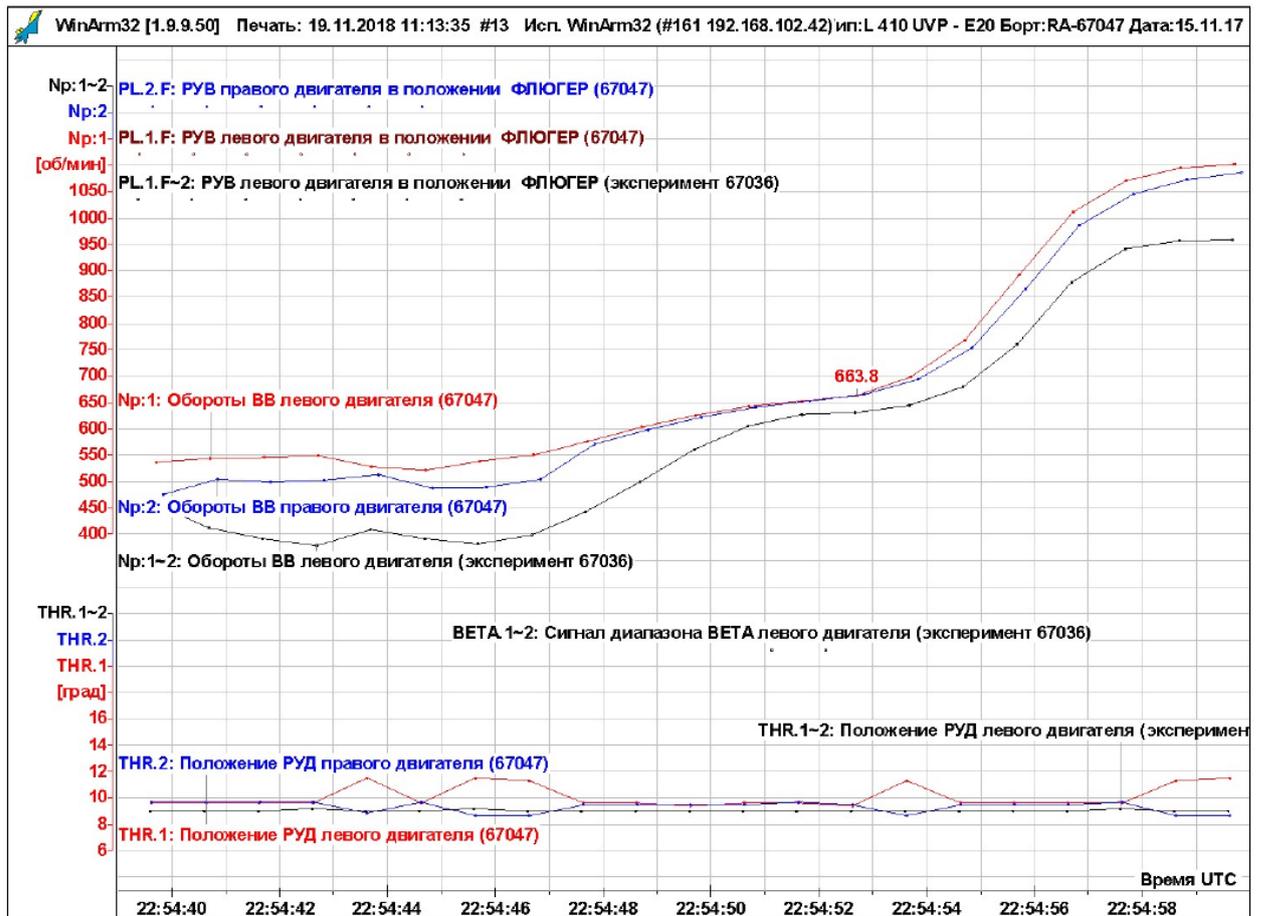
Three following figures (Fig. 13-15) show the overlay of the plot of L410UVP-E20 RA-67047 LH and RH engines' propeller speed (taken before the accident flight) onto the plot of L410UVP-E20 RA-67036 LH and RH engines' propeller speed (taken during the examinations). During the examinations, the propeller blades were recovering out from feathering by three different ways: without pressing of the PROPELLER PITCH LOCK TEST button, with pressing it during 1 s and during 2 s. Parameters' timing was done by the disappearance of single commands "TCLs to FEATHER position" with consideration of the rate of these commands' sampling frequency.

The record traces at figures 13-15 are the evidence that most probably the crew performed the PROPELLER PITCH LOCK TEST by short-time pressing the button (during 1-or-2 s).
