Engine failure and fire on ground involving Gippsland Aeronautics GA-8, VH-AJZ

Gibb River ALA, Western Australia, 22 April 2017

ATSB Transport Safety Report
Aviation Occurrence Investigation
AO-2017-048
Final – 5 September 2017

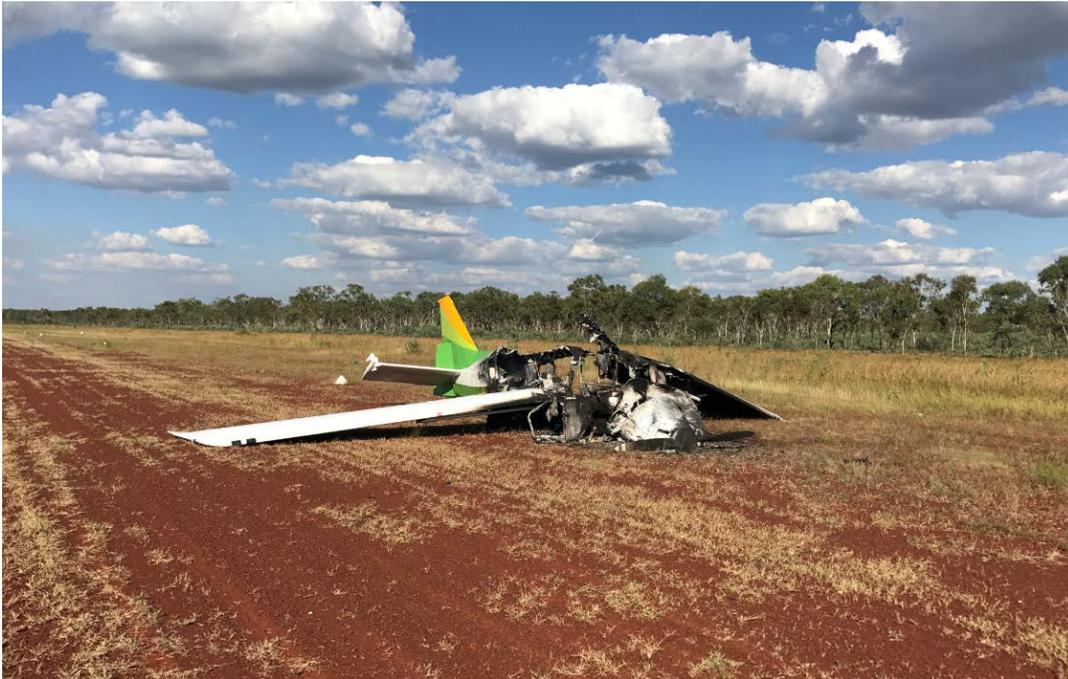
Figure 1: VH-AJZ wreckage

The crew members were not injured. As a result of the fire, the aircraft was destroyed (Figure 1).

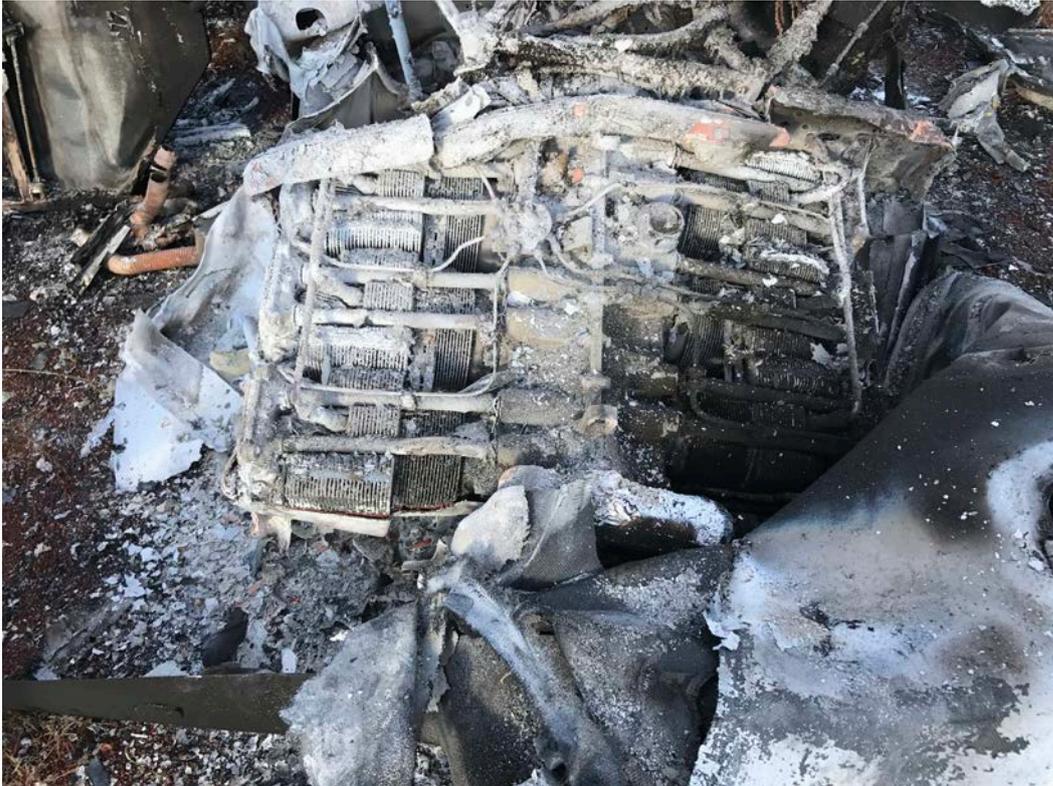
Figure 2: Fire damage to engine

- Due to the significant fire and heat damage, the cause of the fire could not be determined (Figure 2).
- When taxiing in high ambient temperatures and at low power settings, fuel may vaporise within the mechanical engine fuel pump, and this can lead to the engine failing. When operated in these conditions, the aircraft should be taxied with the electric fuel pump on to prevent fuel vaporisation.

The presence of fire on the nose wheel below the engine indicates that the fire was probably fed by a fluid. However, the extent of damage to the engine prevented the reason of the fire being determined.
