# Engine shutdown and collision with terrain involving Beech Aircraft Corporation B200 VH-MVL

Moomba Airport, South Australia | 13 December 2016

**ATSB Transport Safety Report**  
Aviation Occurrence Investigation  
AO-2016-170  
Final – 6 July 2017

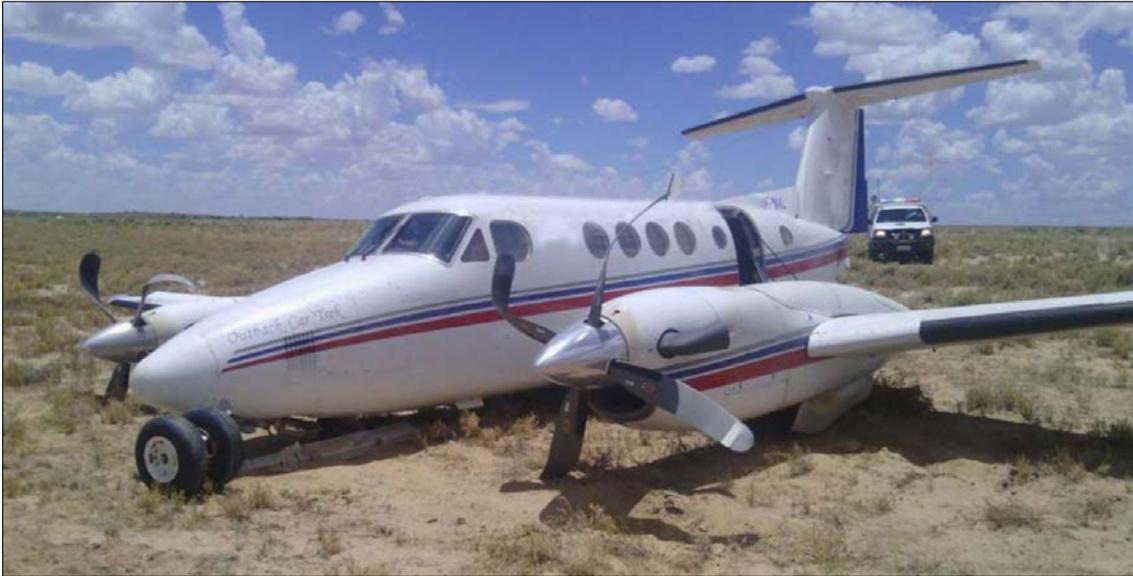
**Figure 1: VH-MVL accident site**

The aircraft landed in the sand to the left of the runway threshold and after a short ground roll spun to the left and came to rest (Figure 1). There were no injuries and the aircraft was substantially damaged.

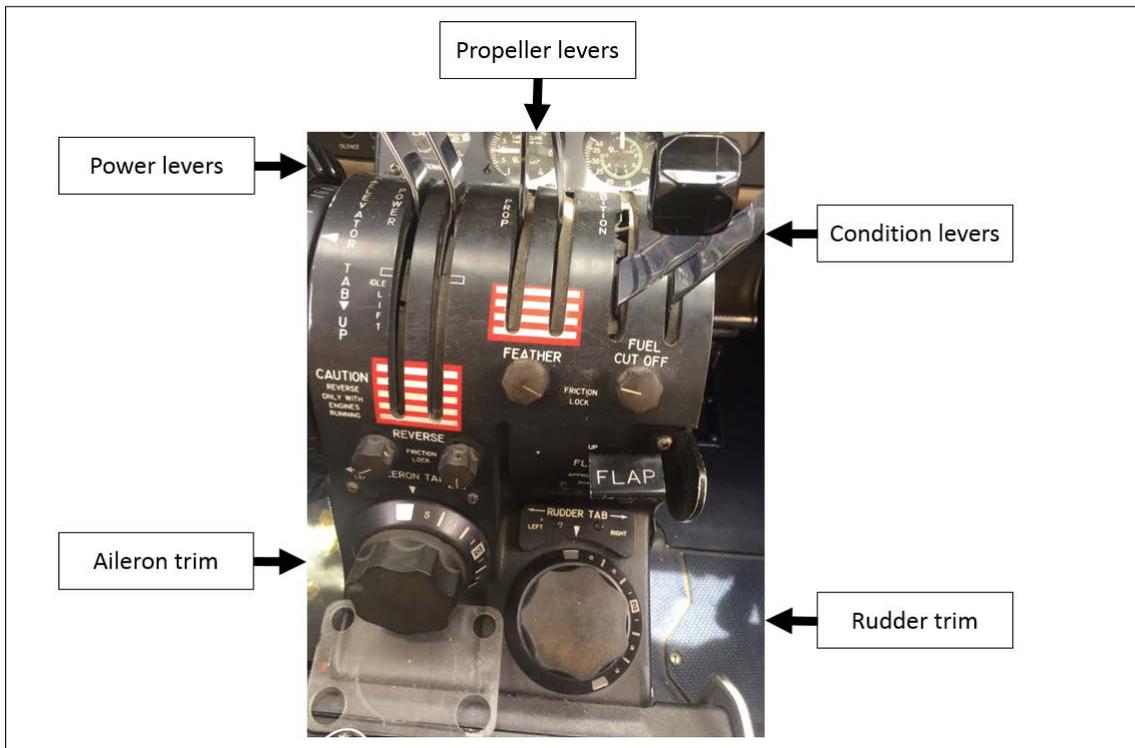
Figure 2: VH-MVL pedestal

Following the accident, an inspection of the left engine revealed the fire extinguisher bottle was discharged, but there were no physical indications of a fire. Damage to the left propeller was consistent with rotation of the propeller at impact and the propeller appeared to be in an unfeathered position (Figure 1). Both propeller control levers were at the 1900 RPM setting (Figure 2). The pilot reported that after the aircraft came to rest they shut off fuel and activated the firewall shutoff valve for the right engine, but were unsure of any other changes they made to switches and controls in the cockpit.

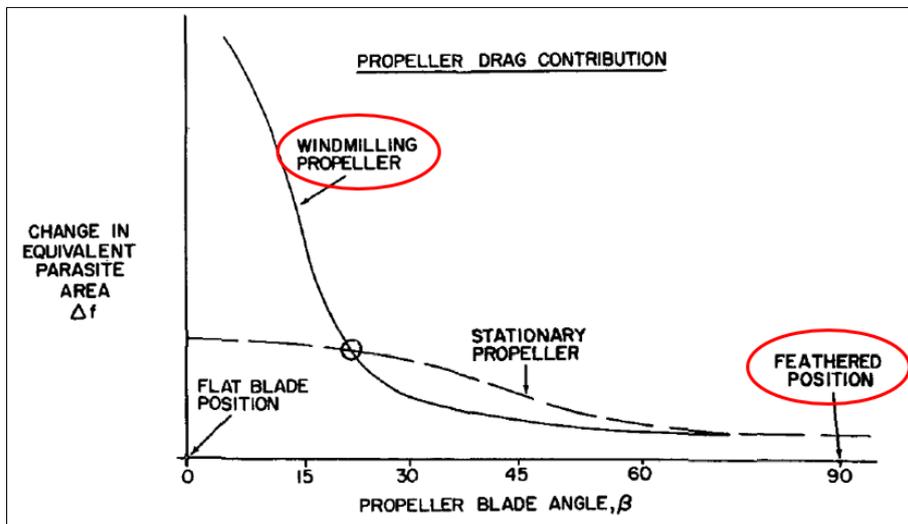
Figure 3: Windmilling propeller drag

Acceleration and climb performance is a function of the excess thrust and power. Therefore, any increase in drag will reduce the aircraft performance. A windmilling propeller can produce a significant amount of drag, which is estimated to be comparable to a parachute canopy of the same area as the propeller disc area (Figure 3).<sup>10</sup>

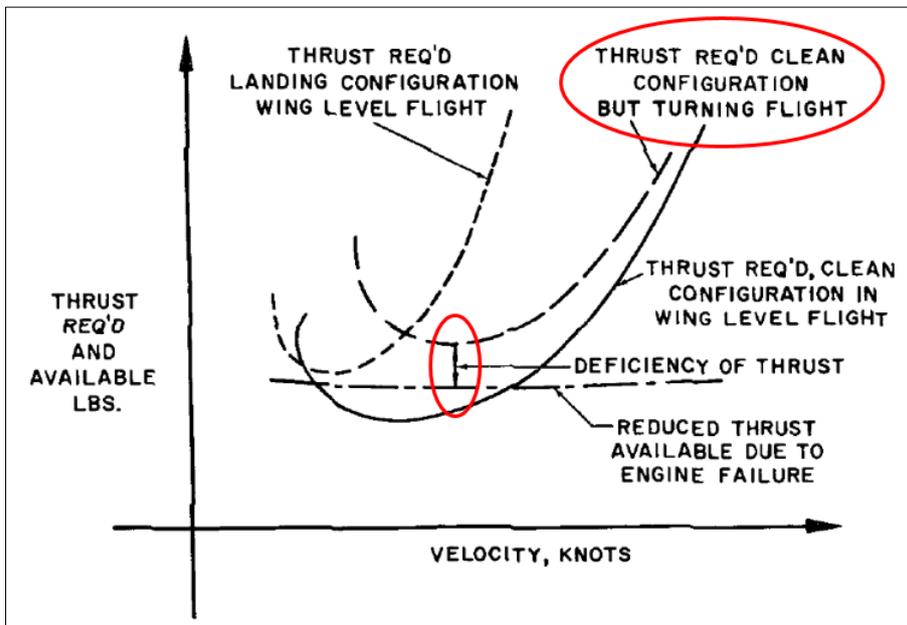
**Figure 4: Thrust required for asymmetric turning flight**

A right turn flown against these forces will produce more drag than a left turn, which will produce more drag than maintaining a constant heading (Figure 4). The extension of landing gear and flap will also increase drag. The combination of factors which increase drag can lead to a critical condition where the thrust required to maintain the planned flight path exceeds the thrust available.
