Loss of control and collision with terrain involving B200 King Air, VH-ZCR

Essendon Airport, Victoria | 21 February 2017

ATSB Transport Safety Report
Aviation Occurrence Investigation
AO-2017-024
Final – 24 September 2018

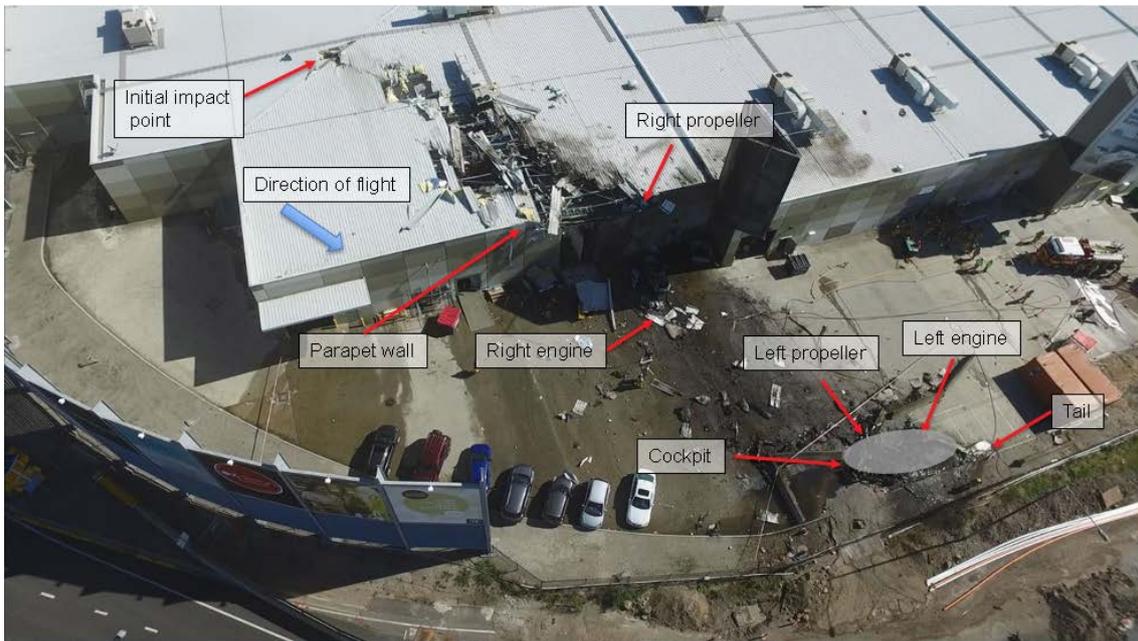
Figure 25: Accident site overview

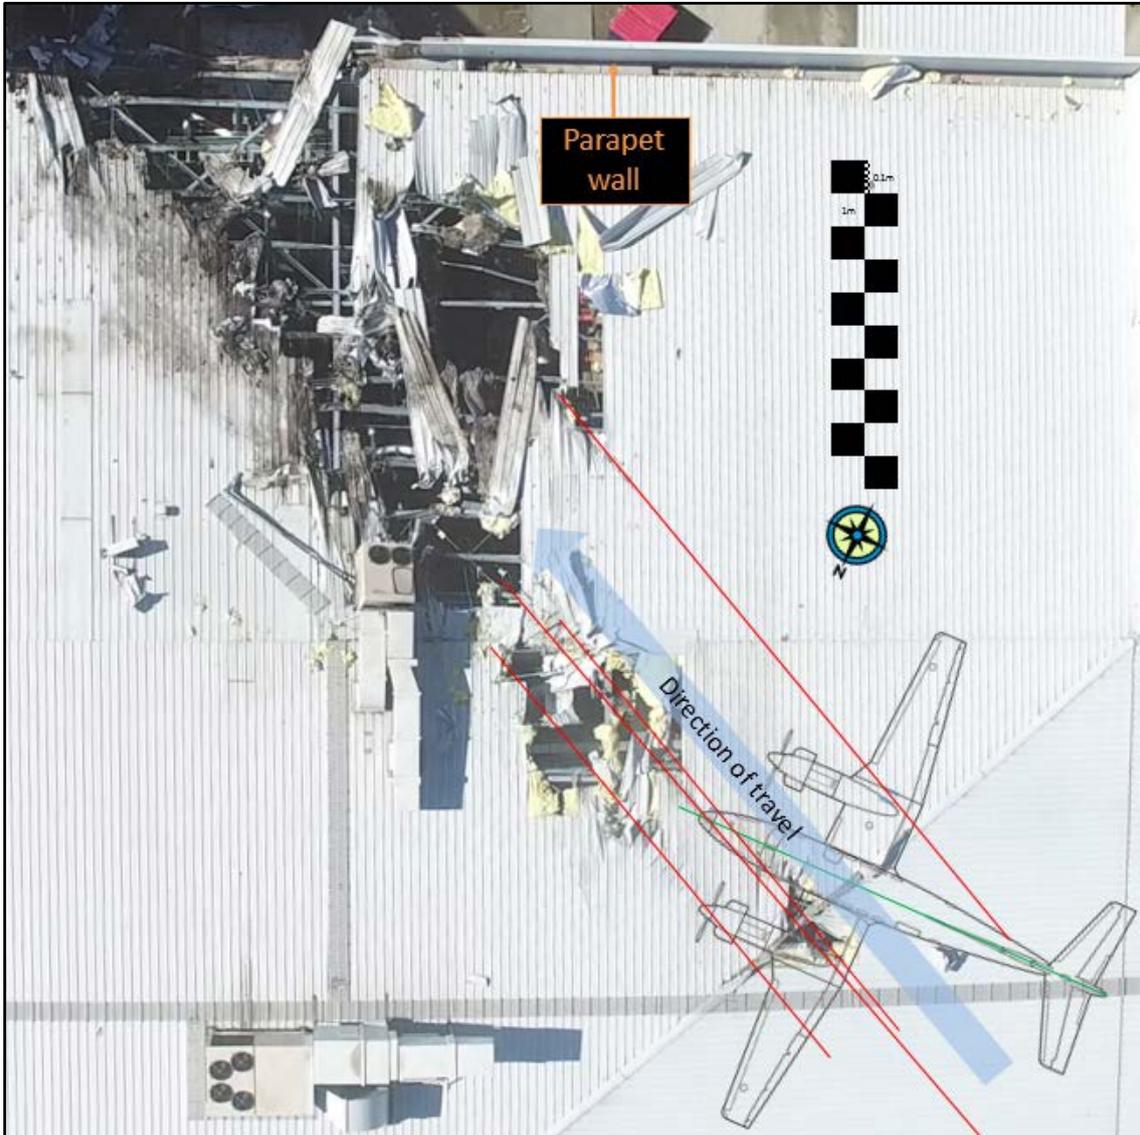
Figure 26: Outlet centre roof impact damage with scaled aircraft aligned with impact marks

Note: Landing gear wheels are offset to the right and apparent wingspan is reduced to allow for a slight left bank.
 Source: Metropolitan Fire Brigade (Melbourne), annotated by the ATSB

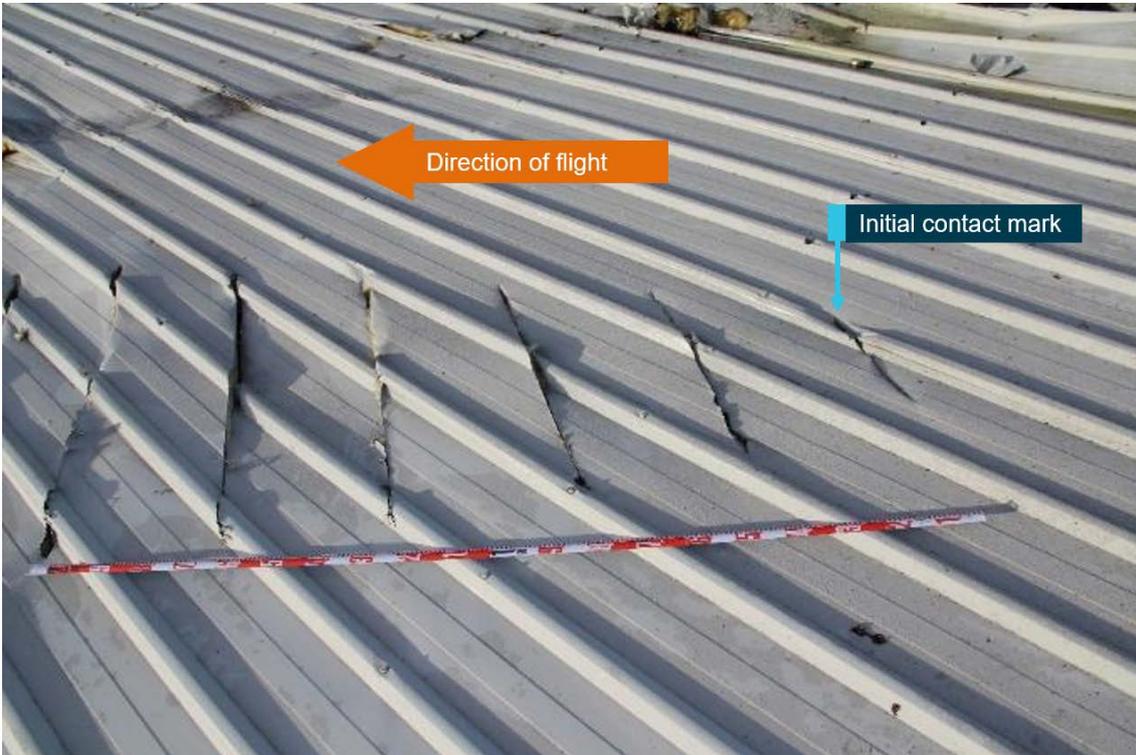
Figure 27: Left propeller slash marks in roofing material with tape measure showing distance between cuts

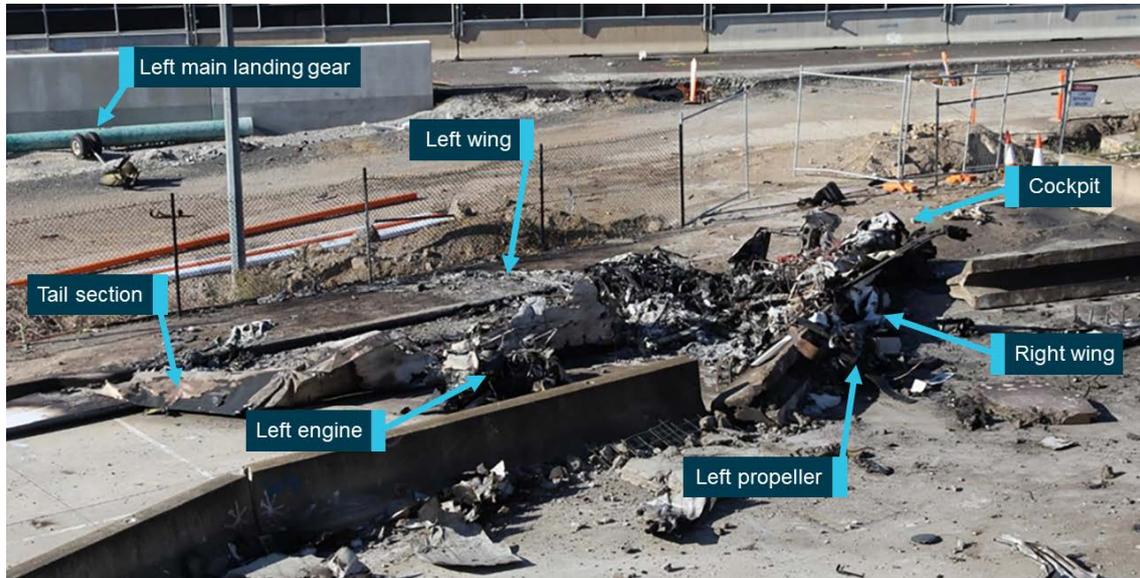
Figure 28: Main wreckage

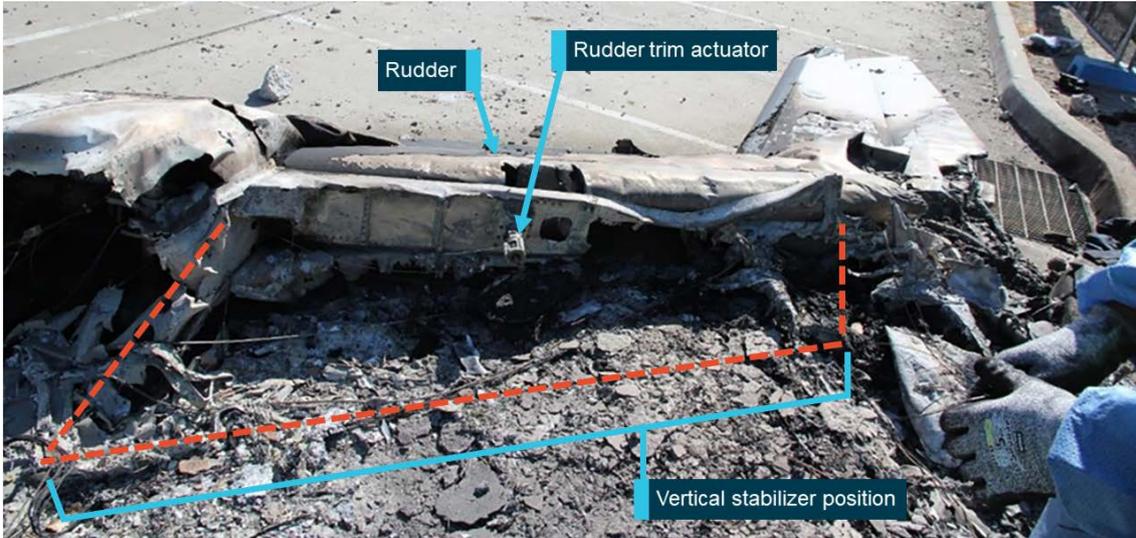
Figure 29: Remains of the vertical stabilizer on its left side showing position of rudder and trim actuator

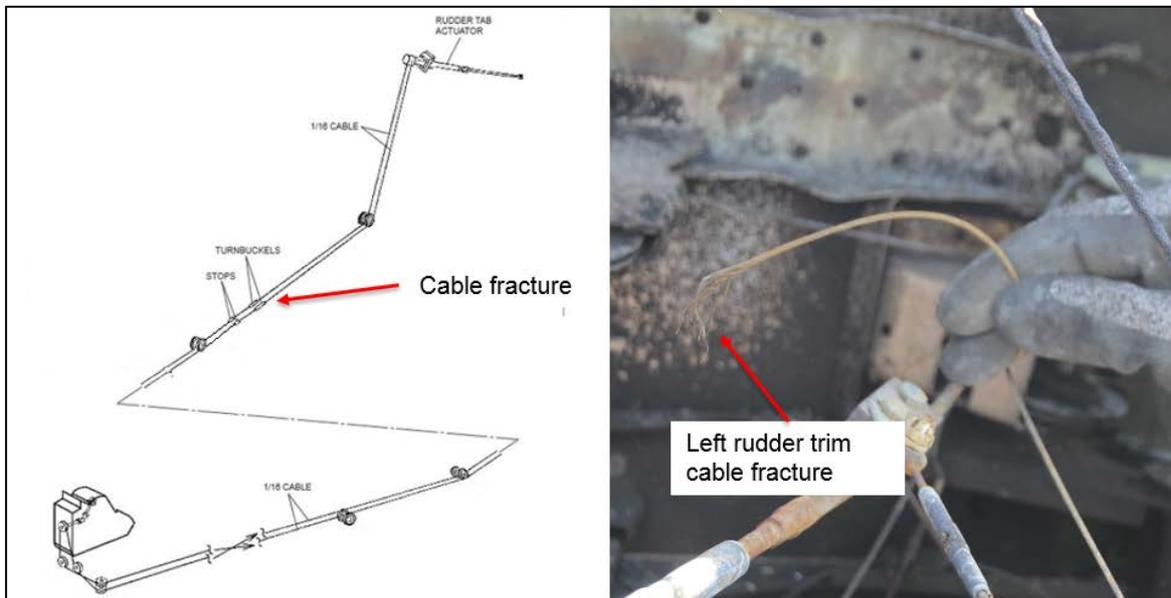
Figure 30: Schematic of rudder trim system showing the approximate cable fracture point (left) and a picture of the left rudder trim cable fracture (right)

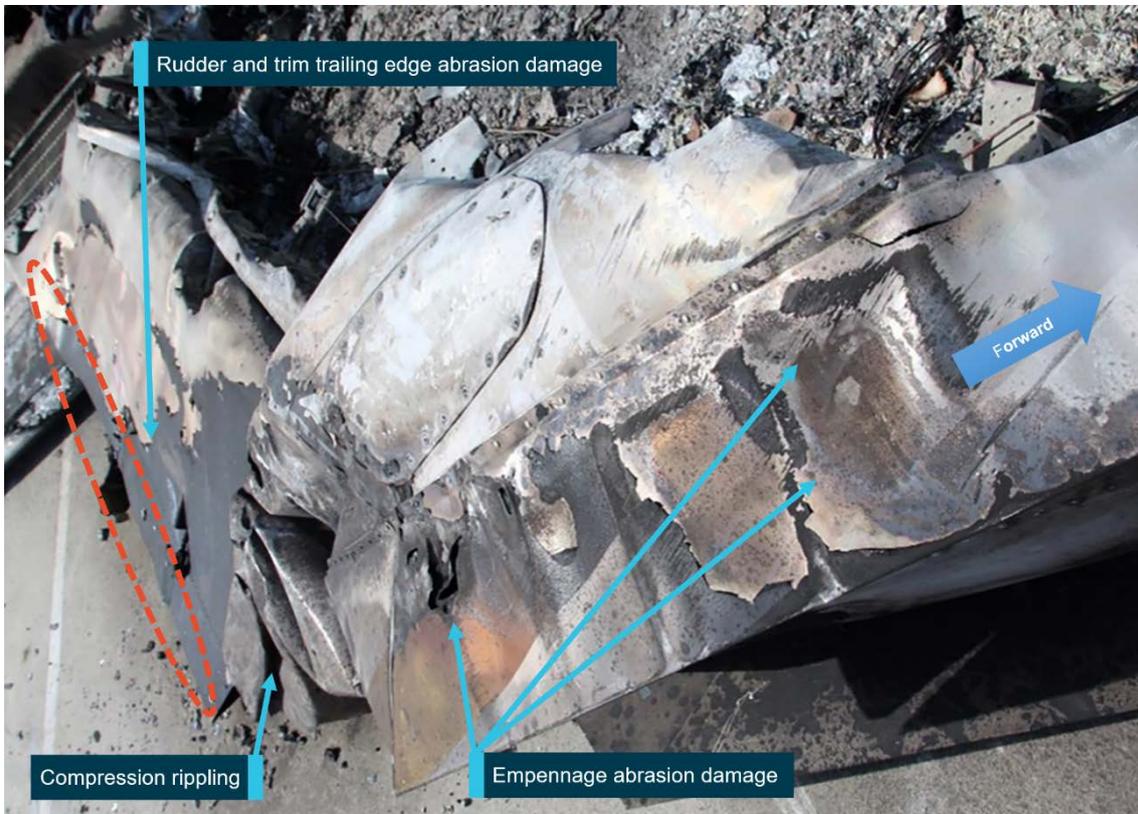
Figure 31: Empennage and rudder viewed from the right showing abrasion damage

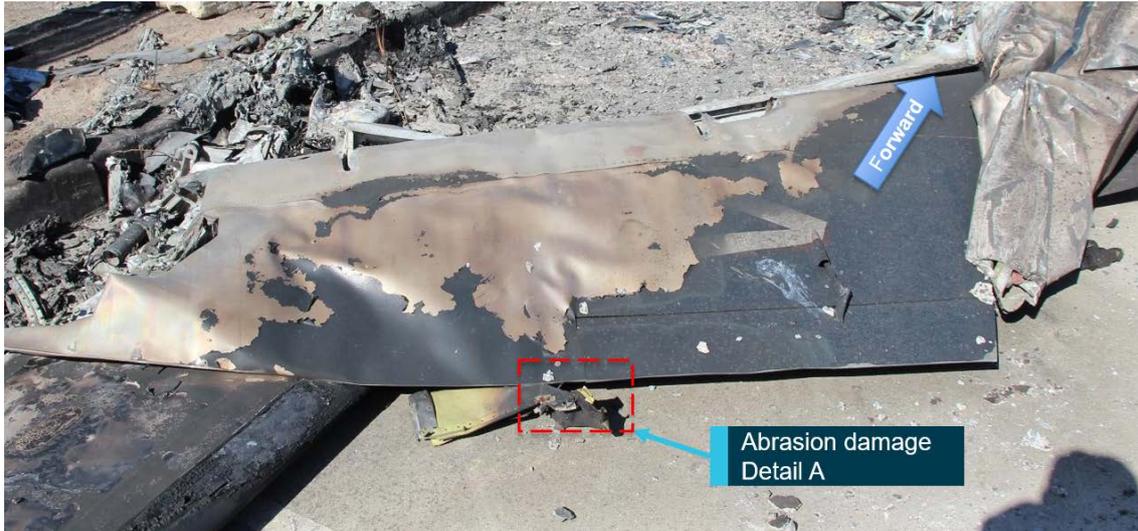
Figure 32: Rudder and rudder trim showing abrasion damage

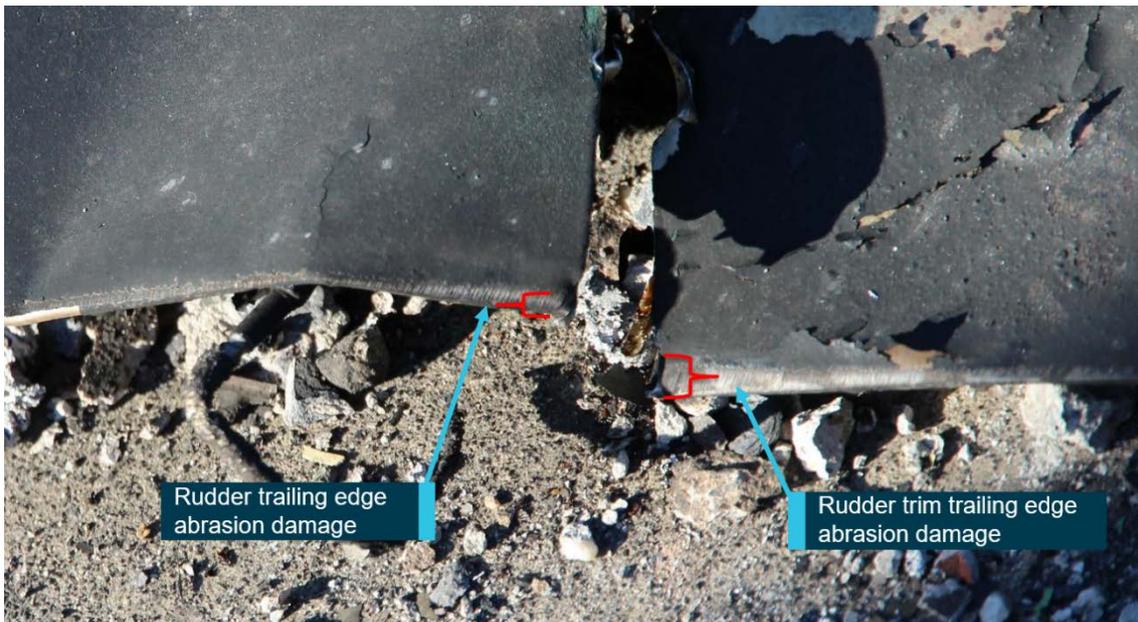
Figure 33: Detail A. Close-up of abrasion damage to rudder and upper surface of rudder trim trailing edge

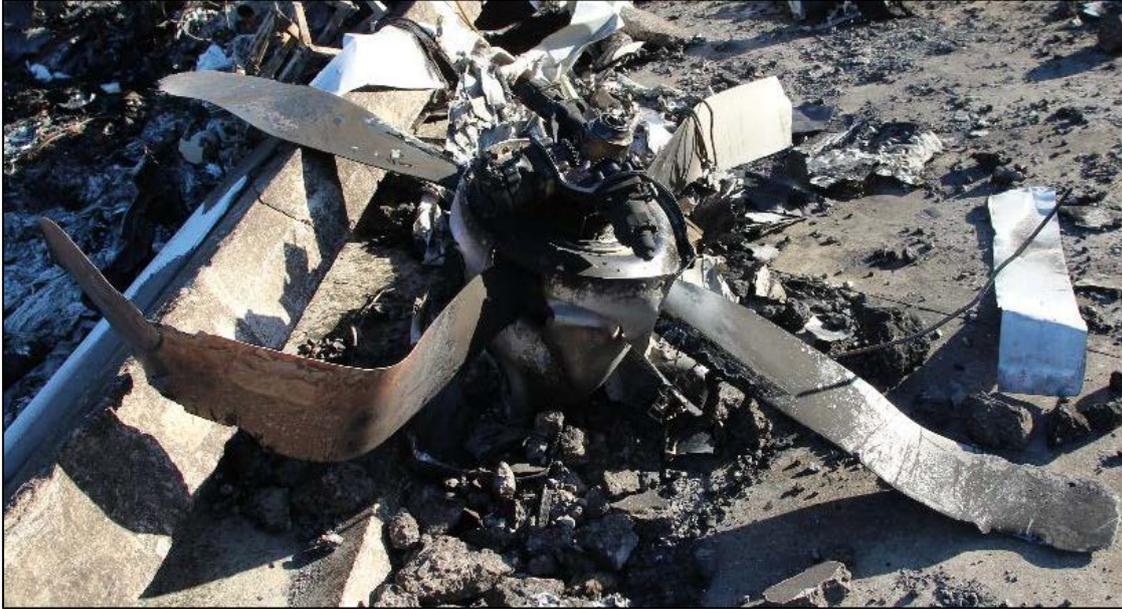
Figure 36: Left propeller viewed from the rear, showing blade-tip fractures, blade gouges and blade bending

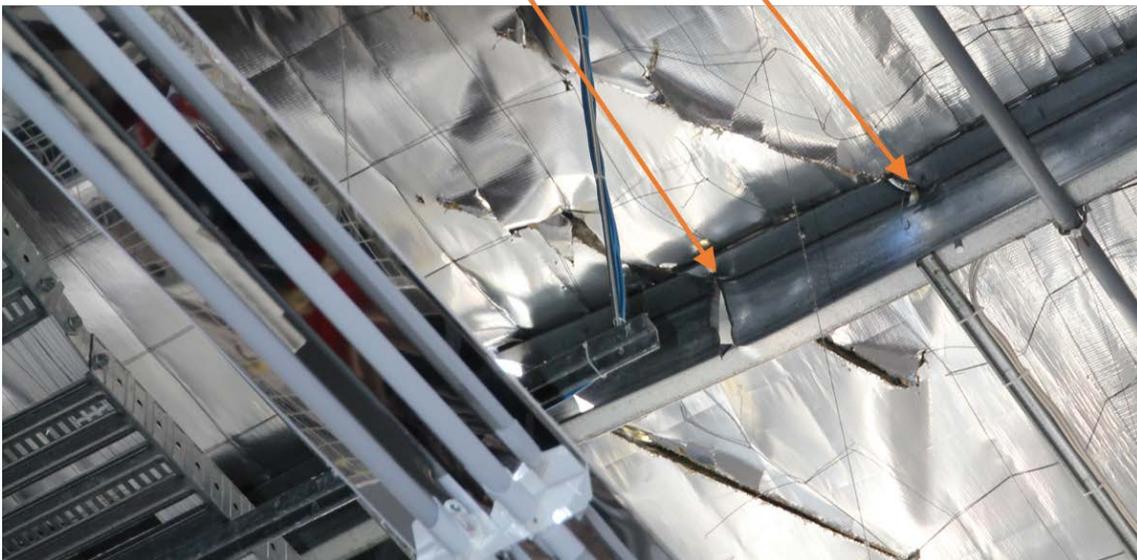
Figure 37: Left propeller cuts through roof structure

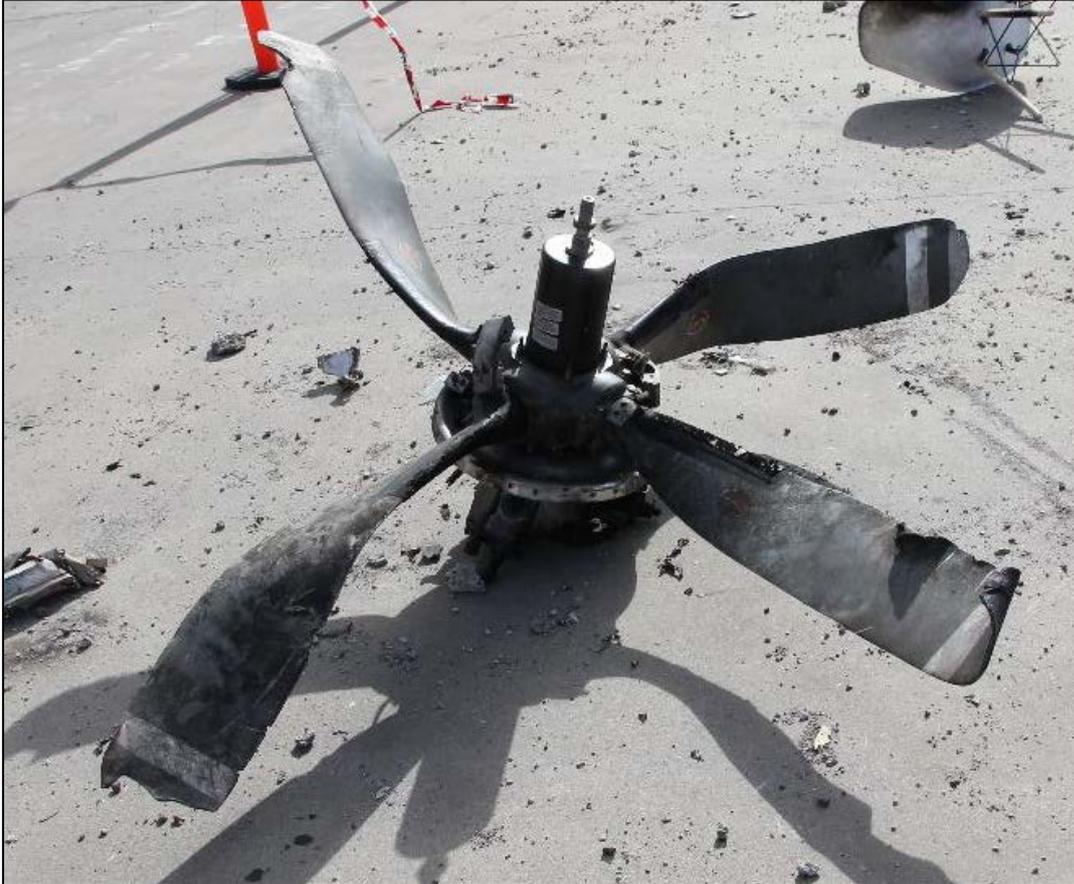
Figure 38: Front view of the right propeller showing bending, chordwise twisting, and leading edge gouging of the propeller blades

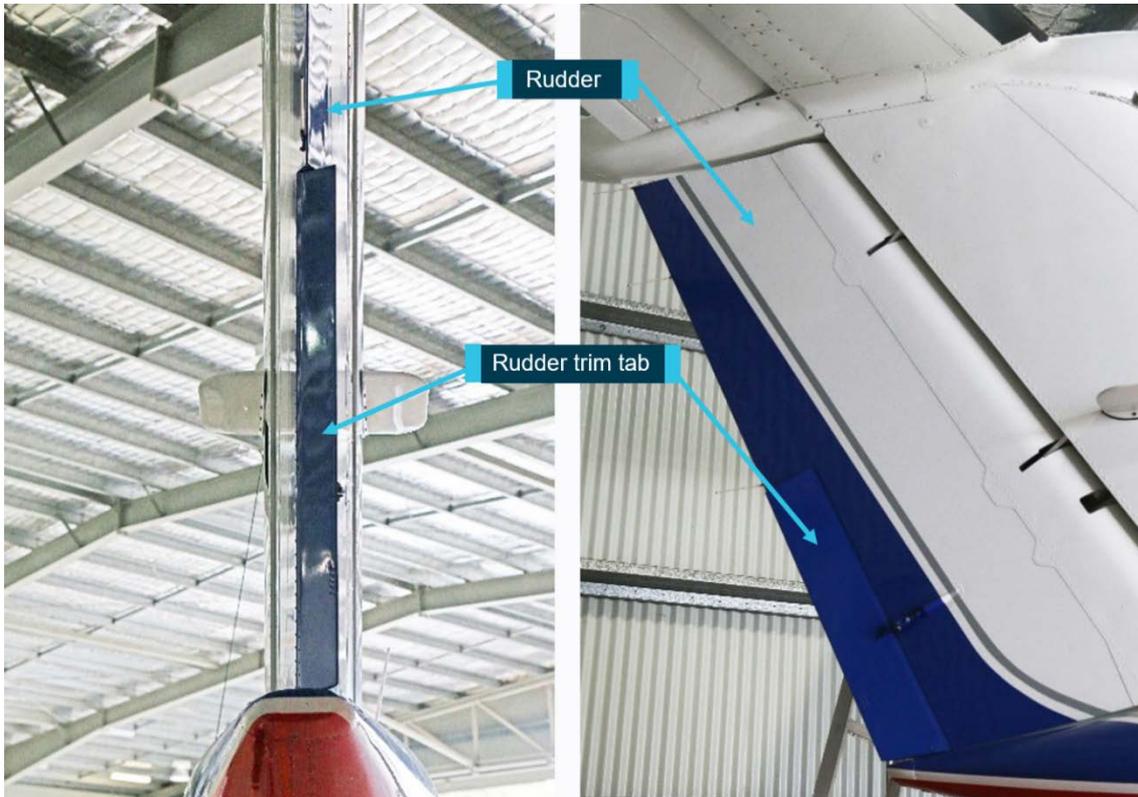
Figure 42: B200 rudder with rudder trim tab set to the full nose-left position

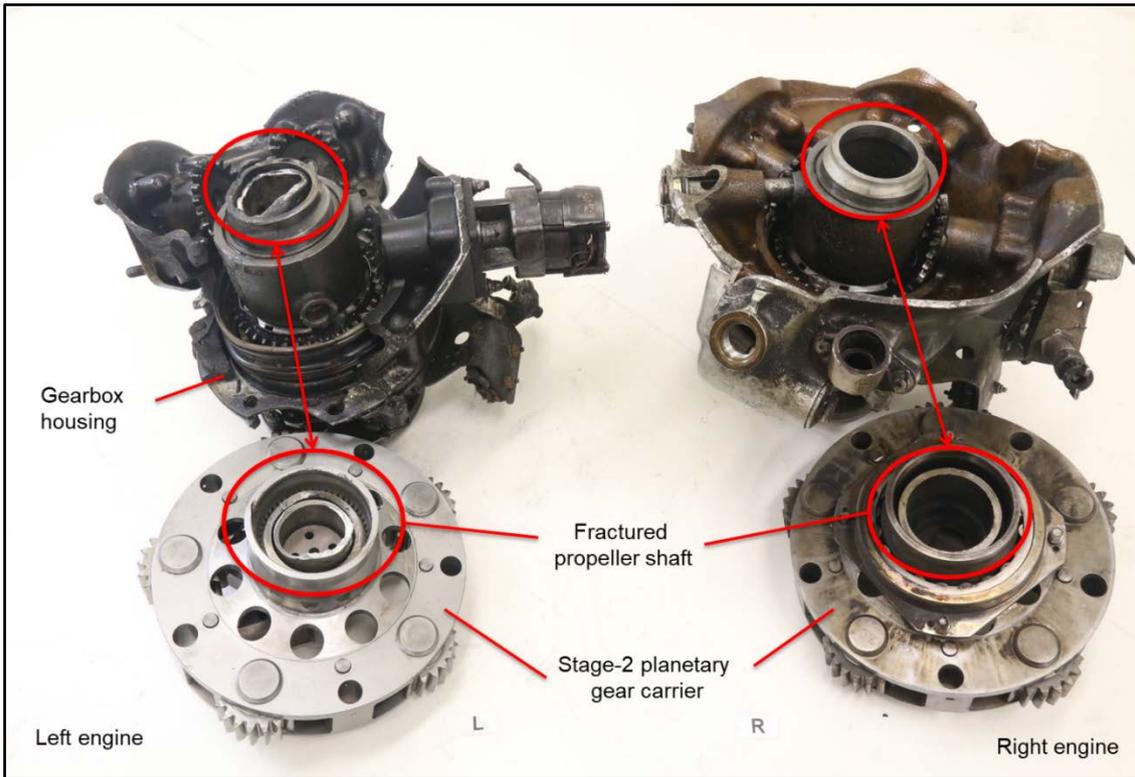
Figure 45: Left and right propeller shaft fractures

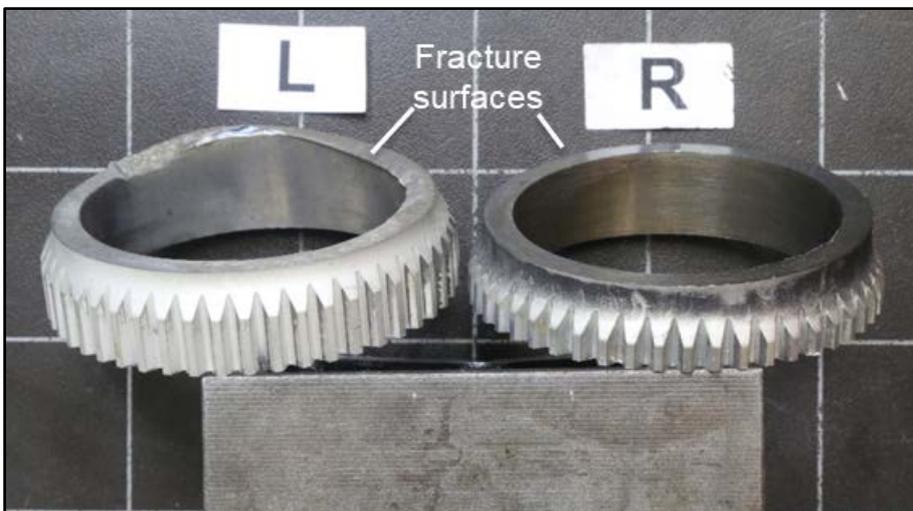
Figure 46: Fractured portion of the propeller shaft from the left and right engines

Note the almost identical planar fracture surfaces.
Source: ATSB

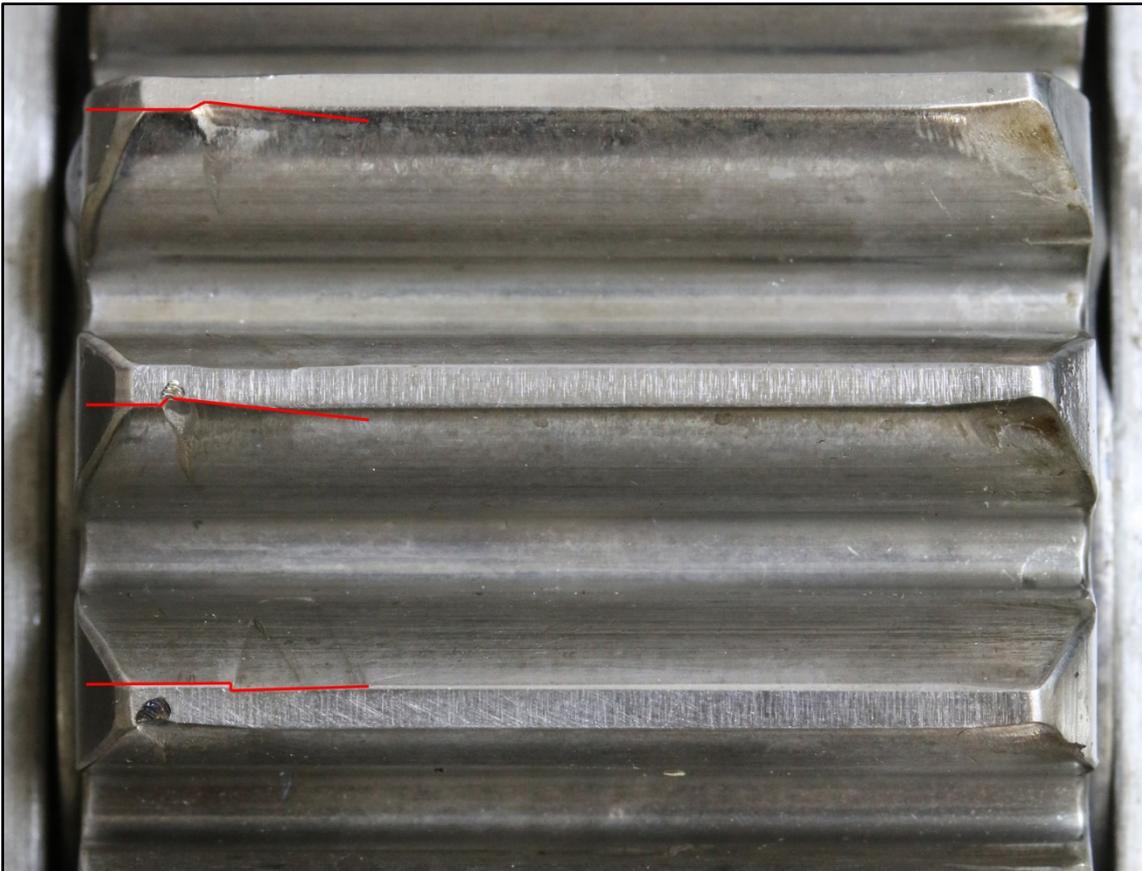
Figure 47: Left engine RGB stage-2 planetary tooth deformation

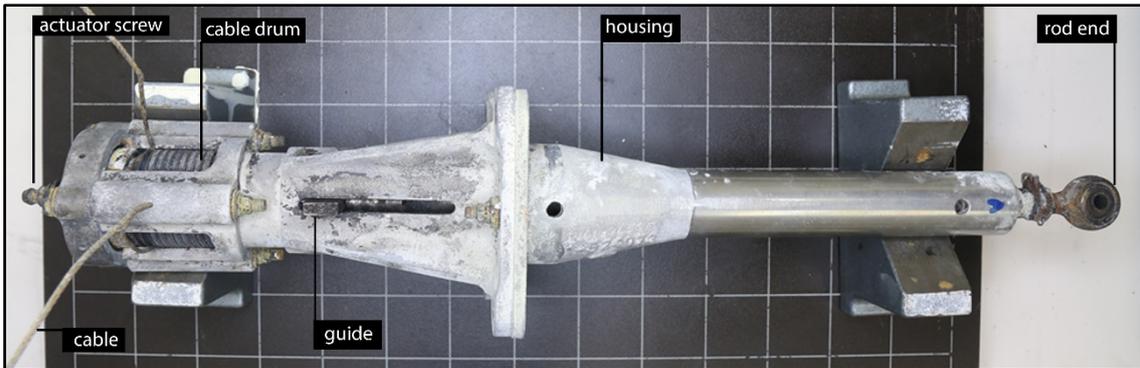
Figure 50: General view of the rudder trim actuator, as received from the accident site

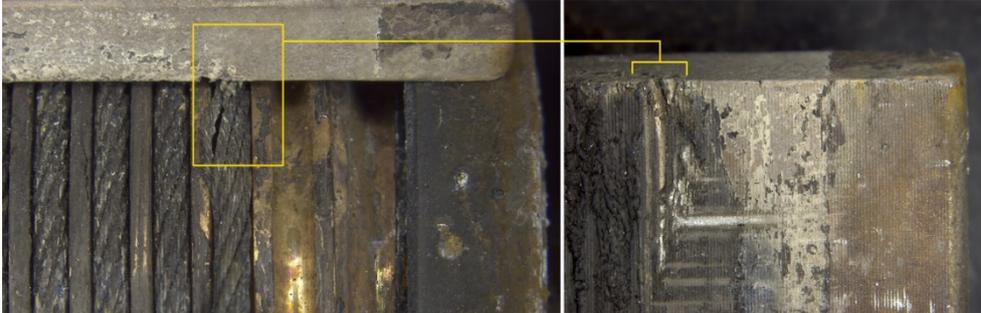
Figure 52: Actuator housing showing the location of the abrasion damage

Sliding contact from the right cable (left image) produced abrasion damage within the housing (right image).
Source: ATSB

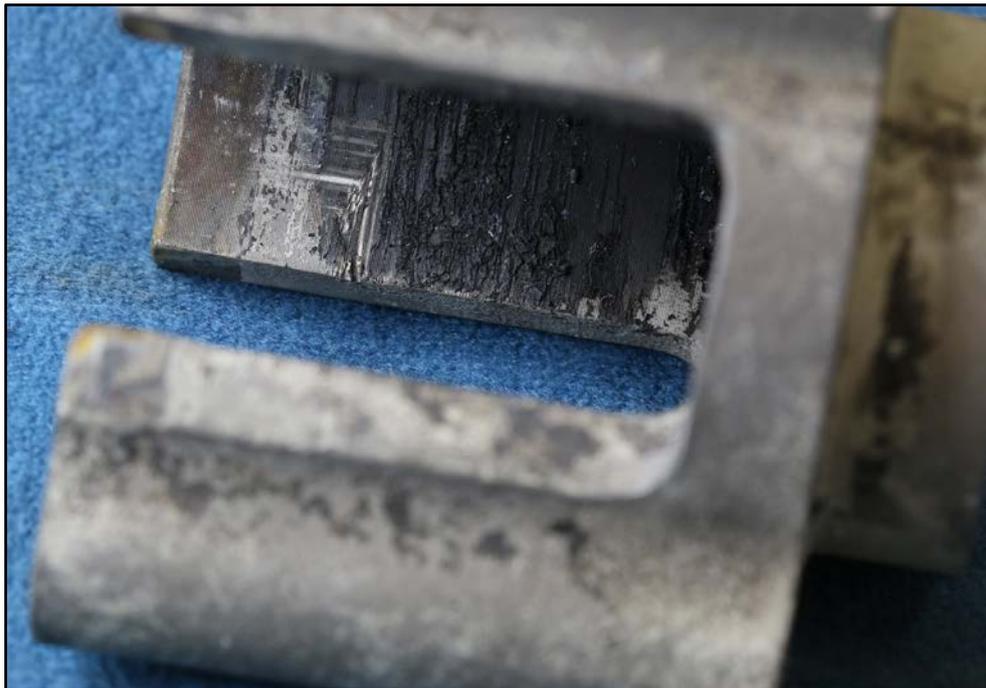
Figure 53: Abrasion damage to the housing attributed to sliding contact from the right cable

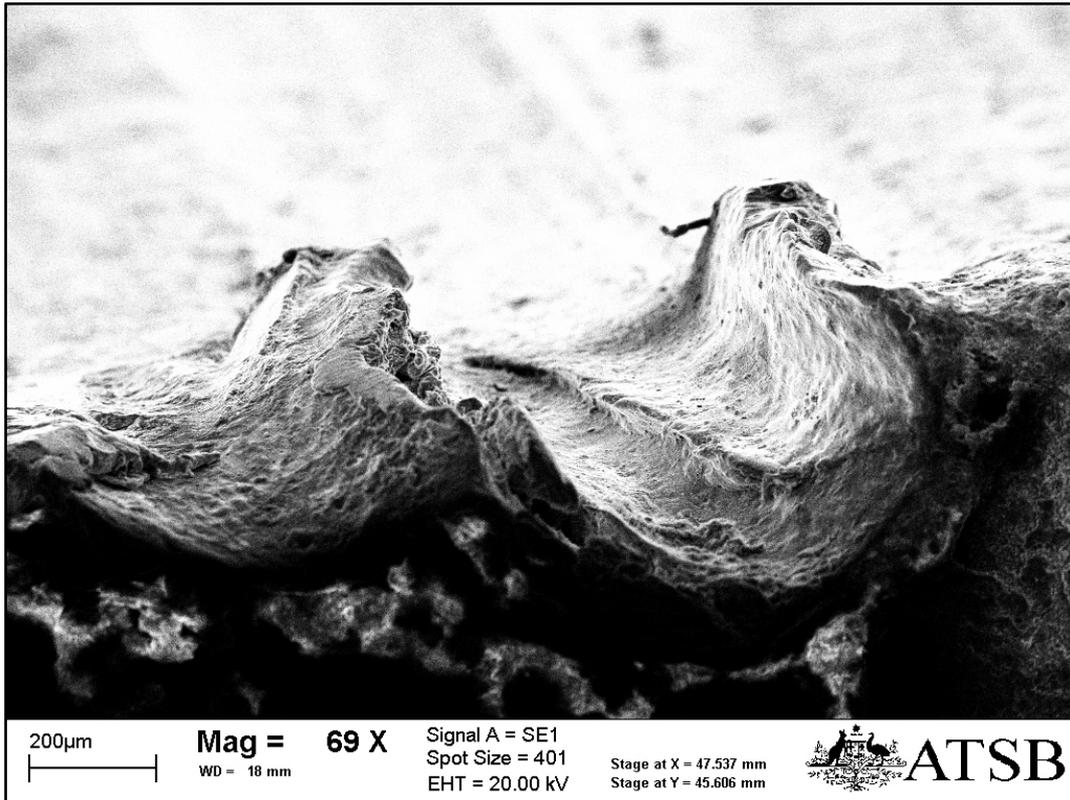
Figure 54: High magnification SEM image of the abrasion damage

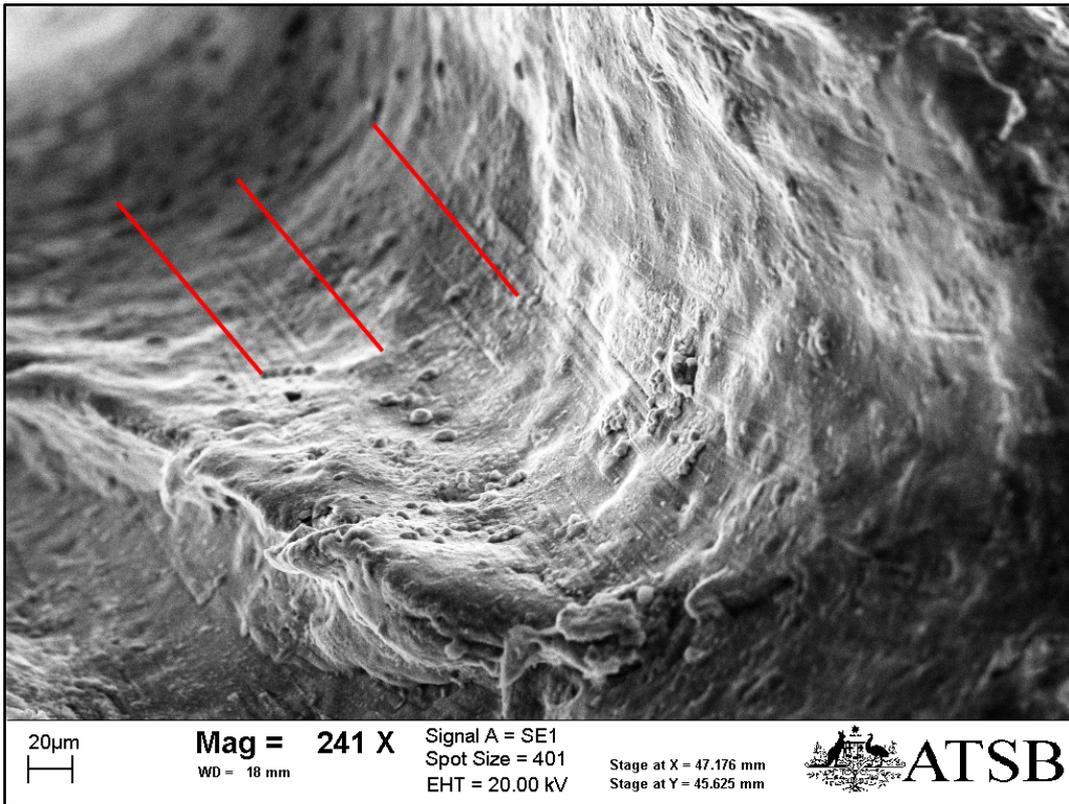
Figure 55: Higher magnification SEM image of the abrasion damage

The red lines highlight the abrasion and scoring resulting from sliding contact between the trim cable and the actuator housing.
Source: ATSB
