AIRCRAFT ACCIDENT REPORT AND EXECUTIVE SUMMARY

Reference:	CA18/3/2/9811	
Aircraft Registration	ZS-CBI	Date of Accident	22 Nov 2017		Time of Accident	1423Z
Type of Aircraft	Hawker Beechcraft Premier 1		Type of Operation	Private (Part 91)		
Pilot-in-command Licence Type	Commercial	Age	61	Licence Valid	Yes	
Pilot-in-command Flying Experience	Total Flying Hours	3048		Hours on Type	641	
Last Point of Departure	Cape Town International Aerodrome (FACT) Western Cape Province					
Next Point of Intended landing	Rand Aerodrome (FAGM) Gauteng Province					
Location of the accident site with reference to easily defined geographical points (GPS readings if possible)						
FAGM Runway 11 beyond the threshold of Runway 29 at GPS S26°14'31.12" E028°09'04.88" at an elevation of 5 483ft						
Meteorological Information	Surface wind 230° at 11kts, temperature 18°, and visibility CAVOK.					
Number of People On Board	2+0	No. of People Injured	0	No. of People Killed	0

Reference Number : CA18/3/2/9811
Name of Owner/Operator : I Branco
Manufacturer : Hawker Beechcraft
Model : Premier 1
Nationality : South African
Registration Marks : ZS-CBI
Place : Extended centre line for Runway 11 at FAGM
Date : 22 N

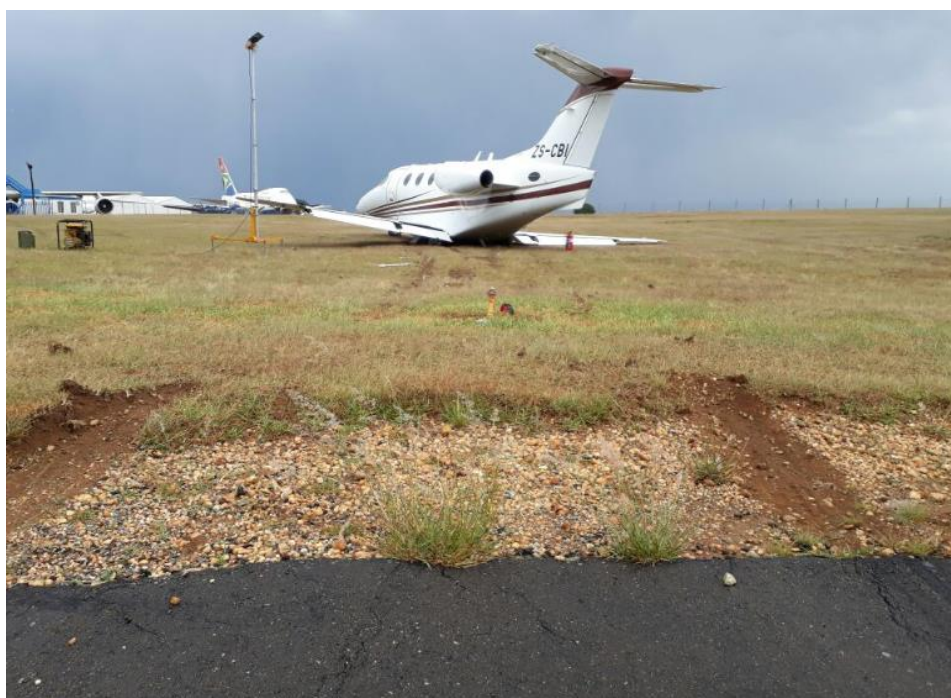
- 1.3.1 The aircraft was substantially damaged.

Figure 1: The aircraft as it came to rest.

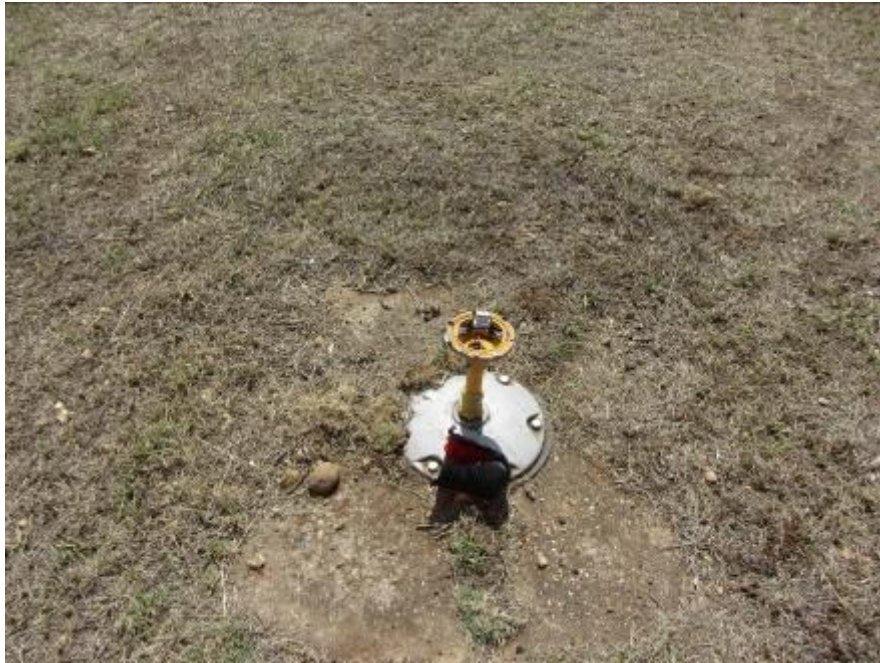
1.4.1 Damage was caused to the runway light on the left side of the extended centre line.

Figure 2: The damaged runway light.

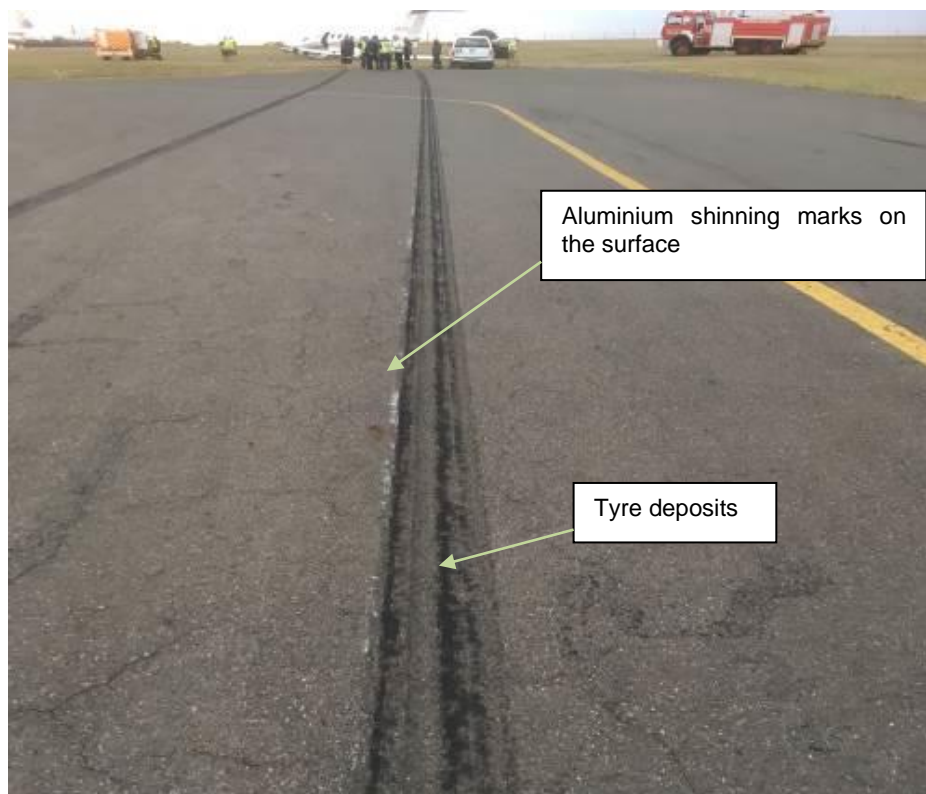
- 1.12.2 Heavy rubber deposits were observed for a length of 180m, indicative of heavy braking on both main wheels on the left of the centre line as seen in Figure 5. The main wheel span was approximately 3m, while the rubber deposits were continuous and steady (indicative of decreasing gradually from the first point of application of emergency brakes), with periodic high and low intensity of rubber deposits and widening and narrowing of the width of tyre brake marks of each wheel. At approximately 80m, the braking marks on the right-hand side were wider with aluminium shinning marks observed on the surface, indicative of the right main wheel hub scratching along the surface, followed by the left hub assembly. It could be seen that the right main wheel burst first. Subsequent light wobbling marks were observed on the surface. These wobbling marks indicate a possibility of the PIC correcting the veering off to the left.

Figure 5: Heavy tyre braking marks, tyre deposits and aluminium shinning marks on the tarmac.

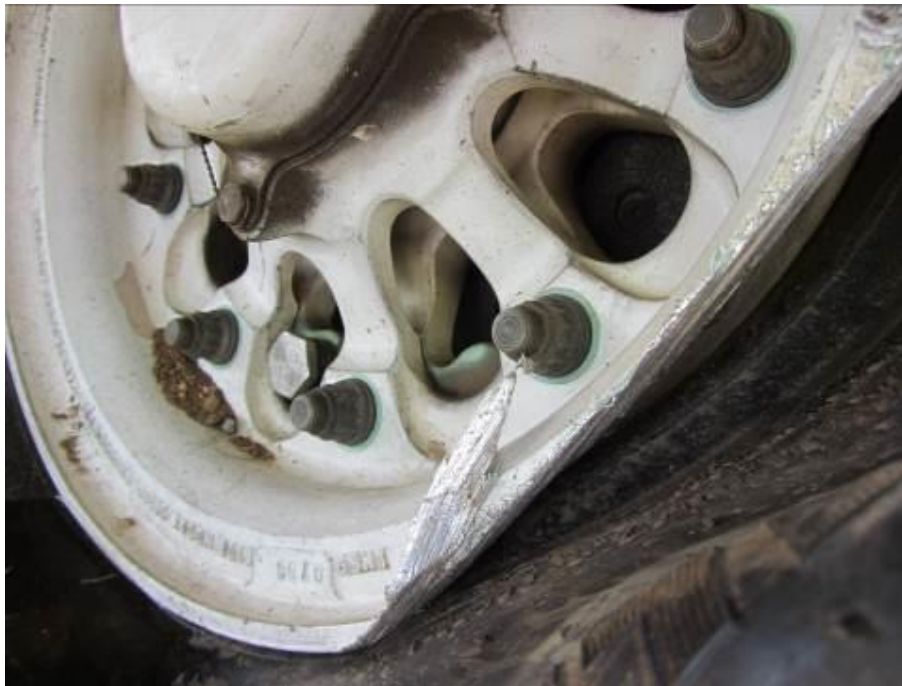
Figure 6: Damage due to erosion on the wheel hub assembly.

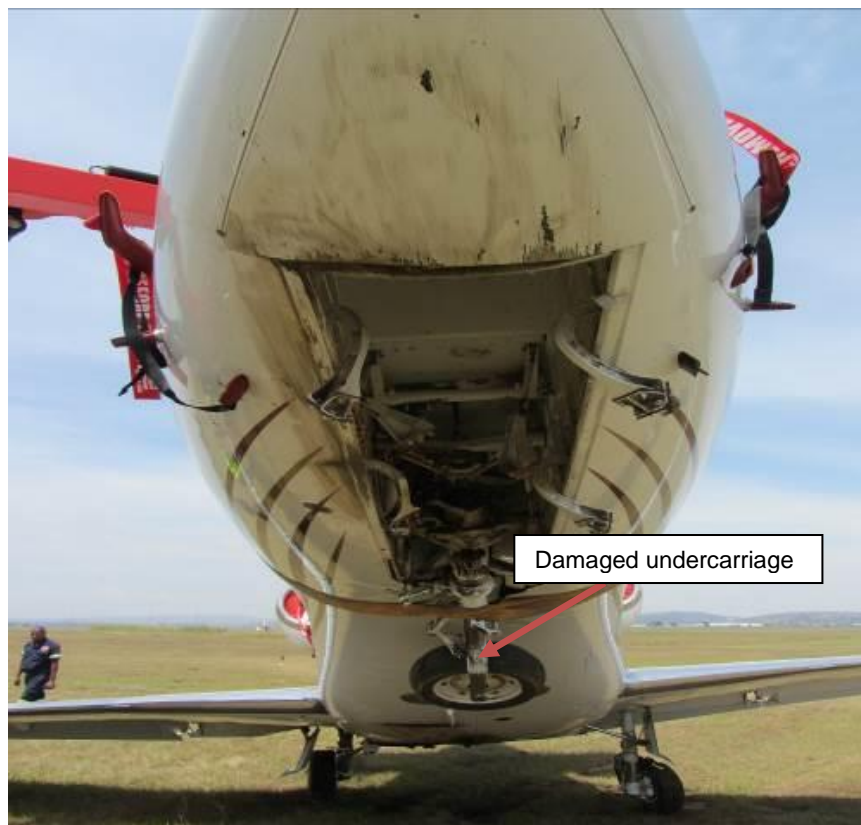
1.12.3 The aircraft, in this condition, continued to roll on the left of the centre line for the remaining length until it came to rest at the edge of Runway 29. At end of the runway, there is a ditch of approximately 200mm in depth. The nose gear dug into the ditch and collapsed, followed by the main undercarriage. The aircraft skidded on its belly, damaging a runway light, until it came to rest with the nose facing slightly to the left of the centre line. The aircraft was substantially damaged on the undercarriage. The flaps were observed to be fully extended in Figure 9. Although the main landing gear struts were disrupted, they were still attached and hanging loose under the belly. The landing gear struts had broken off from the attachment points as seen in Figure 7. Both main tyres were found to have burst at the tread surface having an oval hole which eroded off completely, indicative of erosion due to braking action as seen in Figure 8. Some burning signs were also observed on the plies. A few pieces of tyre plies were also recovered from the runway.

Figure 7: The damaged undercarriage.

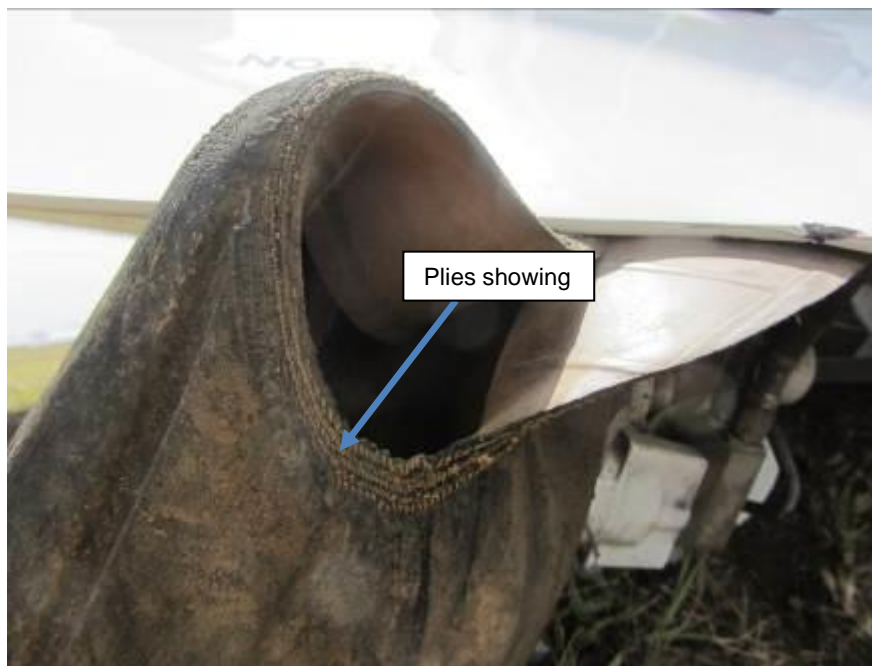
Figure 8: An eroded spot caused by erosion due to heavy breaking.

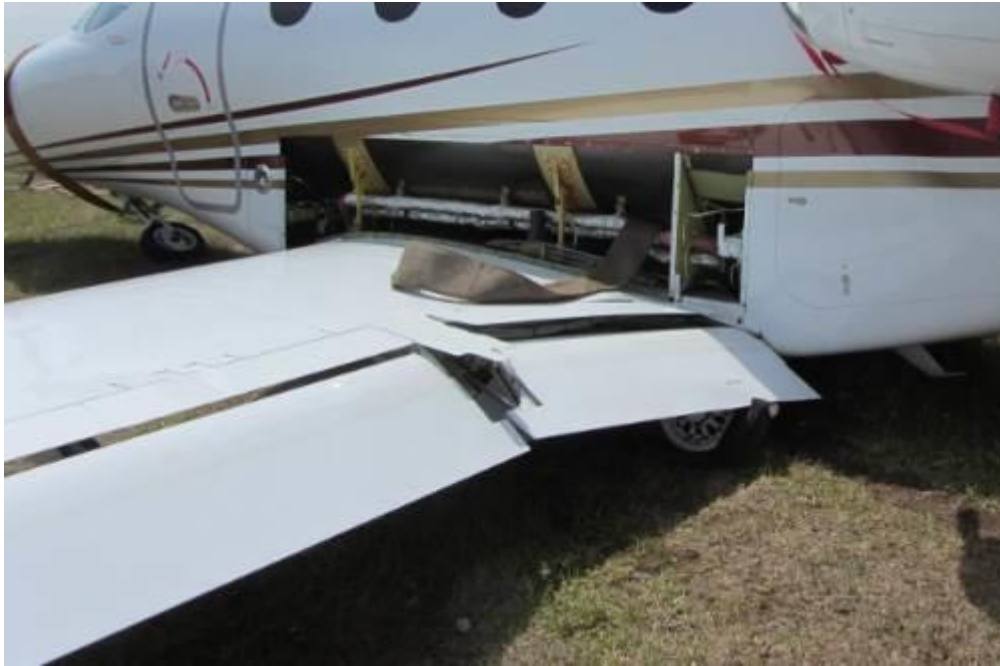
1.12.4 The right-hand flaps were damaged when the fire services gained access to the battery compartment. The belly was observed to have sustained minor scratches and damage caused on the fairings as a result of the undercarriage collapsing. The flaps were observed to be in the fully down position as shown in Figure 9. The cockpit of the aircraft indicated that the flap lever setting was at the fully down position. The lift dump lever was at the down position. The anti-skid switch was in the normal position. The engines were cut off. The emergency brake lever was in the down position.

Figure 9: Flaps in fully down position (picture taken during recovery).

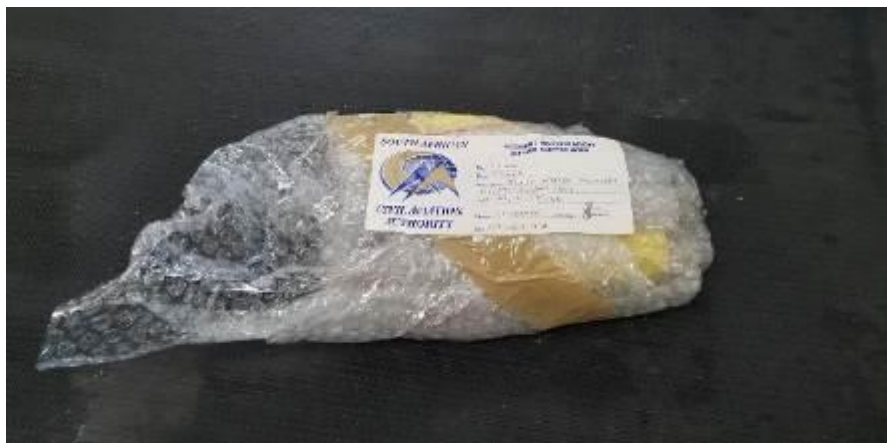
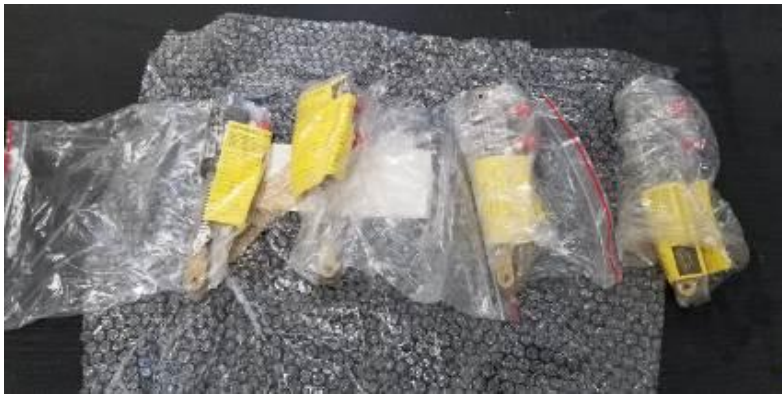
The findings for each brake master cylinder were consistent with in-service units for all three tests. A copy of the test results is referenced in Appendix C of this report.

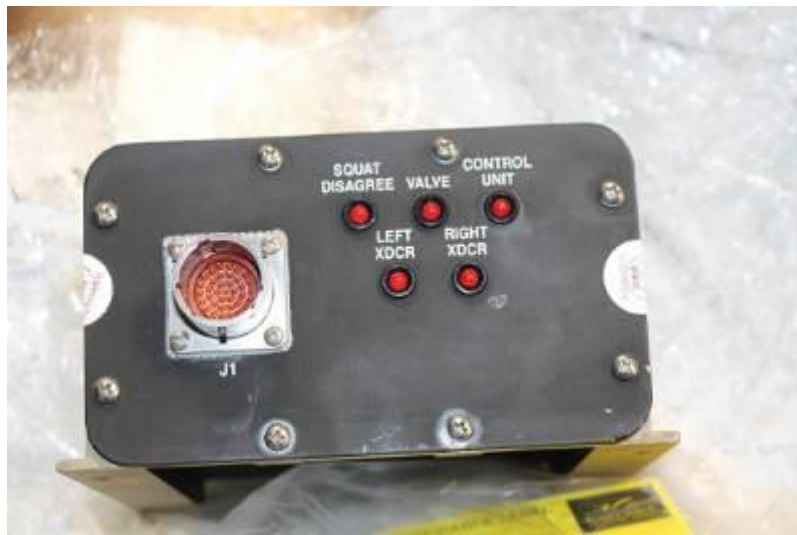
The ACU, part no. 42-989-1, serial no. 362, did not display any external damage and was connected to the test apparatus by an R&O electronics technician, shown in Figure 19 below and in accordance with Crane Aerospace Test Procedure TP42-989-1, which involved the following tests:

Figure 19: Anti-skid control unit instrument panel as received.

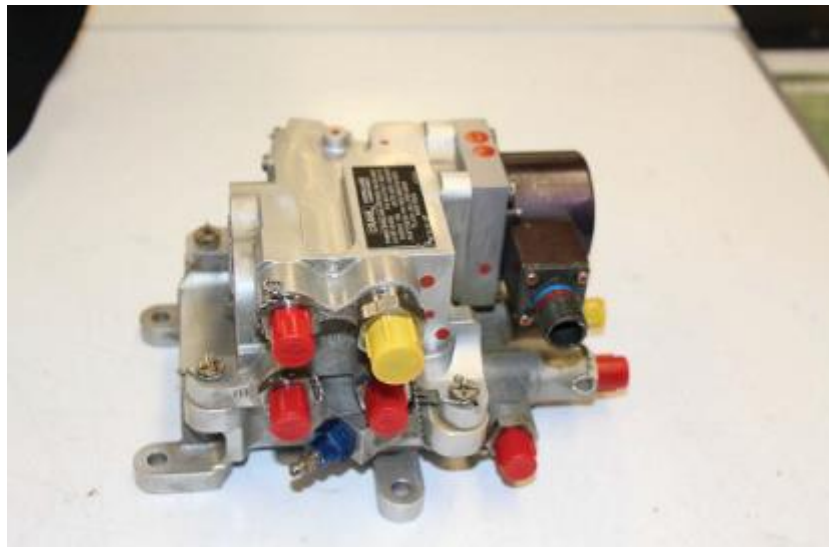
The power brake and anti-skid valve, part no. 84-015-1, serial no. 195, did not display any external damage or visual indications of leakage. The unit was connected to the test bench by an R&O team lead, shown in Figure 2 below and in accordance with Crane Aerospace Test Procedure TP84-015-1. The unit was photographed (see Appendix A) and the following tests were performed:

Figure 20: Power brake and anti-skid valve as received.
