National Transportation Safety Board Aviation Accident Final Report

Location:	Seldovia, Alaska	Accident Number:	ANC19FA035
Date & Time:	July 19, 2019, 10:10 Local	Registration:	N68083
Aircraft:	De Havilland BEAVER DHC 2	Aircraft Damage:	Substantial
Defining Event:	Loss of control on ground	Injuries:	1 Fatal, 1 Serious, 4 Minor, 1 None
Flight Conducted Under:	Part 135: Air taxi & commuter - Non-scheduled

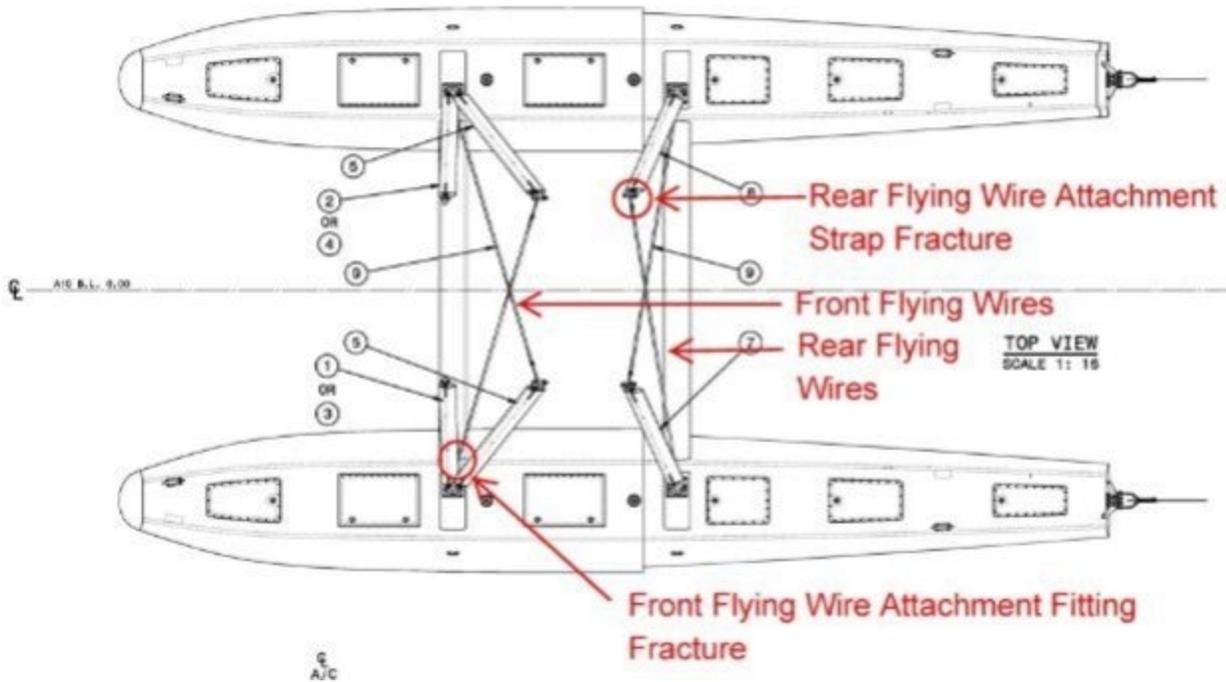
Figure 1- Float Assembly Diagram (courtesy of Aerocet)

Examination of the float assembly revealed fractures in the left front flying wire attachment fitting and the right rear flying wire attachment strap and hole elongation in the left rear flying wire attachment fitting. Additionally, the bolts attaching the two left flying wire attachment fittings to the left float were bent, and the two flying wires that had been attached to the fractured attachment fitting and attachment strap were buckled. While some areas of corrosion were observed on the fractured left forward fitting, the total area of corrosion was a small percentage of the total cross-section, and the remainder of the fracture and associated deformation of the lug was consistent with ductile overstress fracture. Similar areas of corrosion were also observed on each of the intact flying wire attachment fittings.

The airplane nosed over in ocean waters and came to rest inverted. All major components were recovered except for the right wing, right aileron, and right lift strut. Flight control continuity was verified from the control yoke to the right fuselage bellcrank push/pull tube, the left aileron and elevators, and from the rudder pedals to the rudder. An examination of the floats and their attachment rigging revealed that the front left flying wire attachment fitting (attached to the left float) fractured, and the associated flying wire exhibited compression buckling signatures near the upper attachment point. The right rear flying wire attachment strap (attached to the fuselage) fractured, and the associated flying wire exhibited compression buckling signatures near the lower attach point. (See Figure 1). No significant deformation was present on the underside or nose of either float.

An examination of the left float struts and flying wire attachment components was completed by the National Transportation Safety Board (NTSB) Materials Laboratory personnel. The left float struts had fracture surfaces with rough matte-gray features and deformation consistent with ductile overstress with bending or torsion loads.

An examination of the aluminum flying wire attachment fittings revealed that the bolts for attaching the two left flying wire attachment fittings to the left float were bent, and the attachment hole in the intact left rear attachment fitting was elongated. Fractures in the left front attachment fitting and right rear attachment strap were consistent with ductile overstress fracture. Small areas of corrosion were observed on the fractured left forward flying wire attachment fitting; however, the total area of corrosion was a small percentage of the total cross-section, and the remainder of the fracture and associated deformation of the lug exhibited rough matte-gray features consistent with a ductile overstress fracture. In addition, small amounts of corrosion were also observed on the three intact flying wire attachment fittings.
