## Accident

<b>Aircraft Type and Registration:</b>	Boeing 737-4Q8, G-JMCY	
<b>No &amp; Type of Engines:</b>	2 CFM56-3C1 turbofan engines	
<b>Year of Manufacture:</b>	1994 (Serial no: 25114)	
<b>Date &amp; Time (UTC):</b>	19 January 2021 at 0237 hrs	
<b>Location:</b>	Exeter Airport, Devon	
<b>Type of Flight:</b>	Commercial Air Transport	
<b>Persons on Board:</b>	Crew - 2	Passengers - None
<b>Injuries:</b>	Crew - None	Passengers - N/A
<b>Nature of Damage:</b>	Damaged beyond economical repair	
<b>Commander's Licence:</b>	Air Transport Pilot's Licence	
<b>Commander's Age:</b>	56 years	
<b>Commander's Flying Experience:</b>	15,218 hours (of which 9,000 were on type) Last 90 days - 25 hours Last 28 days - 14 hours	
<b>Information Source:</b>	Field Investigation

## Synopsis

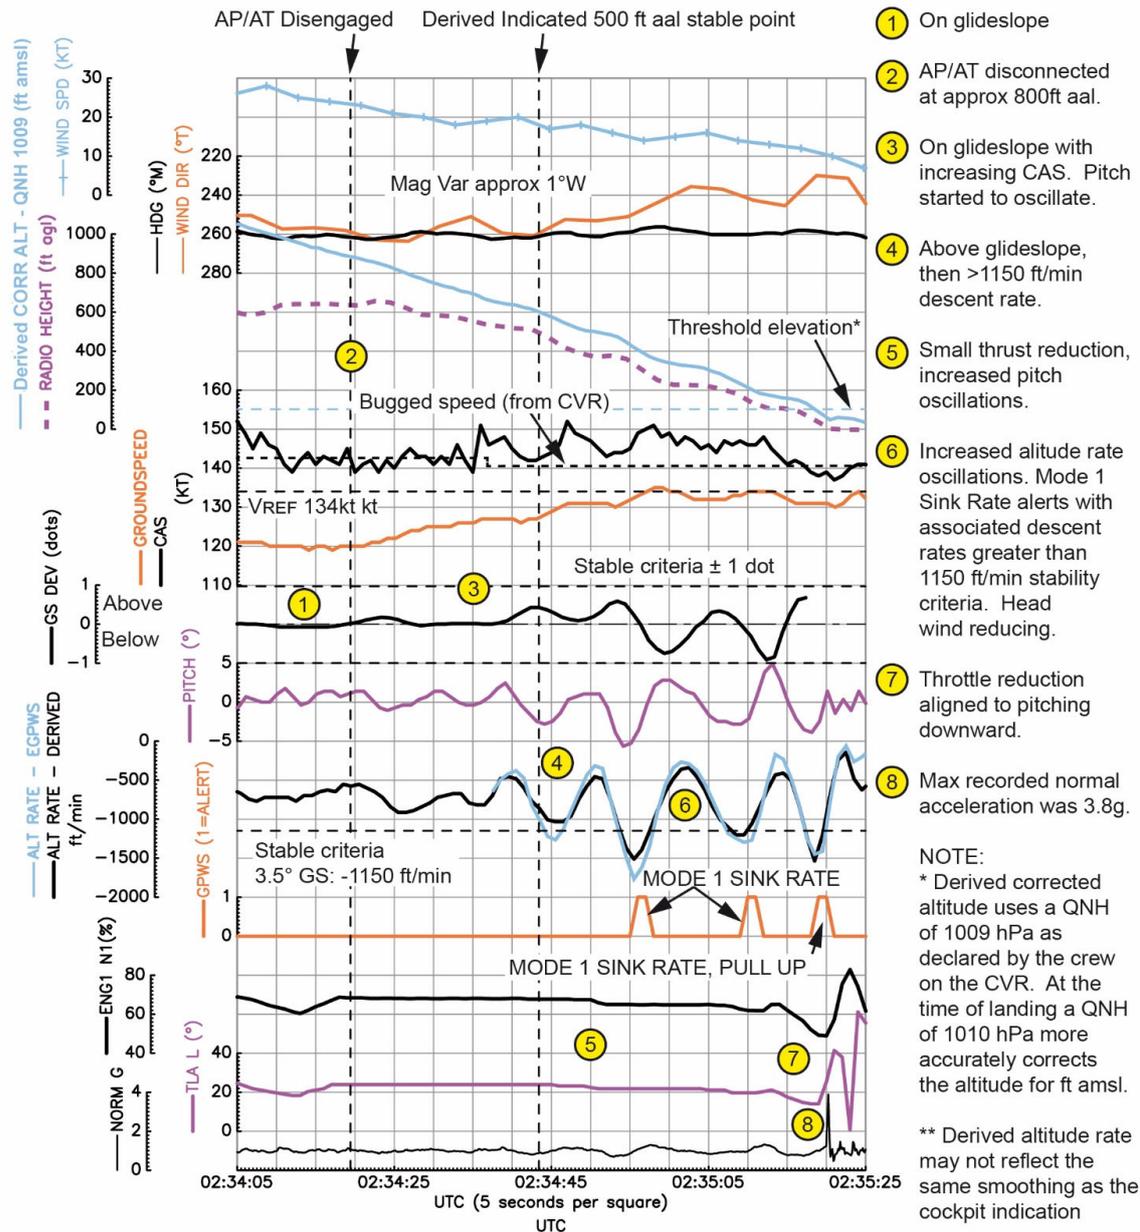
Figure 4 shows the pertinent parameters associated with the approach and landing.

The data indicates that the aircraft did not stall. The maximum vertical acceleration recorded by the FDR on touchdown was 3.8g, at this point there was 3° of left roll. However, FDR sample rates and sensor locations are not ideally placed to determine peak forces on touch down. Altitude rate parameters are smoothed and so lag the aircraft dynamic behaviour. The descent rate values were decreasing on touchdown, but more detailed aircraft modelling was required to better understand the descent rate at touchdown. The airframe manufacturer assessment of the data indicates a calculated descent rate of approximately 24 ft/second. This is consistent with the trends of the combined recordings of the left and right radio heights.

After landing, the aircraft maintained a left roll attitude taxiing to the stand, varying between 1.5° and 4.5°. The right trailing edge flap angle had reduced from 40° to 37° on landing, but later in the landing roll this returned to 40°, matching the recorded left flap angle again. The master caution was triggered as the groundspeed reduced through approximately 20 kt. The FDR recorded low pressure states for the hydraulic A and B systems associated with engine 1 and 2 respectively and hydraulic B electrical systems during the taxi to stand.

Pertinent parameters from the FDR and TAWS recordings

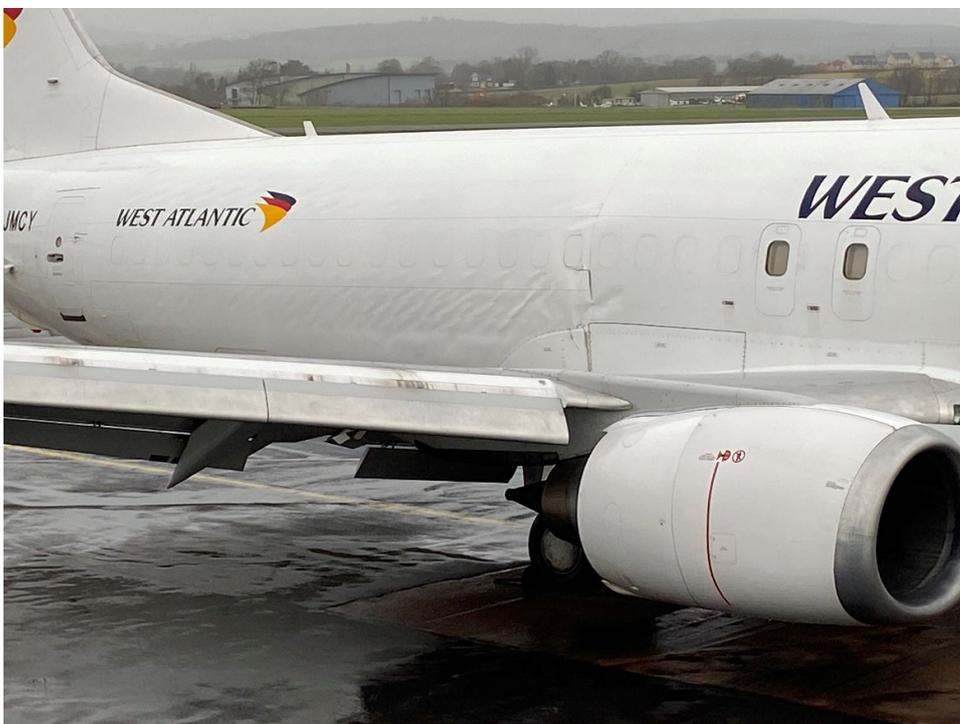
**Figure 5**

The fuselage skin aft of the wings was cracked and buckled, and the rear fuselage was distorted downward, Figure 5. The crown skin was creased and rippled along most of the fuselage.

Photograph looking aft showing distortion of the rear fuselage and rippling in the skin

Safety margins are lower in the aft fuselage skin, thereby accounting for the damage in this area. Overall, the manufacturer concluded that the damage sustained by G-JMCY was consistent with a hard landing.

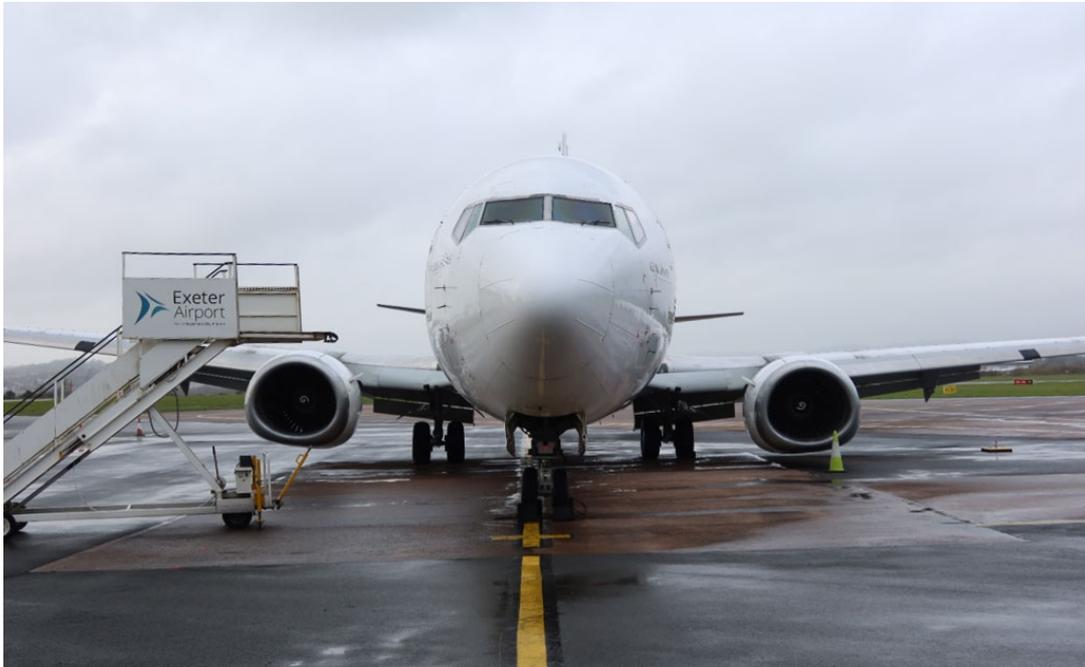
**Figure 6**

Residual hydraulic oil was dripping from several areas but there were no indications of a fuel leak. Both main landing gear shock absorbers were found to be bottomed, and the left main landing gear beam was distorted upwards such that the aircraft was approximately 2° left-wing low (Figure 6).

G-JMCY - left-wing low due to the main landing gear beam damage

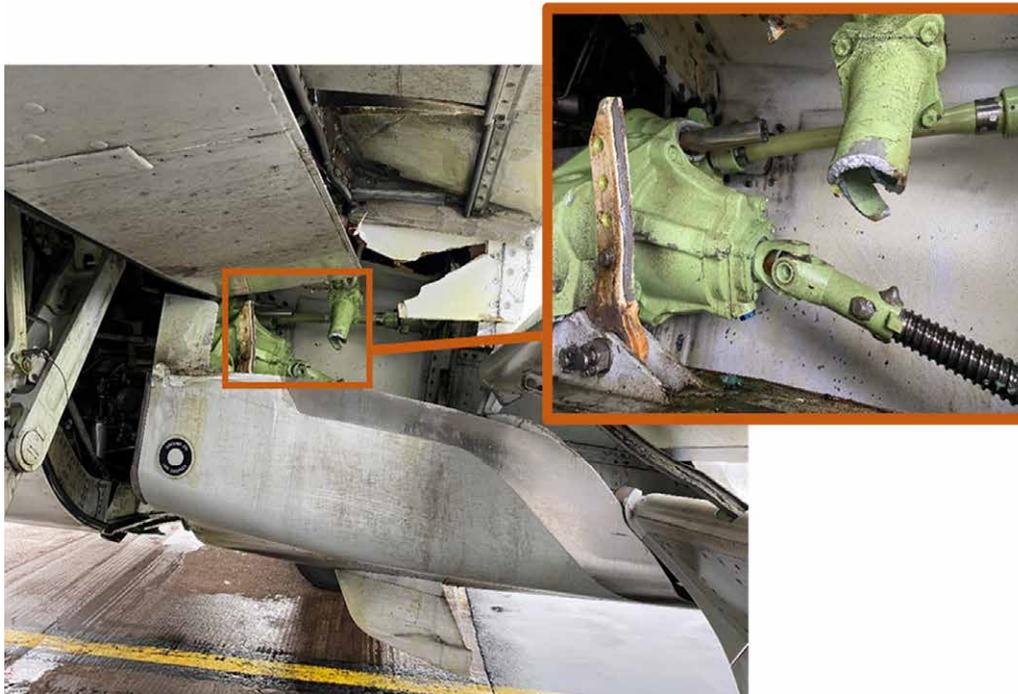
**Figure 7**

There was no obvious tyre damage and the main landing gear drag strut bolts were intact. The engine cowlings were undamaged, so it was apparent that the engines had not touched the runway during the landing. The flap drive mechanism was damaged, and the left-wing inboard driveshaft was bent; the left inboard gearbox casing and its mountings were broken (Figure 7).

View looking inboard under the left-wing. Broken flap gearbox is highlighted
