# Aviation Investigation Final Report

<b>Location:</b>	Ketchikan, Alaska	<b>Accident Number:</b>	ANC21FA069
<b>Date &amp; Time:</b>	August 5, 2021, 10:50 Local	<b>Registration:</b>	N1249K
<b>Aircraft:</b>	DEHAVILLAND DHC-2 MK.I	<b>Aircraft Damage:</b>	Destroyed
<b>Defining Event:</b>	Controlled flight into terr/obj (CFIT)	<b>Injuries:</b>	6 Fatal
<b>Flight Conducted Under:</b>	Part 135: Air taxi & commuter - Non-scheduled - Sightseeing

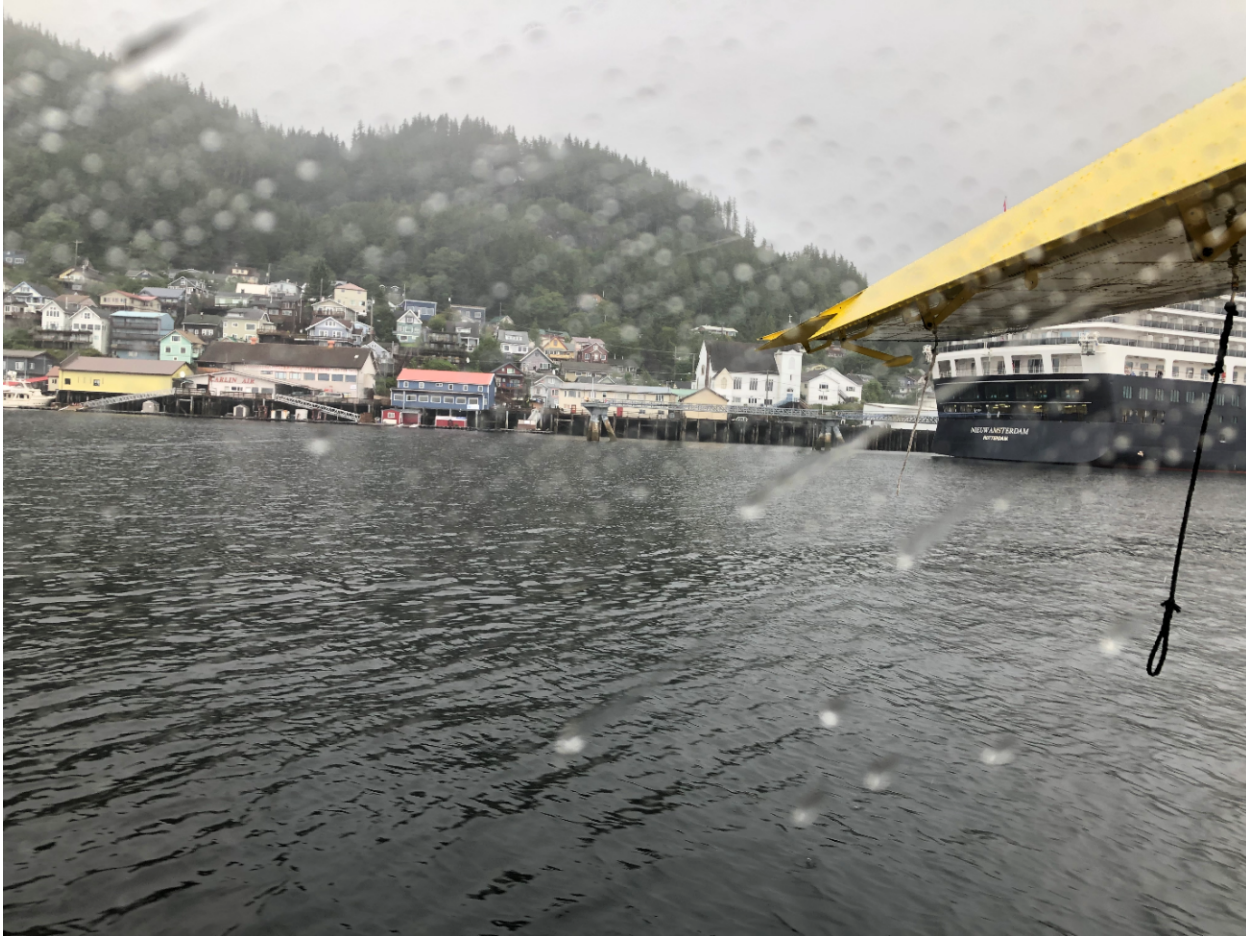
*Figure 1. Photograph taken by a passenger on the accident flight prior to departure. Image depicts the left side view from the accident airplane and shows rain on the passenger window.*

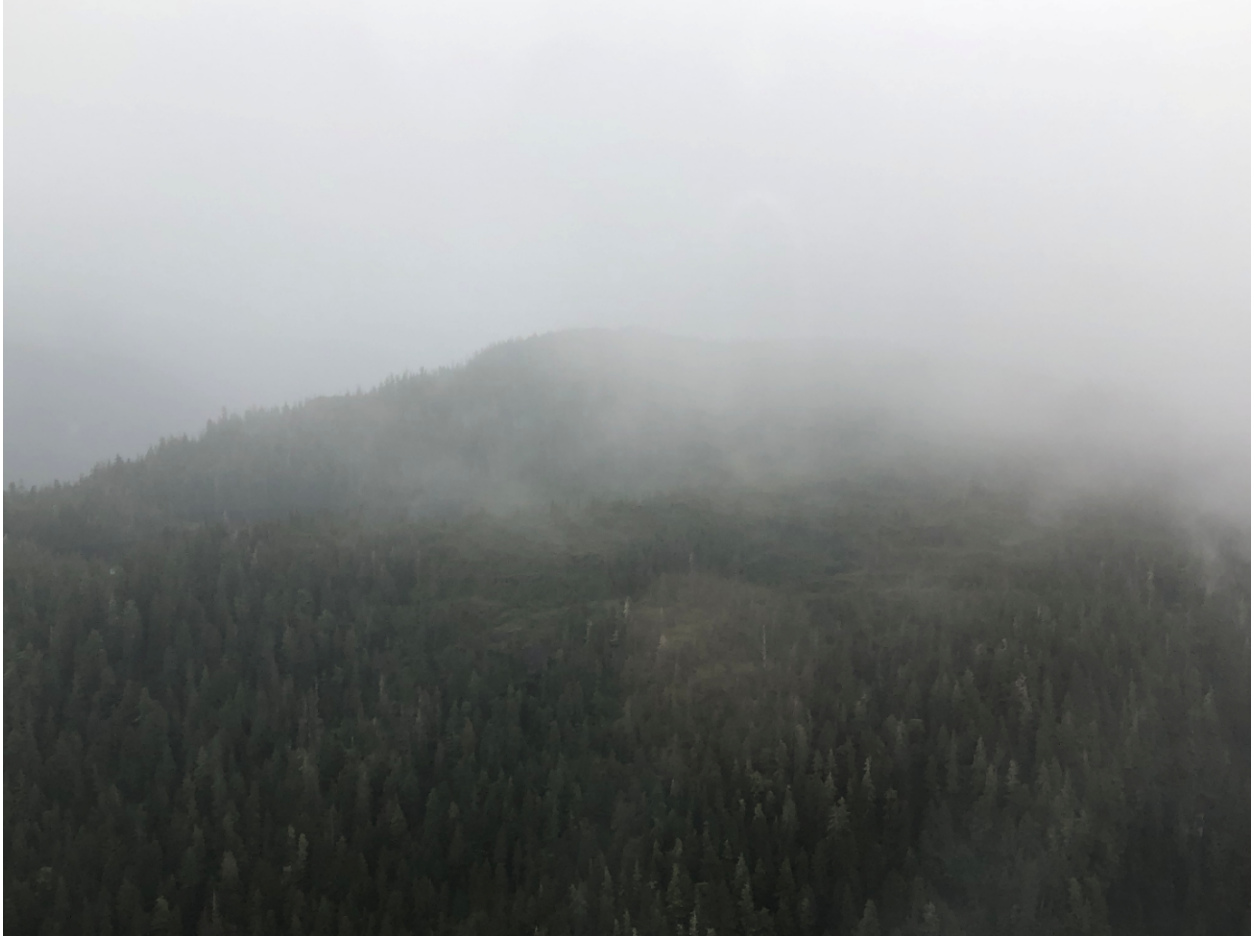
*Figure 2. Photograph taken by passenger at 1048.*

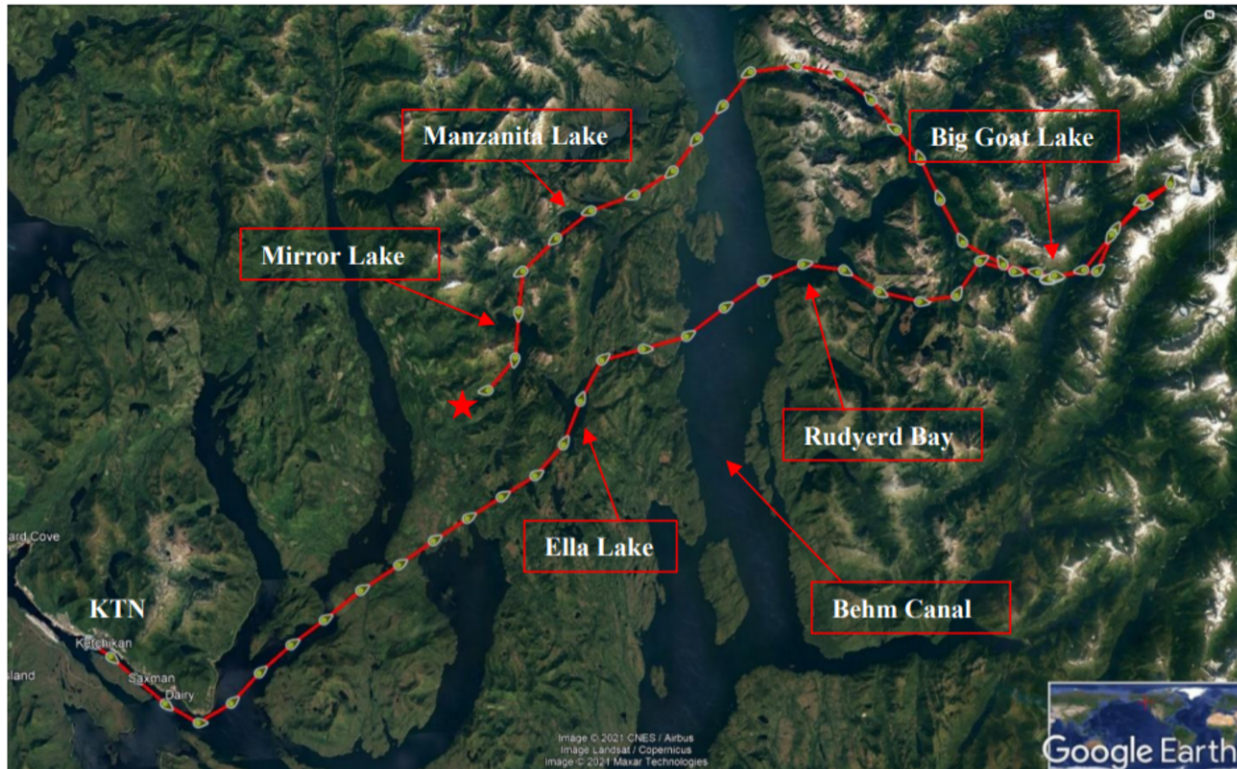
*Figure 3. Spidertracks image of accident flight. Arrows denote direction of travel and red star indicates approximate location where accident occurred.*

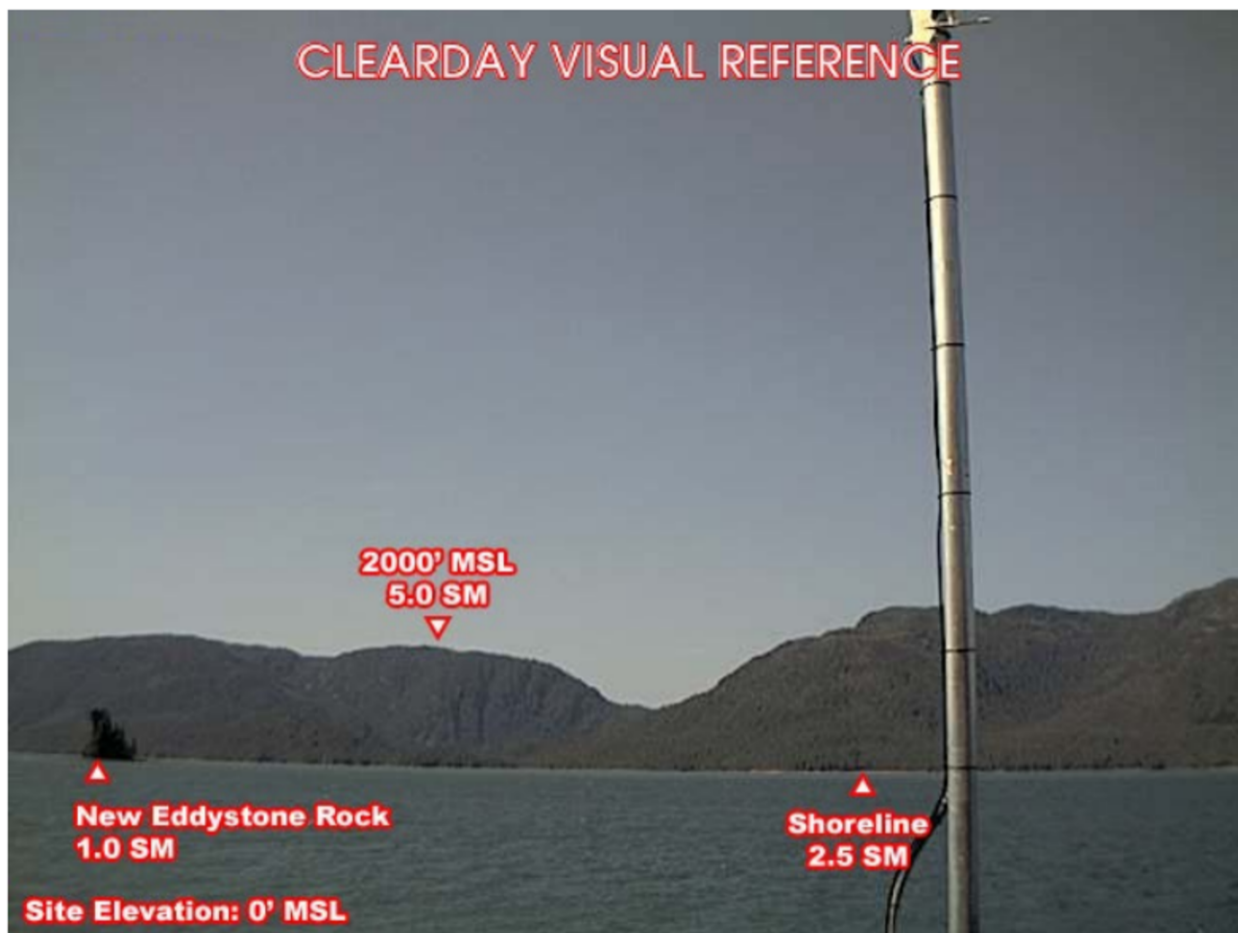
*Figure 4. FAA weather camera from Misty Fjords west view from a standard clear sky weather day*

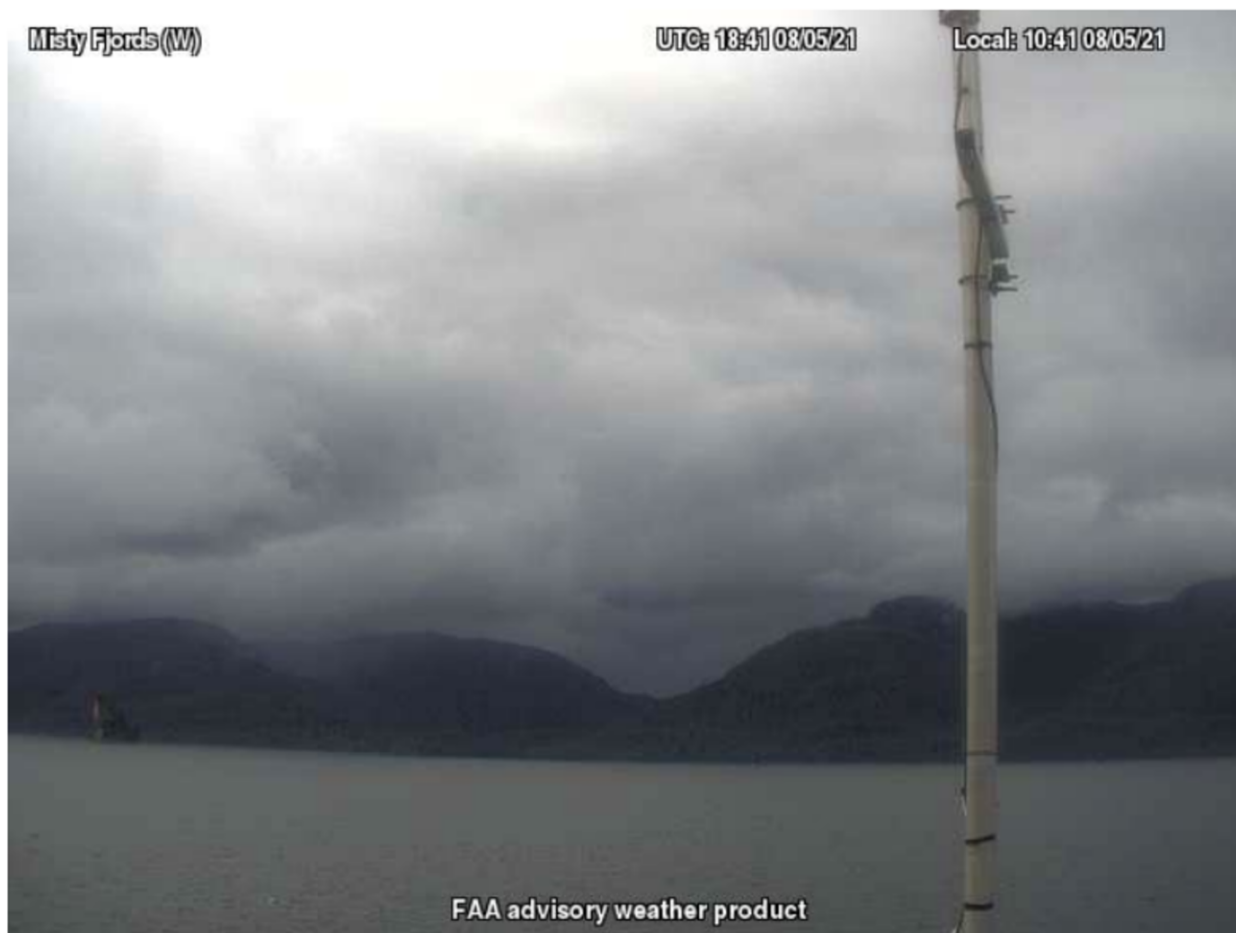
*Figure 5. FAA weather camera from Misty Fjords west view from 1041, which was just after the airplane crossed Behm Canal on the return portion of the accident flight.*

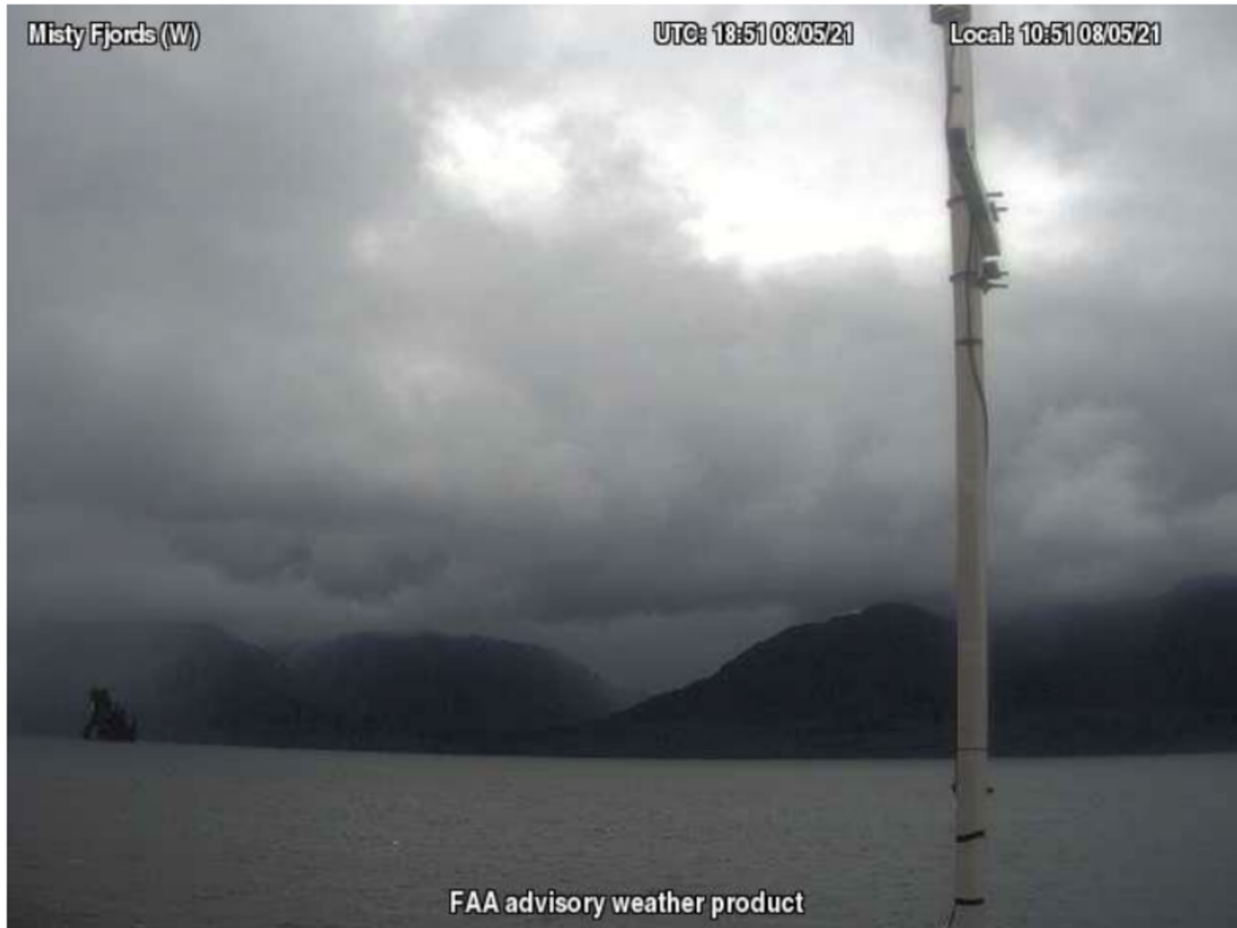
*Figure 6. FAA weather camera from Misty Fjords west view from 1051, which was about 3 minutes after the accident.*

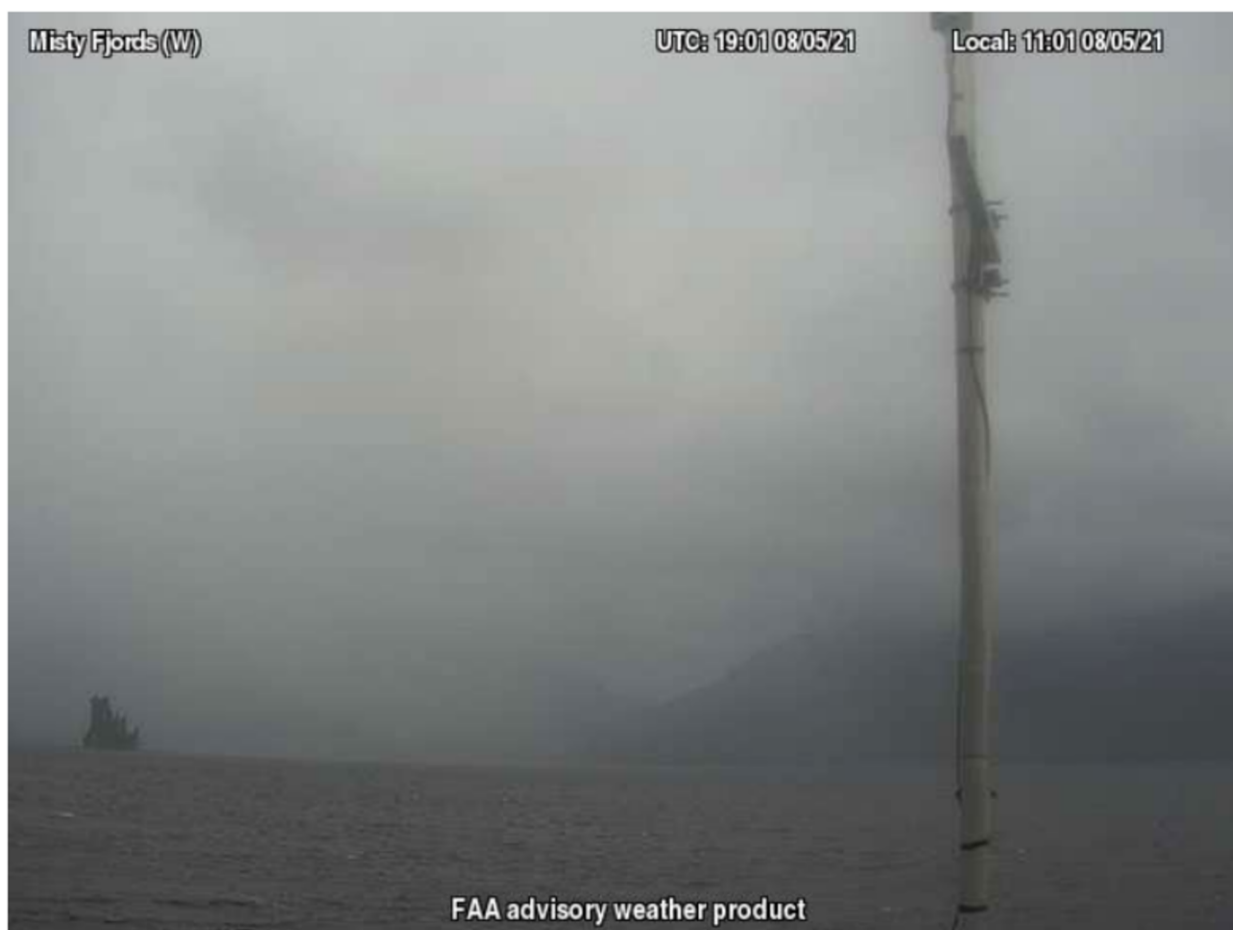
Figure 7. FAA weather camera from Misty Fjords west view from 1101, which was about 13 minutes after the accident.

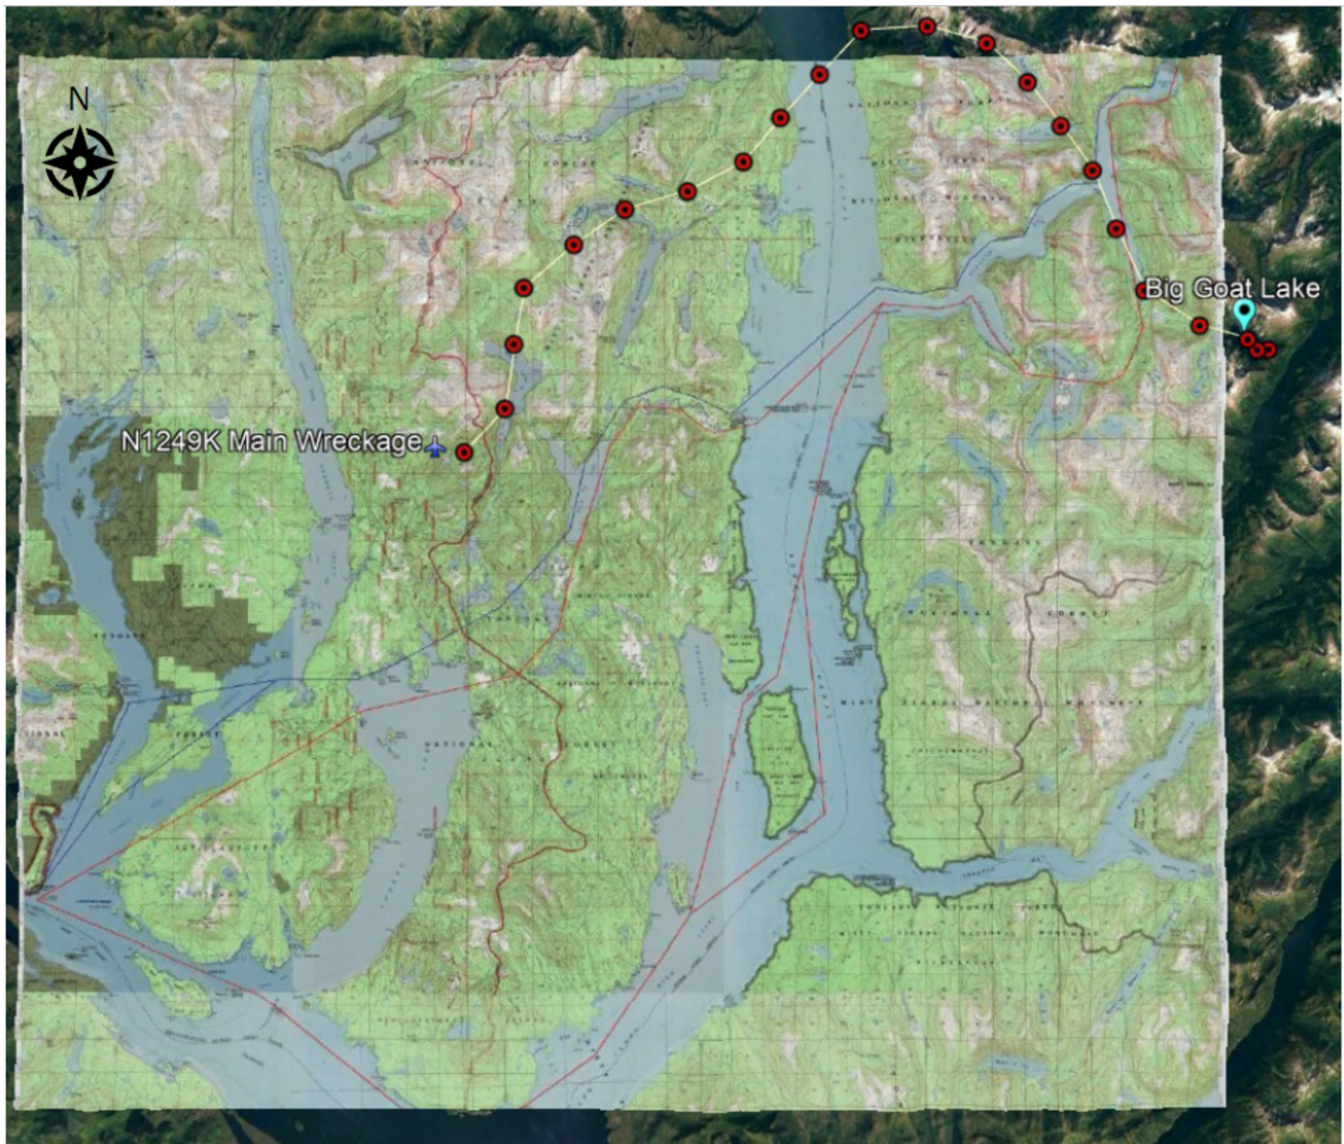
*Figure 8. View of standard Misty Fjords Routes outlined in the Letter of Agreement. Also, the accident flight is overlaid and depicts the flight from Big Goat Lake to where the wreckage was located. The blue lines denote the inbound routes to the Misty Fjords. The red lines in the map denote the outbound routes from the Misty Fjords.*

Southeast Aviation, LLC was a signatory on the LOA. The accident flight did not follow the standard Misty Fjords route outlined in the LOA, nor did it comply with the recommended altitudes for flights into and out of the Misty Fjords.
