Aviation Investigation Final Report

Location:	Myrtle Beach, South Carolina	Accident Number:	ERA21FA224
Date & Time:	May 21, 2021, 18:14 Local	Registration:	N575BC
Aircraft:	Piper PA-31P	Aircraft Damage:	Destroyed
Defining Event:	Aircraft maintenance event	Injuries:	1 Fatal
Flight Conducted Under:	Part 91: General aviation - Personal

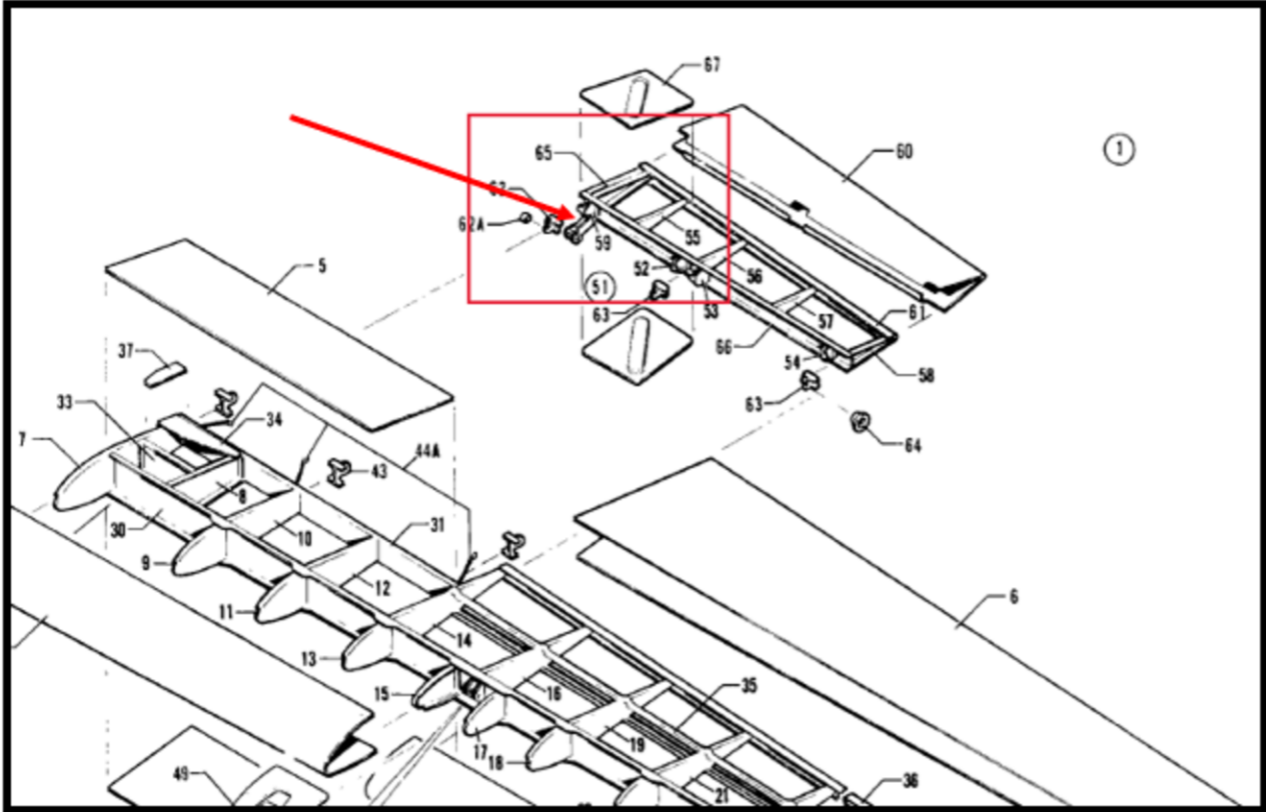
The maintenance facility also maintained a different version of the accident airplane, which was designed with the elevator trim tab control rod and control horn positioned on the bottom of the trim tab. It is possible that the mechanic may have thought the trim tab installation on the accident airplane was the same, which could explain why the mechanic inadvertently installed the elevator trim tabs in reverse. Although the illustrated parts catalog (IPC) warned in the introduction section that the IPC should not be used for rigging and installation purposes, a figure on a subsequent page of the IPC incorrectly depicted the elevator trim tab control horn positioned on the bottom side of the elevator trim tab. Had the mechanic referred to this figure, it may have contributed to the incorrect installation of the trim tabs.

According to the Piper PA-31P illustrated parts catalog, the Elevator Assembly figure incorrectly depicted the control horn on the bottom of the trim tab. (see Figure 1.) The illustrated parts catalog also noted in the Introduction section that, “UNDER NO CIRCUMSTANCES SHALL THIS CATALOG BE USED FOR RIGGING AND INSTALLATION PURPOSES.”

Figure 1. Excerpt from Illustrated Parts Catalog showing the control horn located on the bottom side of the elevator trim tab.

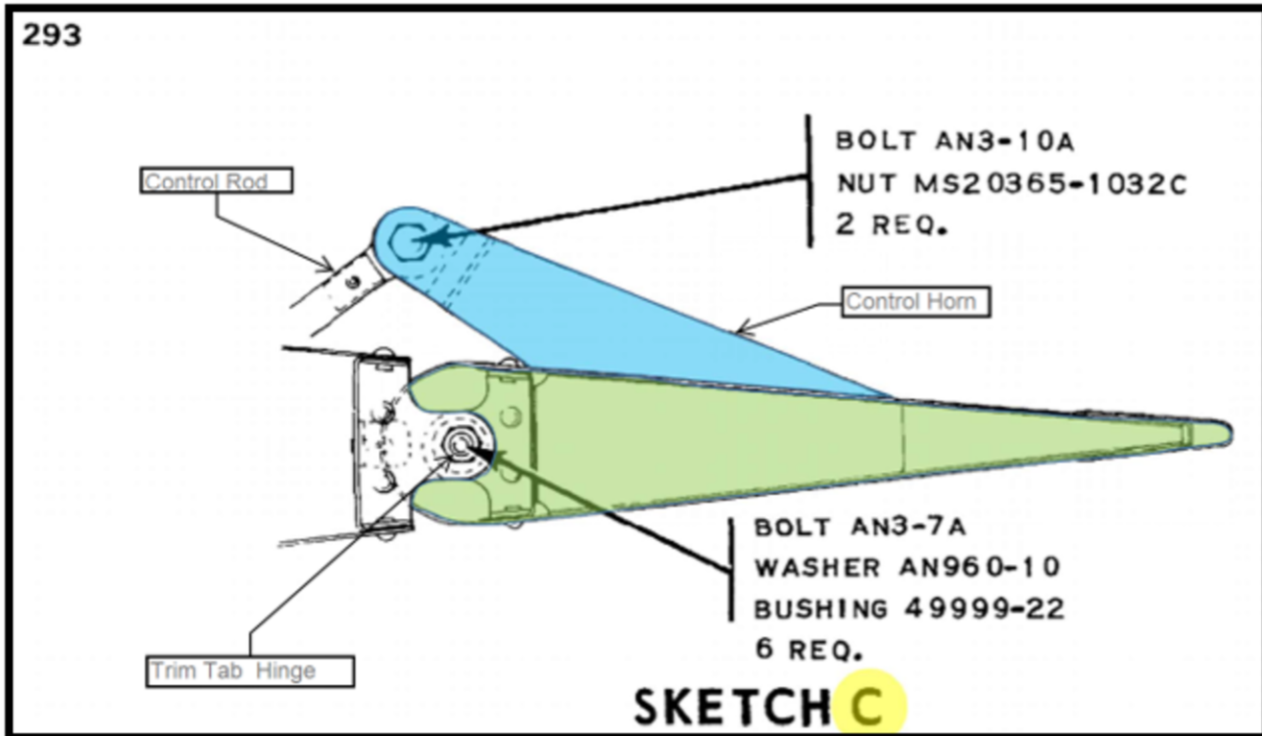
According to the Piper PA-31P maintenance manual, the elevator and elevator trim control figures correctly depicted that the control rod attached to the control horn as located on the top of the elevator trim tab. The instructions to install the elevator trim tab indicated to, “refer to figure 4-5.” Figure 2 is an excerpt from Figure 4-5 in the maintenance manual.

Figure 2. Excerpt from Airplane Maintenance Manual showing the trim tab hinge, with the control horn, and control rod located on the top side of the elevator trim tab.
