AIRCRAFT ACCIDENT REPORT
AAIA# AO-21-009

**Loss of Control Inflight and
Uncontrolled Collision with Terrain (Ocean)**

Piper Navajo PA-31-350
N827RD
South Bimini,
Bahamas

16th April, 2021

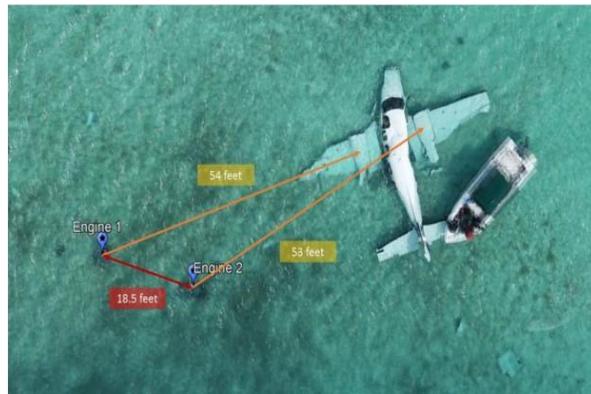
The extent of damage to the aircraft was substantial. Both left and right engines were dislodged from their installed position on the aircraft as a result of the initial impact and subsequent crash sequence.

- The left engine was located in waters approximately 54 feet left from its installed location on the aircraft
- The right engine was located in waters approximately 53 feet from its installed location on the aircraft, both engines were found 18.5 feet apart.

The field of debris was confined to an approximate 100 feet radius from the center of the fuselage. The aircraft came to rest at coordinates N25°42.4' and W079°15.9'.

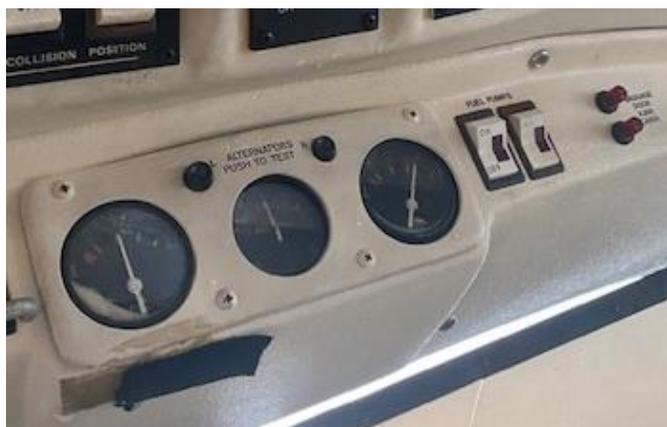
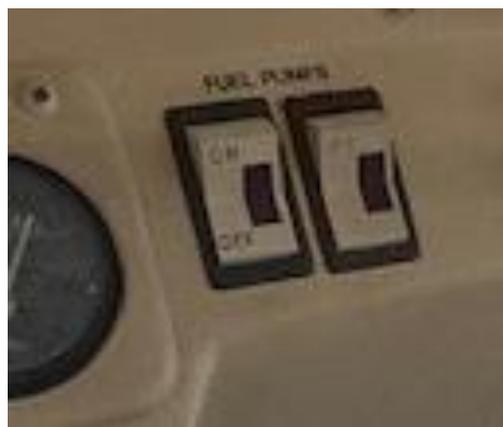
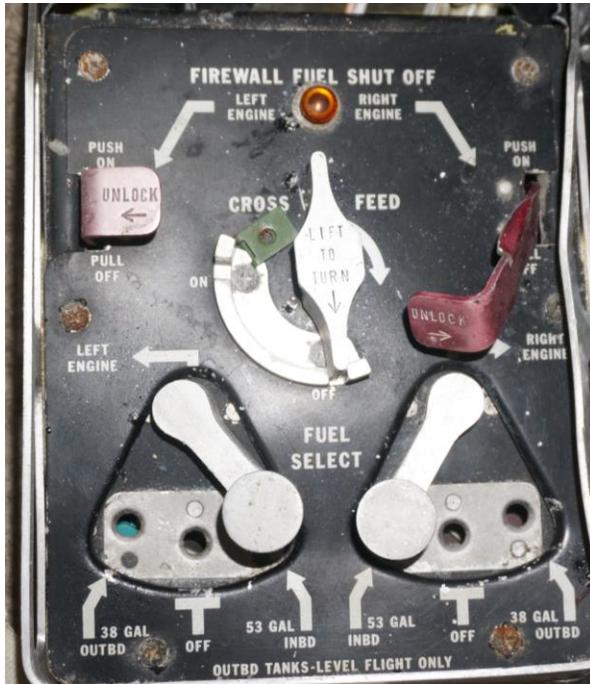
While the use or non-use of the fuel pumps could not be definitively determined to be a cause or a contributing factor in the accident, it is note-worthy, as they are required to be “**ON**” during take-offs and landings as per manufacturers documentation noted below.

9. All fuel pumps should be on for takeoffs and landings. On airplanes not equipped with fuel boost pumps*, the emergency fuel pumps should be on and operating on the ground for starts and when temperatures are above 75°F. With fuel boost pumps installed, use of the emergency fuel pumps will not normally be required for climbs or cruise at any altitude. However, high power climbs to high altitude under conditions of elevated ambient temperature, high climb rate, and extremely volatile fuel may cause a fuel boost pressure warning light to illuminate and/or the engine fuel pressure gauge to indicate unsteady fuel pressure. The emergency fuel pump should be turned on to provide stable engine operation during the high power operations, but may be turned off after level-out if reduction to cruise power extinguishes the boost pump warning light, and if engine fuel pressure remains steady with the emergency fuel pump off.
