# Aviation Investigation Final Report

<b>Location:</b>	Oroville, California	<b>Accident Number:</b>	WPR19FA230
<b>Date &amp; Time:</b>	August 21, 2019, 11:32 Local	<b>Registration:</b>	N91GY
<b>Aircraft:</b>	Cessna 560XL	<b>Aircraft Damage:</b>	Destroyed
<b>Defining Event:</b>	Runway excursion	<b>Injuries:</b>	10 None
<b>Flight Conducted Under:</b>	Part 135: Air taxi & commuter - Non-scheduled

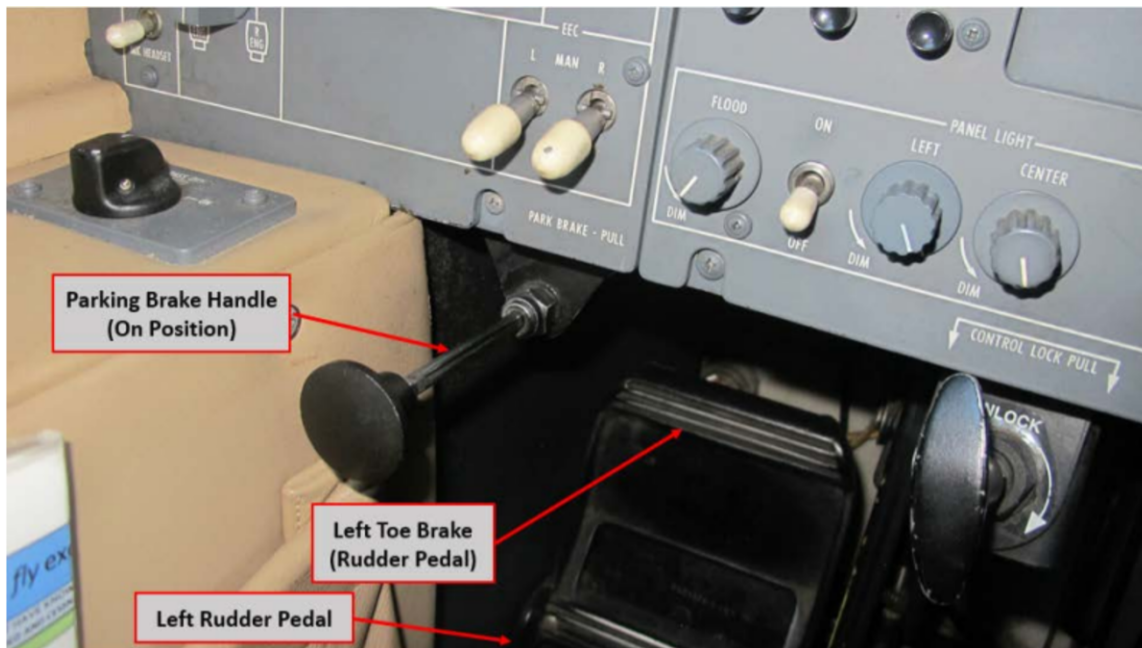
Figure 1: View of the parking brake pull knob in the ON position in reference to the instrument panel in an exemplar CE-560XL.

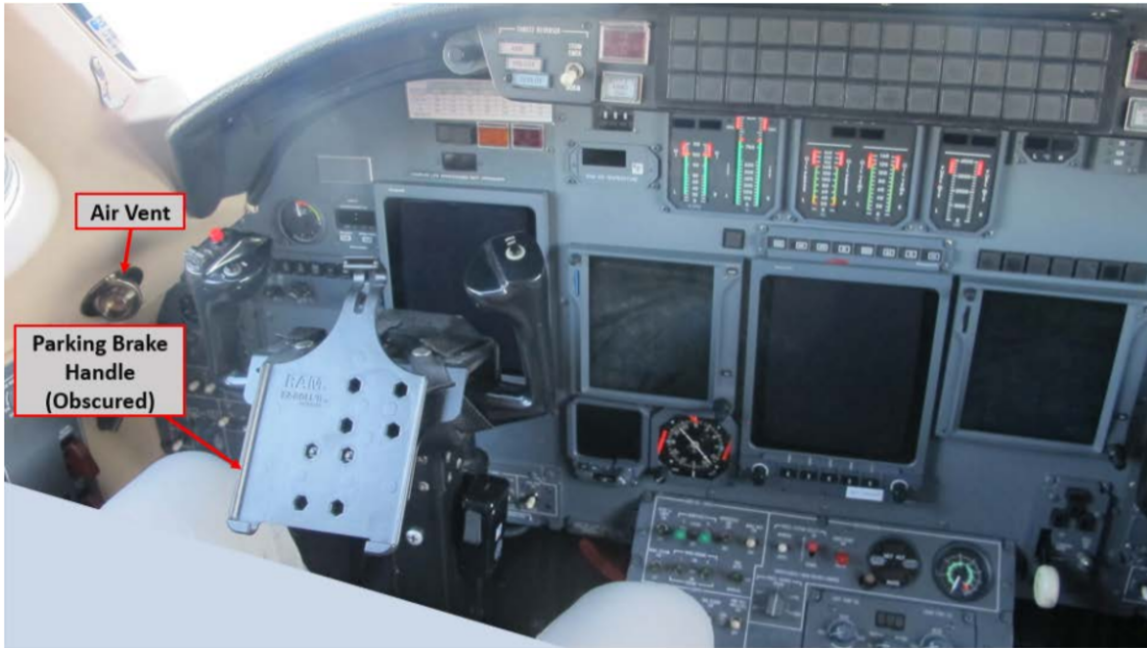
If the CE-560XL toe brakes are not fully depressed when the parking brake valve is engaged, then only partial pressure would be trapped by the parking brake valve. In a submission for this investigation, the manufacturer stated that the parking brake valve is designed to also trap pressure in the brake lines if the parking brake pull knob is pulled first, followed by application of the toe brakes, but the manufacturer's operating manual does not include that information. The parking brake pull knob on the CE-560XL is located on the lower left side of the instrument panel near the left-seat pilot's left knee, which obscures it from the view of the right-seat pilot (see figure 2).

Figure 2: Location of the obscured parking brake pull knob within an exemplar CE-560XL

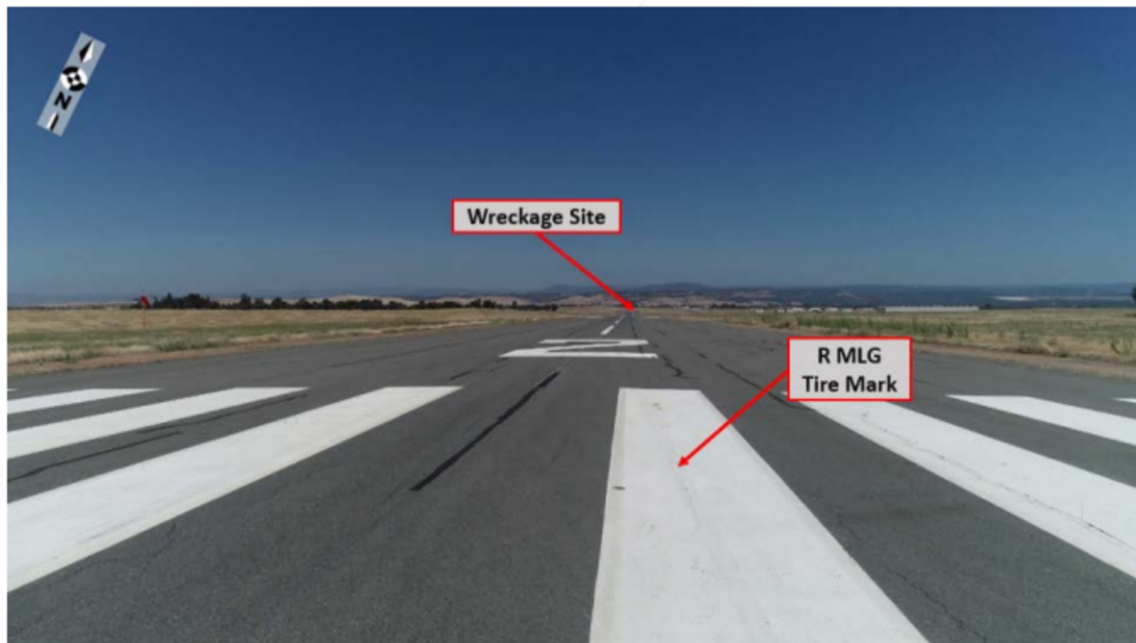
Examination of the runway revealed tire transfer marks which originated from near the runway 2 hold short line and progressed onto the runway then continued throughout the entire length of the runway, runway overrun, and a perpendicular oriented runway (see figure 3). The

Figure 3: View of the approach end of runway 2, with right main landing gear (MLG) transfer marks annotated.

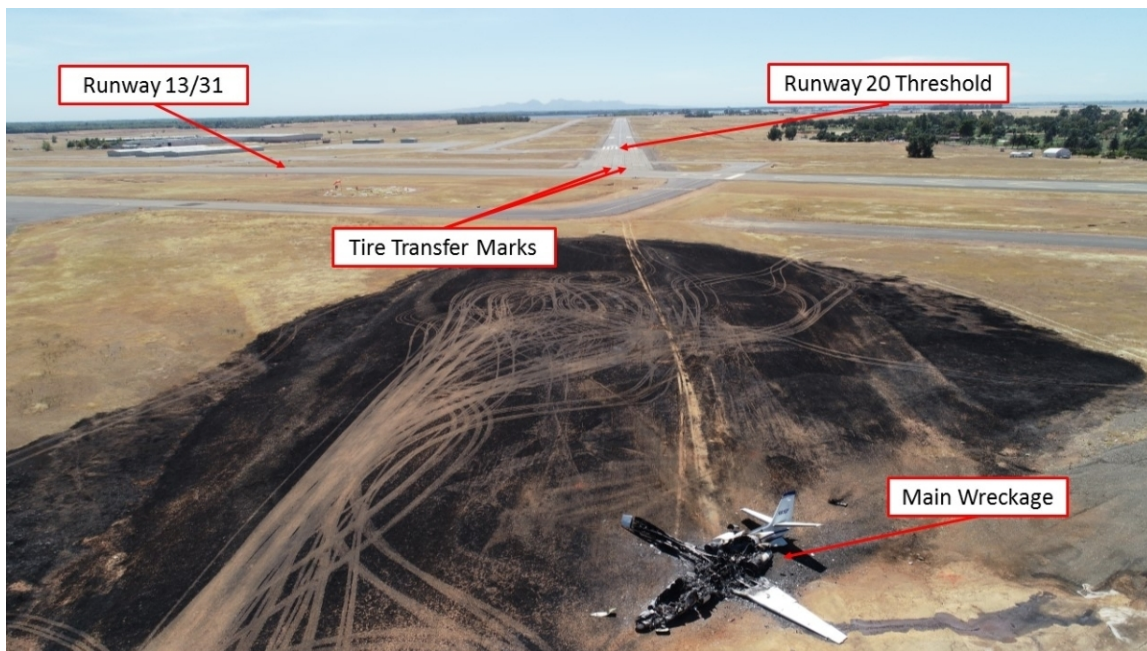
tire marks extended into a grassy area, across a taxiway, and within the grassy area near the main wreckage (see figure 4).

Figure 4: View of the accident site and runway environment.

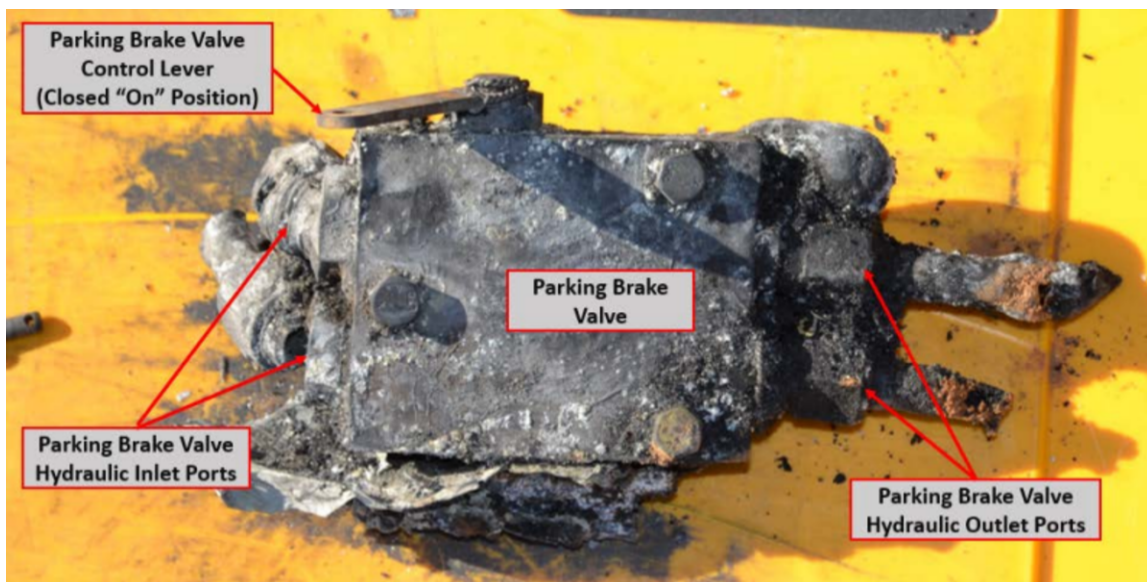
The parking brake valve was located loose in the wreckage and was damaged by fire. The parking brake control cable was attached to the valve and all attaching hardware was present. The cable was removed from the valve without disturbing the valve lever position, but the cable could not be actuated due to unknown obstructions/interference that could not be determined on scene. Based on a visual inspection of the lever position, the brake valve was in the ON position, as shown in figure 5. No part identification or data plate could be found on the component.

Figure 5: Parking brake valve after removal from the wreckage

The parking brake valve was scanned using computed tomography and the resulting images showed internal valve components in a closed position, which is consistent with an ON position.

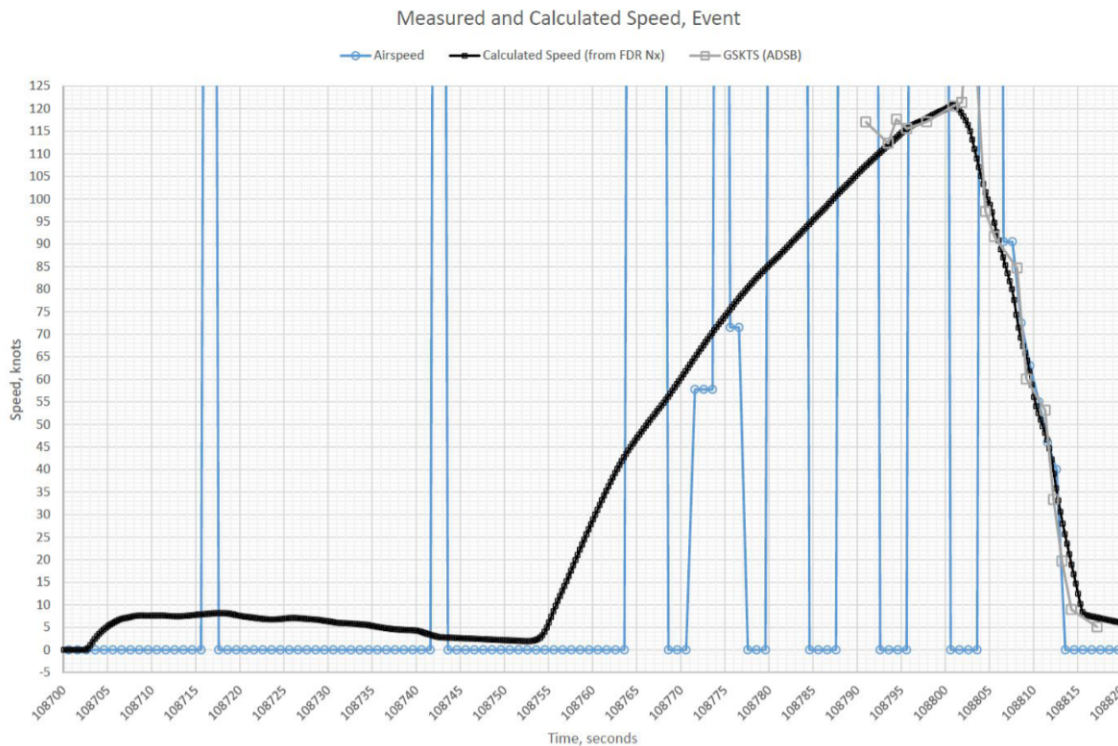
Data obtained from the onboard flight data recorder revealed that 16 of the 59 parameters, including airspeed, contained invalid data. A performance study based upon longitudinal acceleration data (which was found to be valid) revealed that the airplane had reached a maximum speed of about 120 knots during the takeoff sequence, as shown in figure 6. The calculated takeoff-decision and rotational speeds in a normal configuration for the accident takeoff were 106 knots, and angle-of-climb speed was calculated to be 123 knots.

Figure 6: Comparison of calculated ground speed, flight data recorder airspeed, and automatic dependent surveillance-broadcast data.

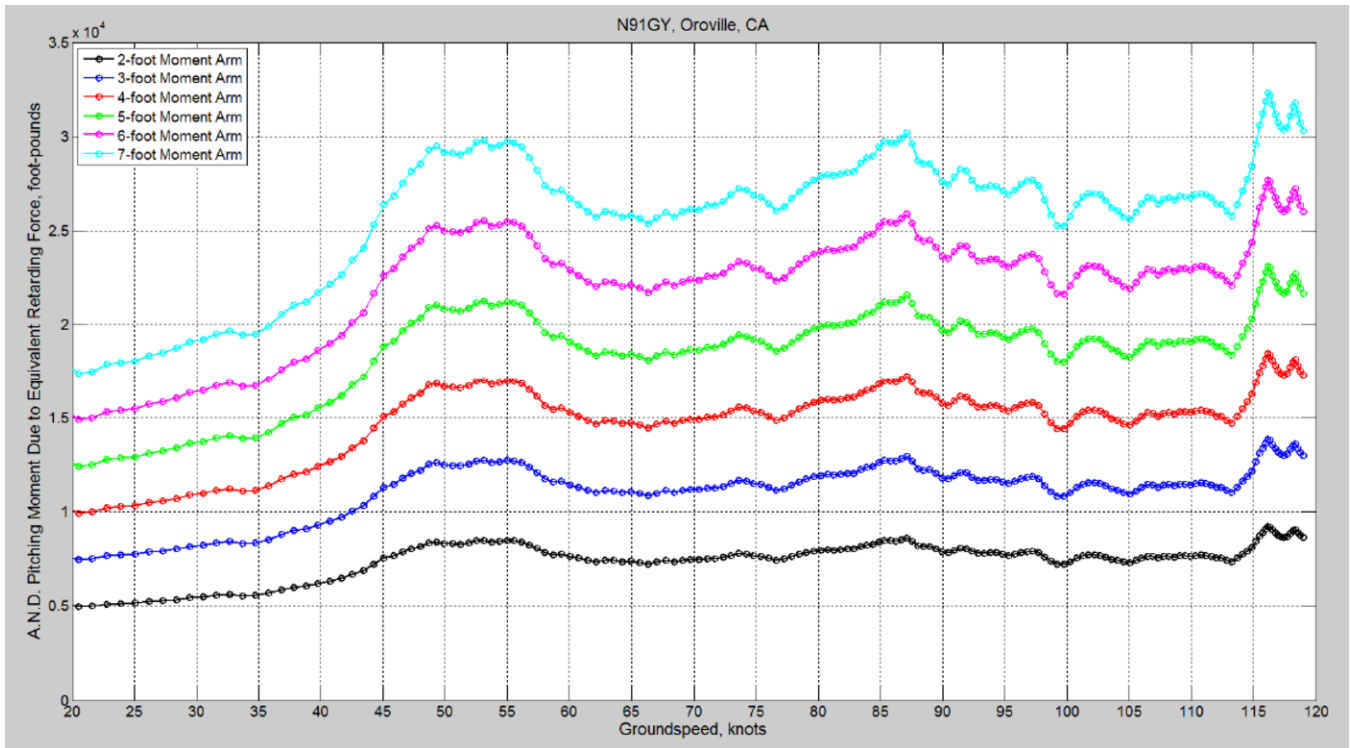
moment capability was calculated between about 10,300 and 12,800 ft-pounds (ft-lb). Based on CE-560XL engineering drawings and the accident airplane's weights, a vertical moment arm was estimated at 3.5 ft. The airplane nose down pitching moment calculations using CE-560XL engineering models (figure 7) indicate about 13,000 ft-lb for groundspeeds between 90 and 110 knots and a 3.5 ft moment arm, which matches or exceeds the available airplane nose up pitching moment capability for the accident CG loading values. Thus, the accident airplane's unexpected retarding force directly competed against and could inhibit airplane nose up elevator/horizontal stabilizer authority at rotation speed for the accident CG loading value.

Figure 7: Estimated airplane nose down pitching moment due to calculated equivalent retarding force during the accident takeoff ground roll.

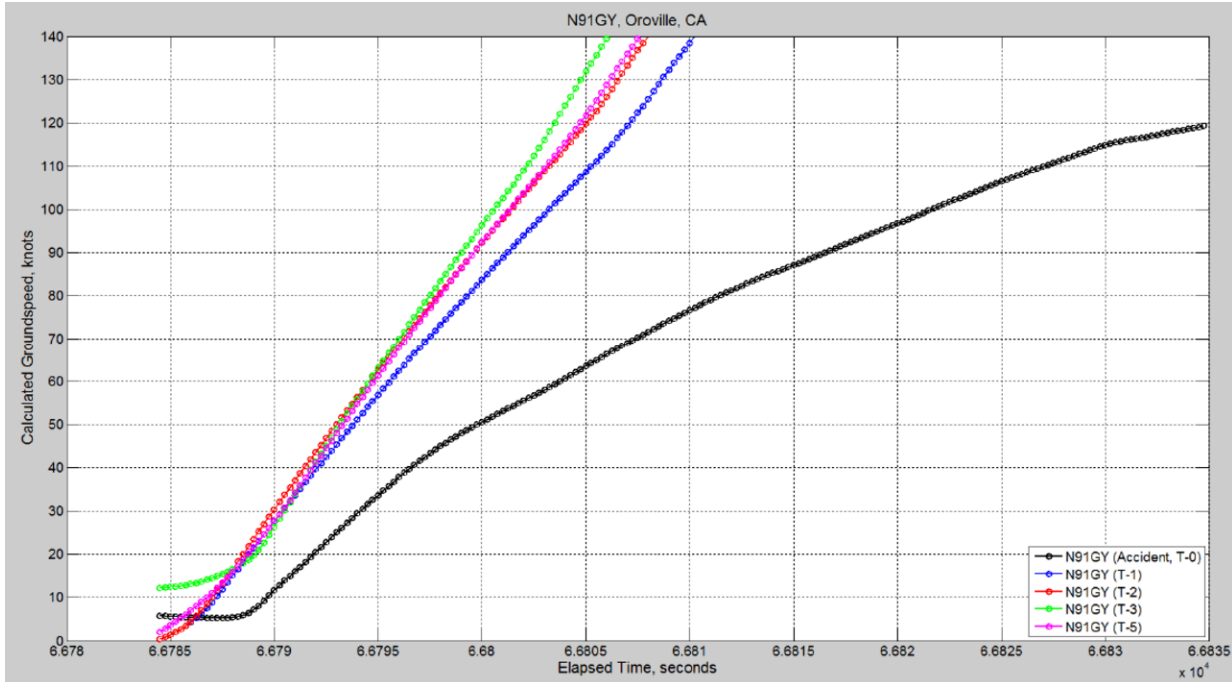
The magnitude and direction of the unexpected retarding force adversely affected the airplane's acceleration and rotation capability during the attempted takeoff as well as deceleration capability when stopping. Figure 8 shows the airplane's groundspeed for previous takeoff sequences as compared to its degraded groundspeed during the accident takeoff (black line and symbols).

Figure 8: Calculated airplane groundspeed values for previous takeoffs and the accident takeoff.
