Aviation Investigation Final Report

Location:	West Palm Beach, Florida	Accident Number:	ERA21LA011
Date & Time:	October 8, 2020, 11:15 Local	Registration:	N8132Q
Aircraft:	Cessna 414	Aircraft Damage:	Substantial
Defining Event:	Runway excursion	Injuries:	7 Serious
Flight Conducted Under:	Part 91: General aviation - Personal

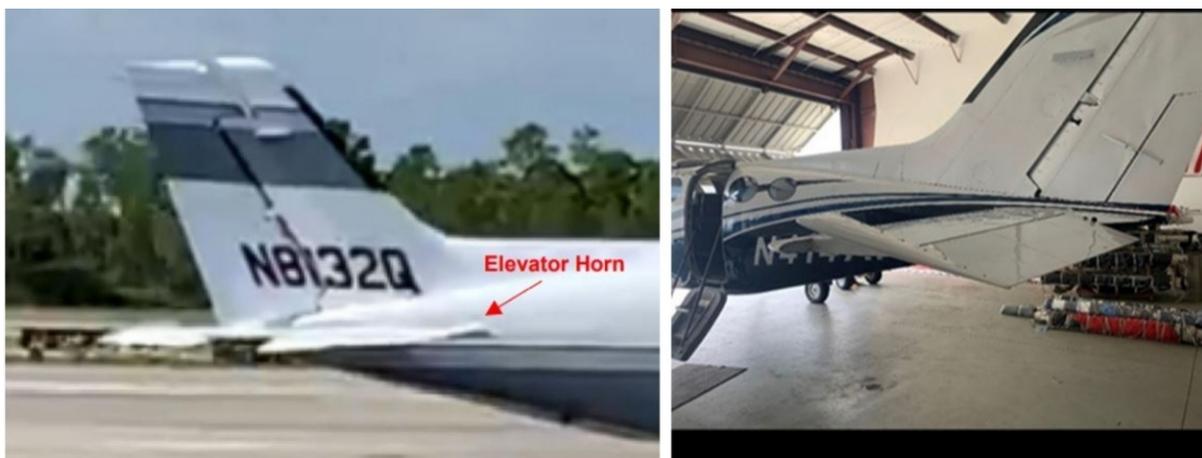
Review and analysis of a video that captured the airplane during its taxi to the runway showed that the elevator control position was similar to what it would be with the control lock installed. While the pilot and copilot reported that they did not observe the control lock installed during the takeoff, the position of the elevator observed on the video, the successful postaccident functional test of elevator, and the unsecured flight control lock being located behind the

pilot's rudder pedals after the accident suggest that the control anomaly experienced by the pilots may have been a result of the control lock remaining inadvertently installed and overlooked by both pilots prior to the takeoff.

Witness and airport surveillance videos were sent to the NTSB Vehicle Recorders division for a detailed video study. The witness video showed the airplane as it began to taxi on the ramp. Still images captured from the video show the elevator was in the trailing-edge-down position with the elevator horns above the horizontal stabilizer. An exemplar airplane with a control lock installed was used for reference and showed the elevator in a trailing-edge-down position with the elevator horns above the horizontal stabilizer surface. The accident airplane's exact elevator position, although similar to the exemplar airplane with a control lock installed, could not be calculated from the still images (see figure 1).

Figure 1 – Still frame from video footage of the accident airplane's elevator during taxi (left) compared to the elevator on an exemplar airplane with a control lock installed (right).
